# Inspecting dock road slab structures with ground penetrating radar

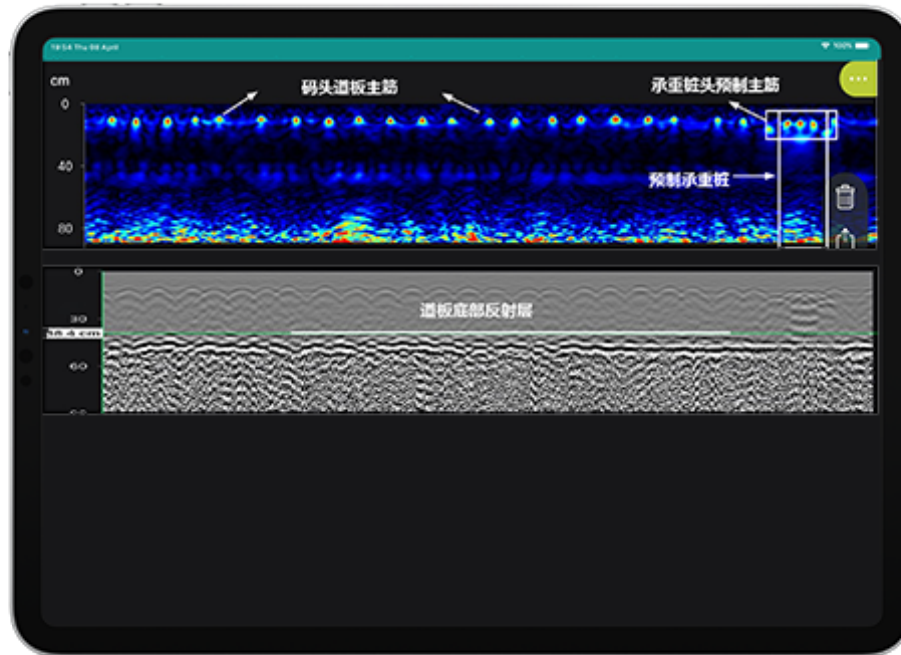
The radar map of the Road Plate detected by GP8000

As can be seen from the figure, the GP8000 can clearly detect the health of the debut plate structure: the main rib is clearly visible, the bottom reflection is clear and continuous, flat, and there is no large-scale spalling and damage at the bottom.

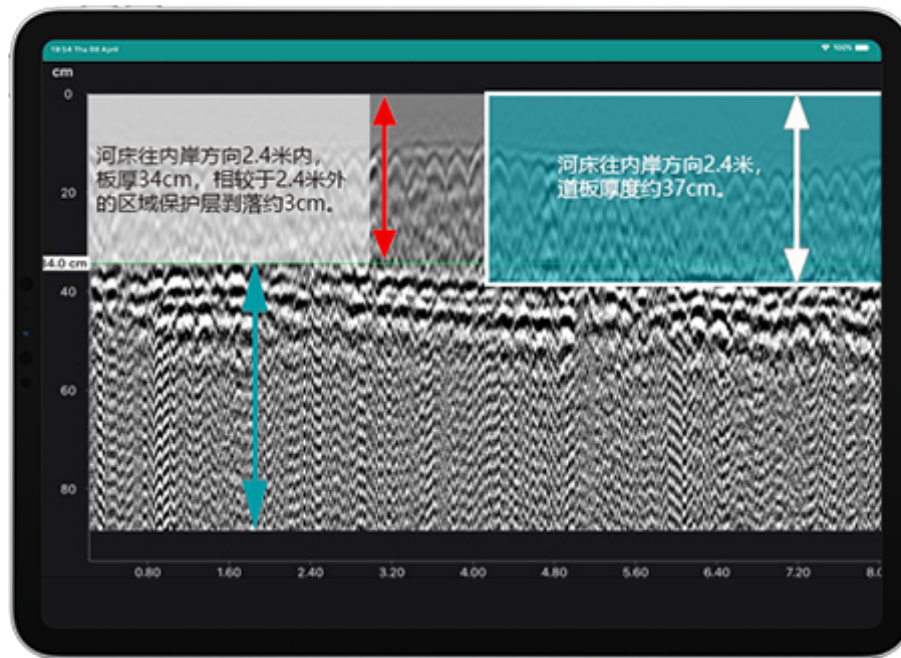
### Suspected damage to the road plate detected by GP8000

Through the GP8000 radar checking test, it is not difficult to find that the thickness of front plate where riverbed is within 2.4 meters to the inner bank is about 34cm; and the thickness of back plate where the riverbed is 2.4 meters away from the inner bank is about 37cm. that means the protective layer of the front plate is reduced by about 3 cm.

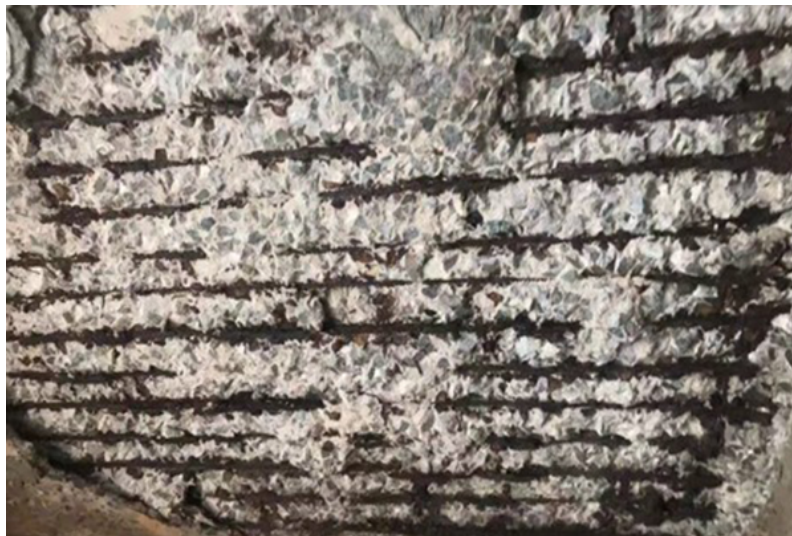
Rusting and peeling areas (front plate)

During the dry period, the field conditions verified by the inspectors coincided with the response of the [GP8000](#) GPR detection signal. Due to the impact of the water wave, the front road plate is attacked by moisture and ions for a long time, resulting in the long-term corrosion activation state of the steel reinforcement inside the concrete. This caused the concrete protective layer to corrode and crack, peeling, resulting in the exposed steel bar, which in turn aggravates the damage of the steel bar and the lack of bearing capacity of the road plate.

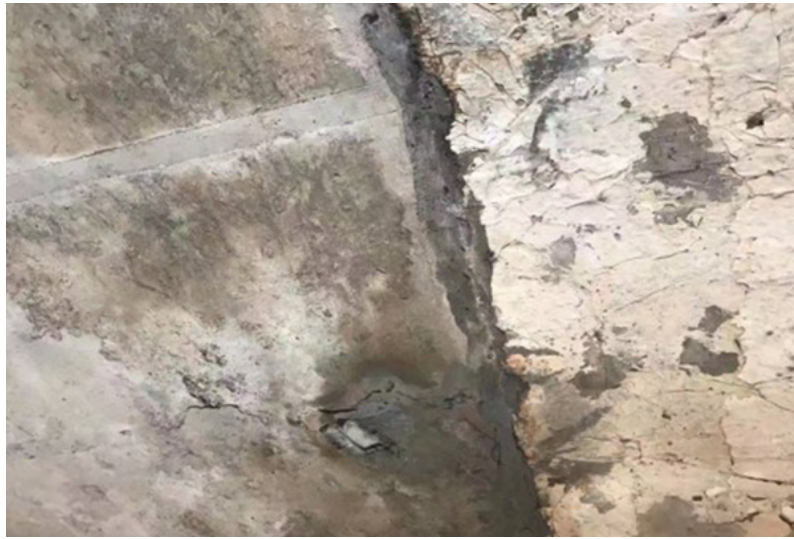
Undamaged areas (back plate)

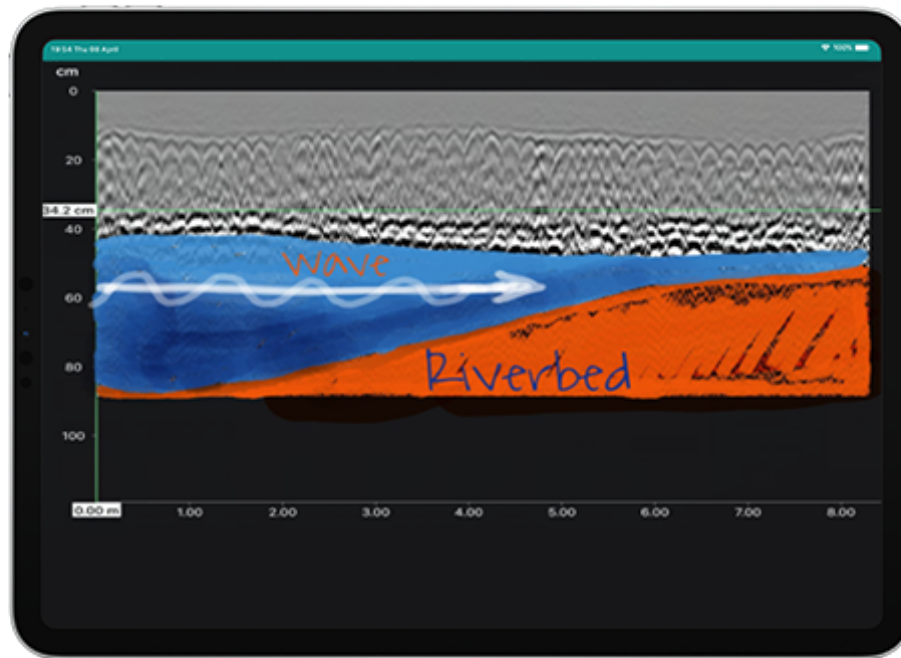
Cross-sectional view of water wave erosion
