Inspecting dock road slab structures with ground penetrating radar

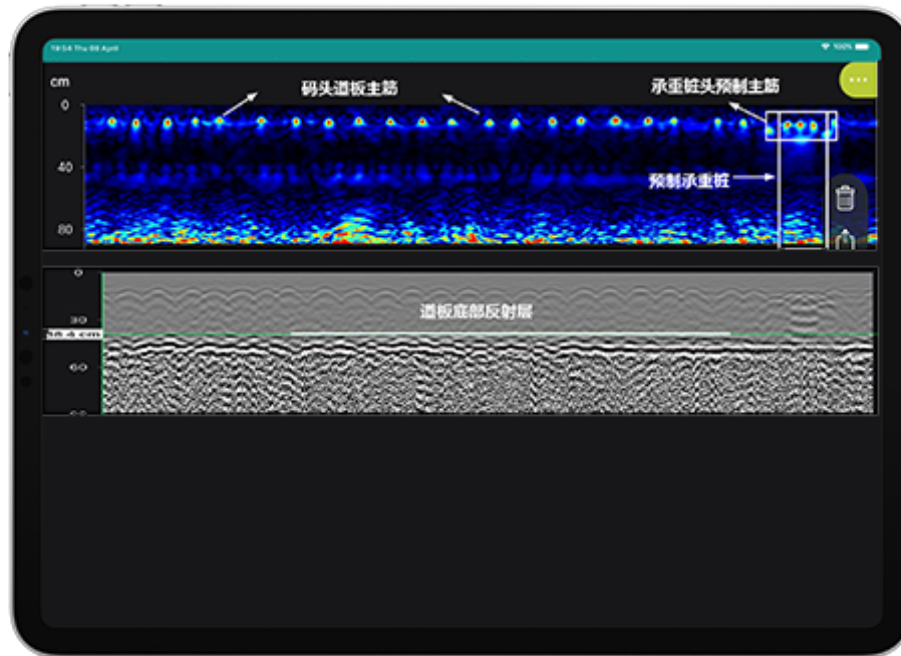
The radar map of the Road Plate detected by GP8000

As can be seen from the figure, the GP8000 can clearly detect the health of the debut plate structure: the main rib is clearly visible, the bottom reflection is clear and continuous, flat, and there is no large-scale spalling and damage at the bottom.
