Time-critical investigation and testing of a precast concrete beam using Ultrasonic Pulse Velocity (UPV)

Overview

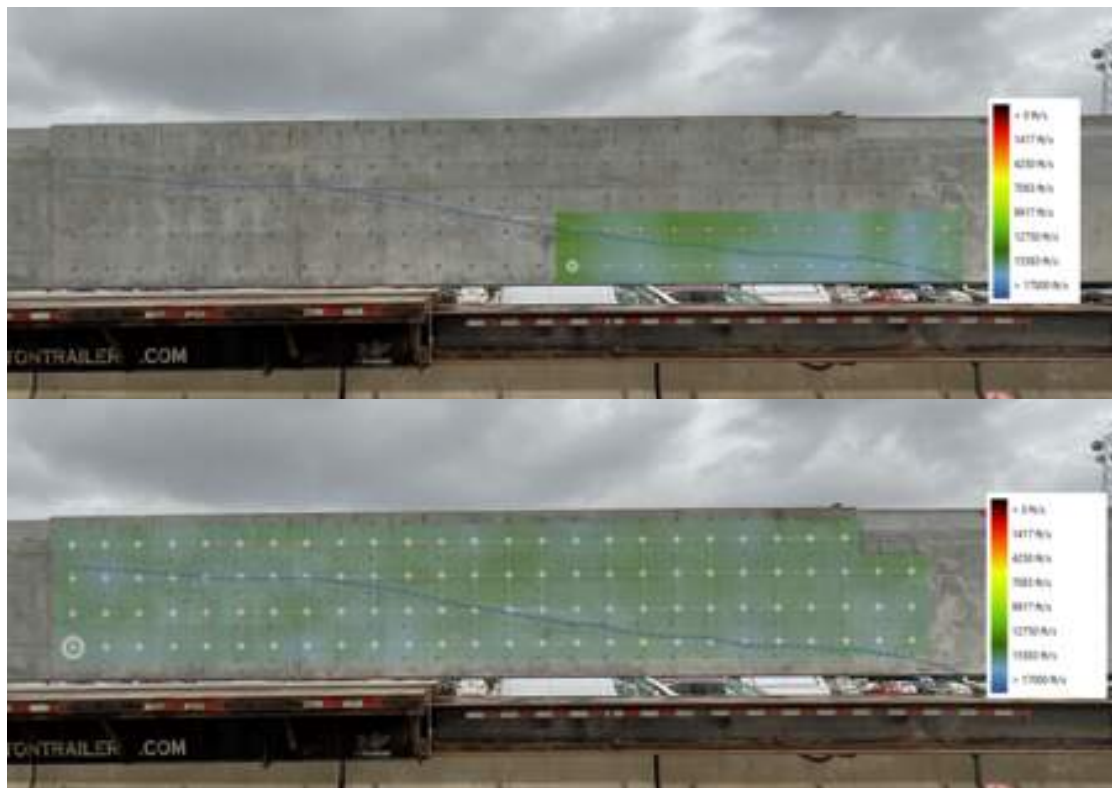
To evaluate the presence of a potential discontinuity, UPV was performed on a 26 ft by 5 ft grid on the South face of the beam with a 1 ft transducer spacing. Indirect velocity readings ranged from 14,390 ft/s to 16,555 ft/s with an average 15,440 ft/s (results are shown superimposed on a photograph of the beam). A 12 ft by 3 ft indirect transmission grid was also performed on the North face of the beam with a 1 ft transducer spacing. These indirect velocity readings ranged from 14,205 ft/s to 16,420 ft/s with an average 15,480 ft/s.

It was clear from the results that the velocities were similar throughout the measurement grid and do not indicate discrepancies or areas of weakness. Therefore, the UPV measurements indicated the beam has been placed monolithically and did not suggest the presence of a cold joint or discontinuity.
