# Revealing hidden voids and unexpected findings on the post-tensioning ducts of concrete bridges

## Screening Eagle uncovers surprising results with non-destructive testing on Huntingdon Railway Viaduct in the UK with National Highways

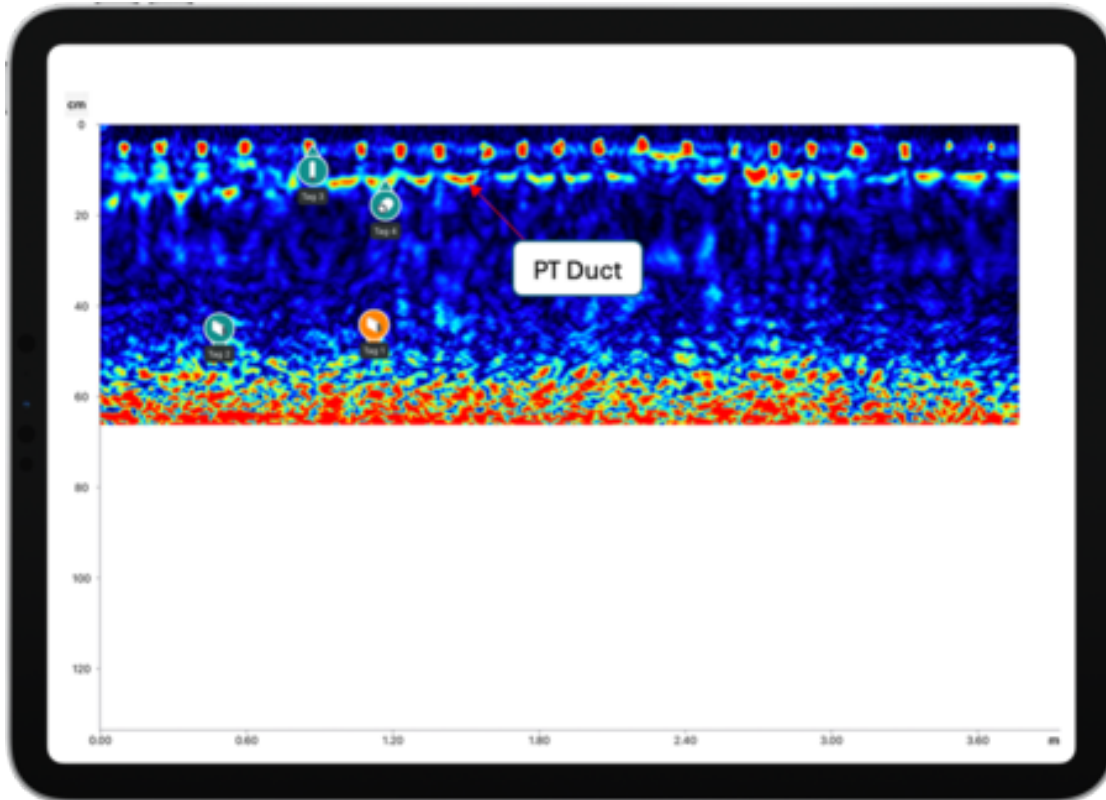
GPR Scan with Proceq GP8800 showing the path of the PT duct.

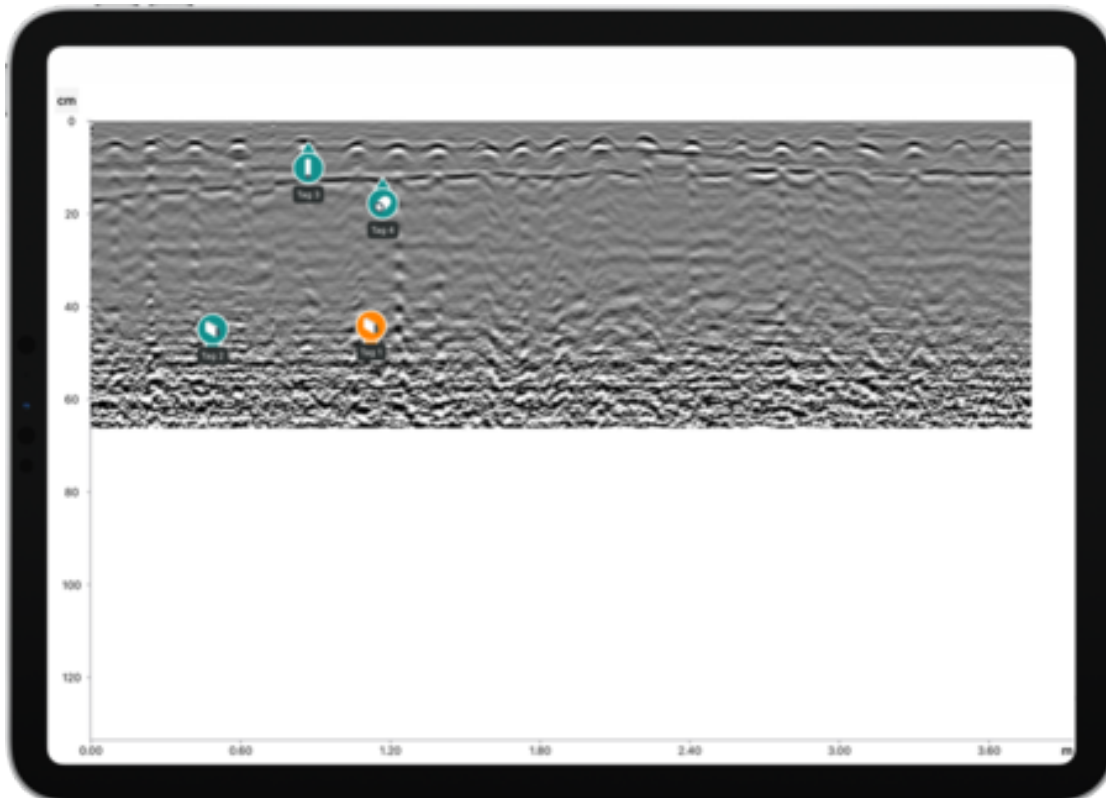
Radargram view showing double reinforcing bars above the PT duct (apart from the last 2 bars on the right.)

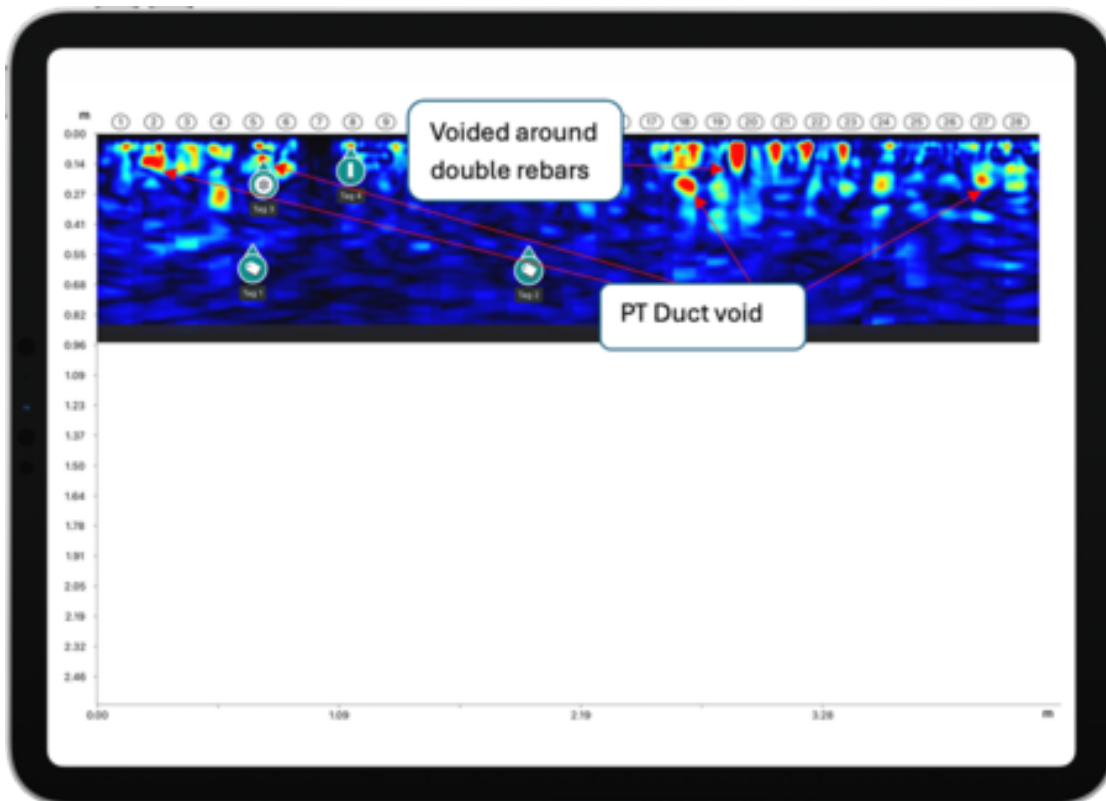
Results from the PD8050 showing localised voiding, taken over the same location as the GPR scans. Additionally the double rebars appear to have voiding around them.

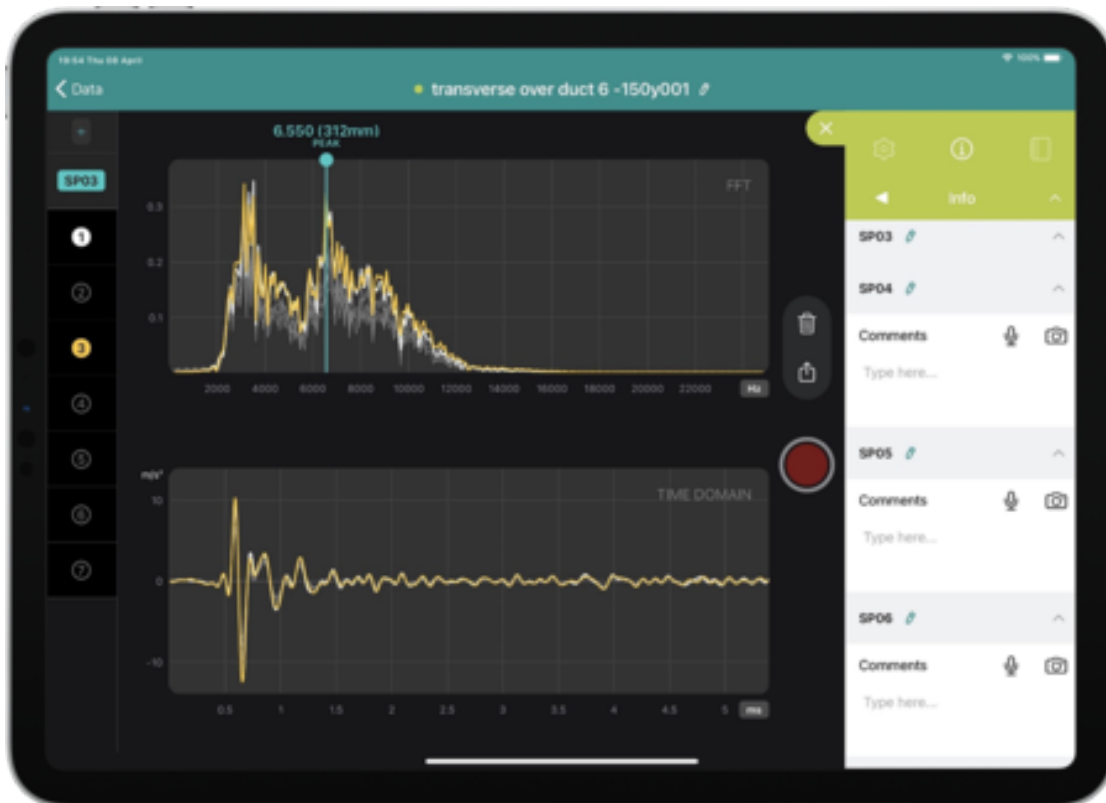
Another area was previously communicated as possibly being voided. Initial scans with GPR showed nothing, but the follow-up tests with the PD8050 and PI8000 both showed air voiding.

Air voiding as shown with Pundit PI8000 ultrasonic impact echo technology, taken in the same spot as the PD8050.

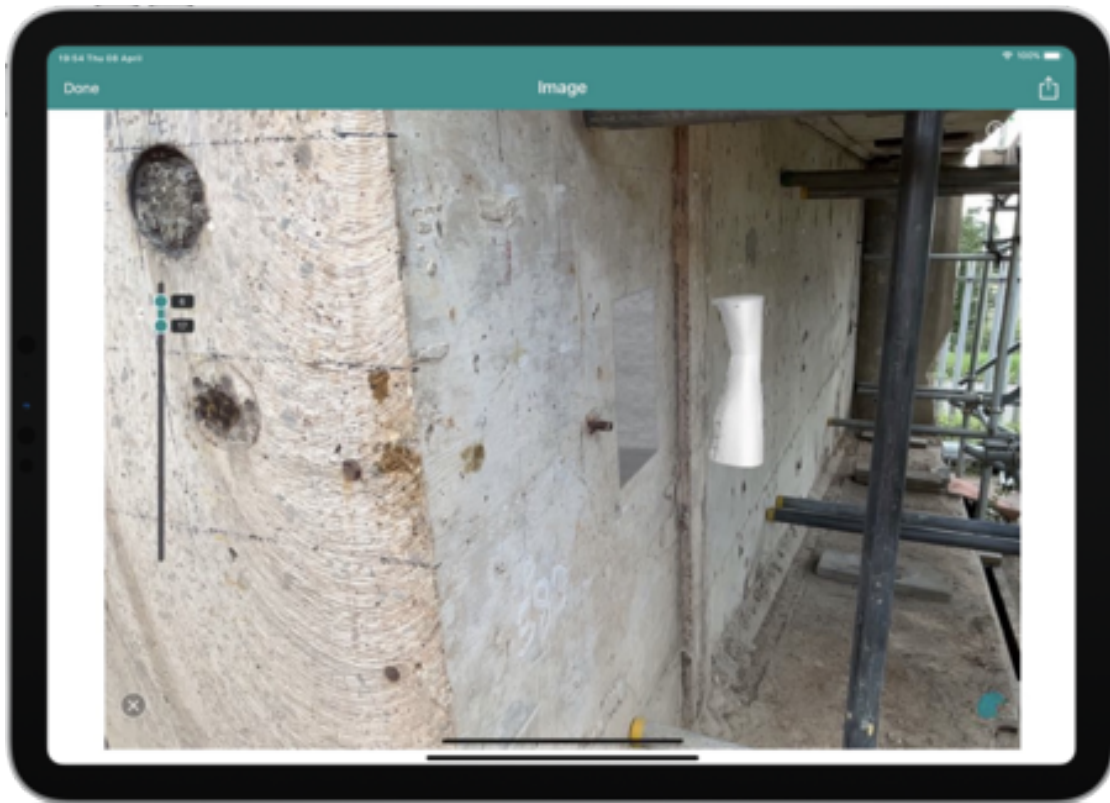
Augmented reality representation of the void taken with the Pundit PD8050 ultrasonic pulse echo technology.

The AR view above shows the possible shape of the void, which appears to be a duct of some type, or perhaps a grouting channel or drain. It is not metal, and does not appear to reflect EM waves from the GPR.

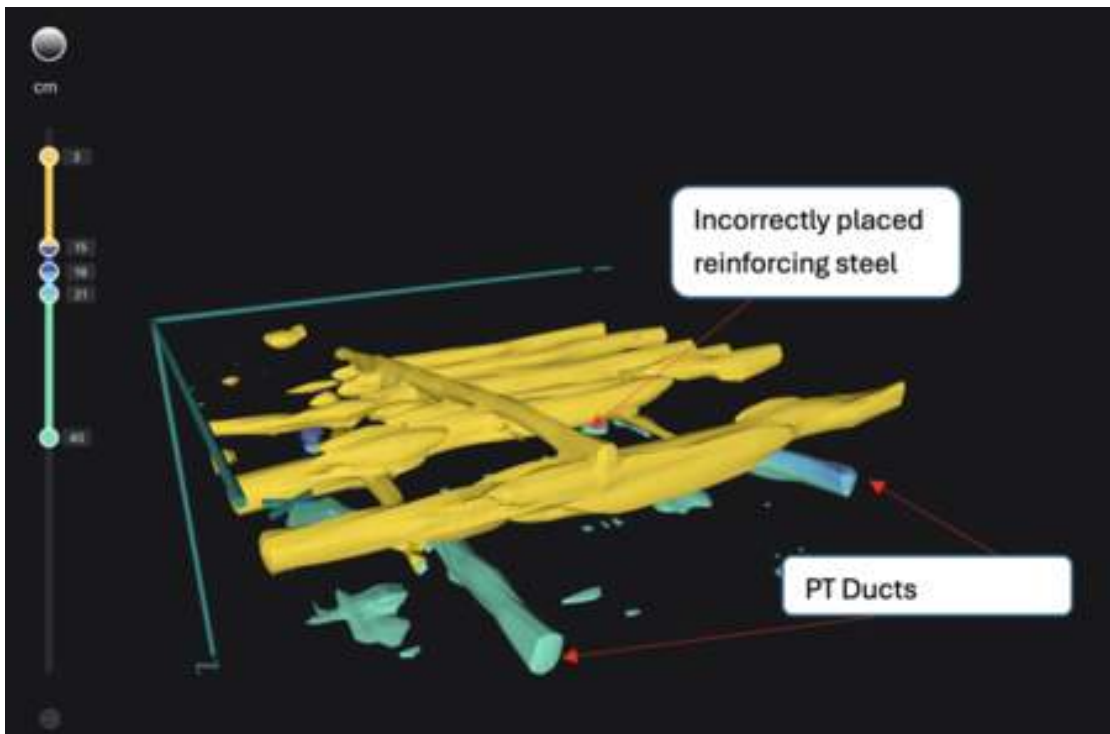
3D scan showing incorrectly placed reinforcing steel

As seen from the results, an unexpected transverse rebar was detected with the Proceq GPR. An incorrectly placed transverse rebar could lead to issues with corrosion due to low cover, or potential structural weakness. Above we can also see the 2 post-tension ducts below the steel reinforcing mesh. They travel from right to left, getting deeper.

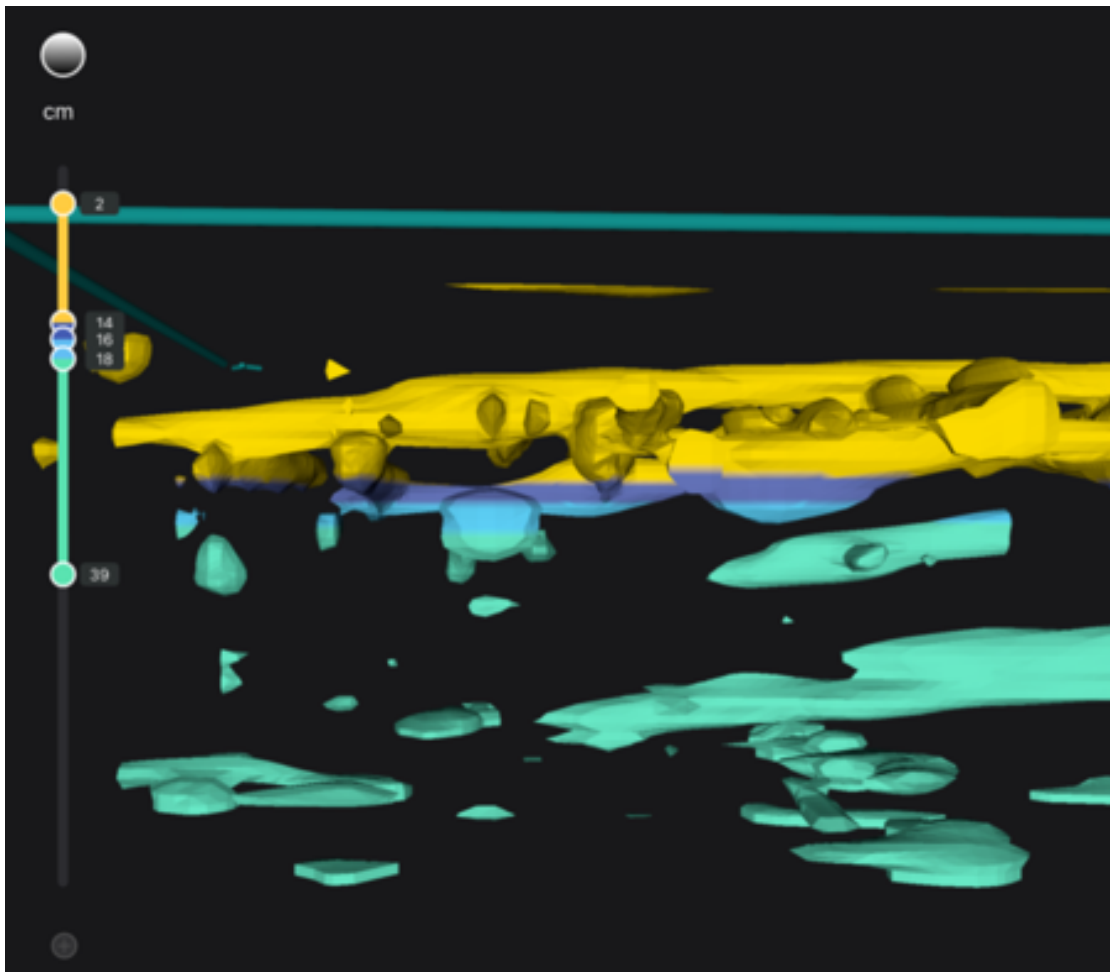
GPR Data displayed on the iPad revealing an incorrectly placed transverse reinforcing steel.

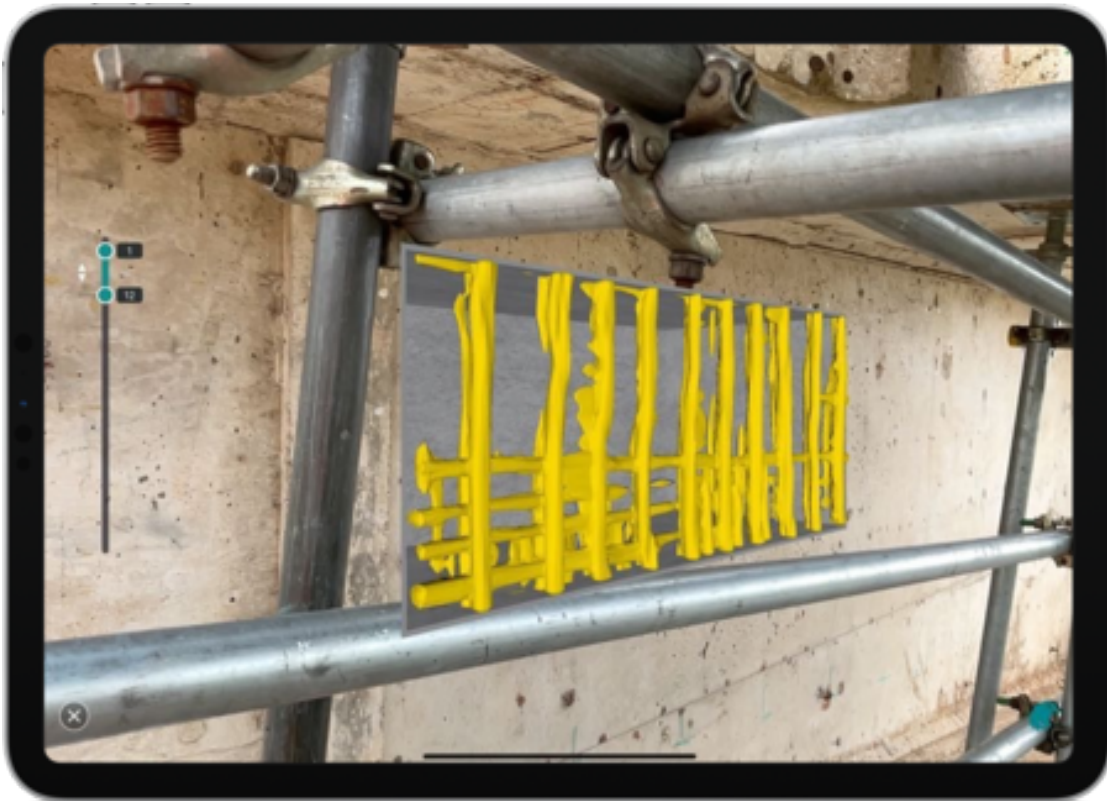
Augmented reality view of the GPR data results showing the rebar configuration with missing horizontal rebar at the top.

Oddly, the GPR data shows that there are no horizontal steel reinforcement over the top of the duct location. This is unlikely to be a design feature and is most likely a construction fault.

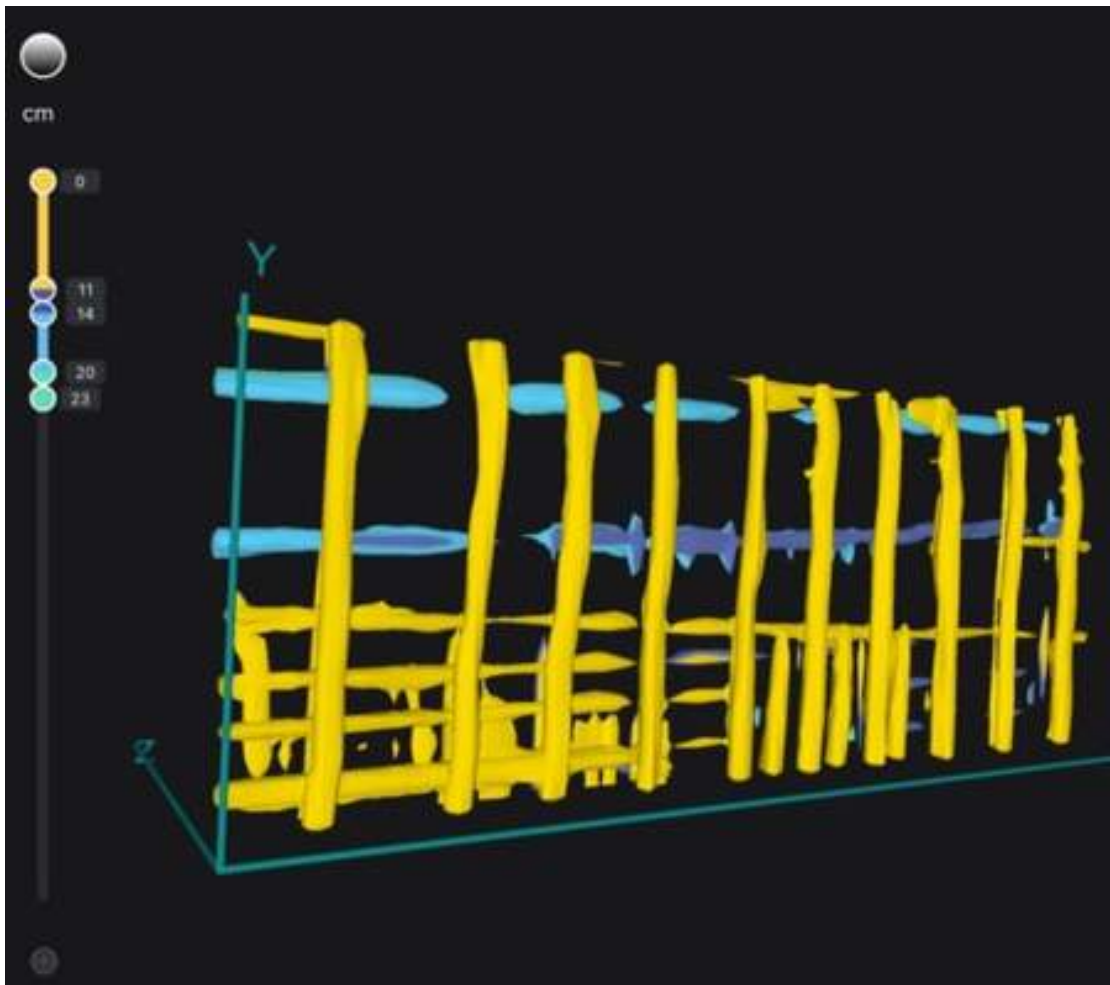
3D view showing PT Ducts sitting under location of missing horizontal reinforcement

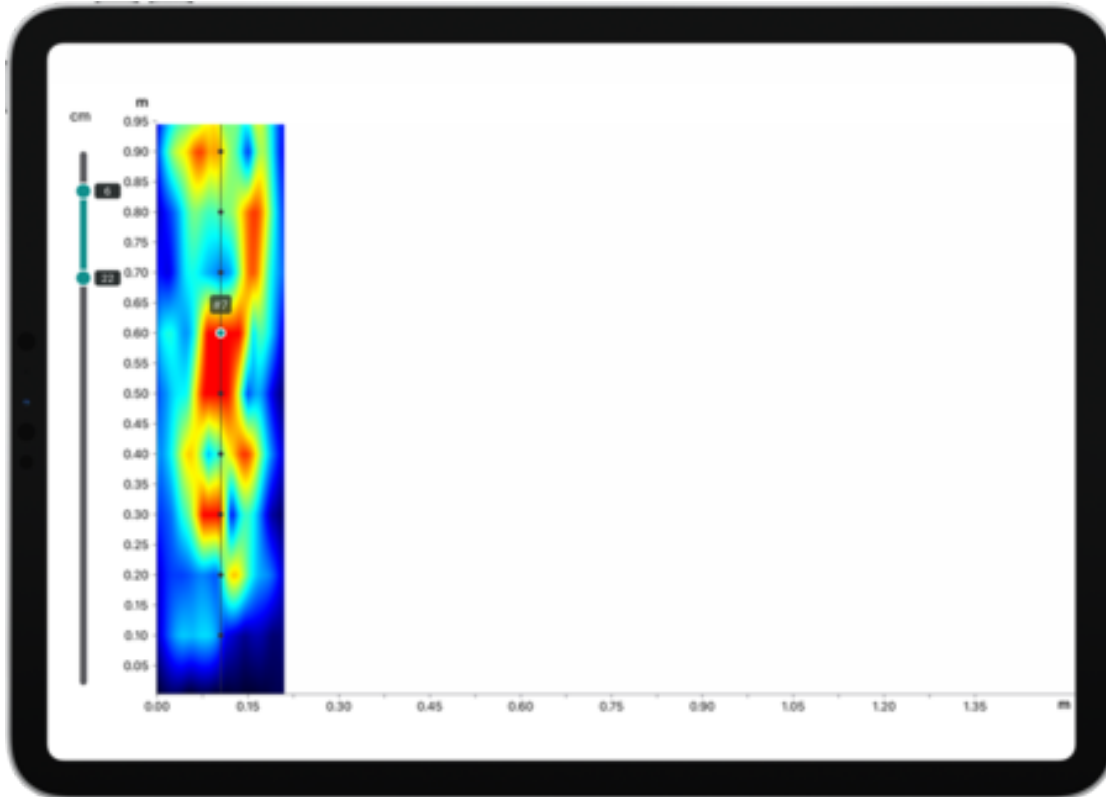
At the location below, PD8050 data clearly shows voiding inside the PT duct. This is the red area shown in the scan data.

The red areas indicate where air is present within the duct using UPE technology.

The PD8050 helps identify locations of the PT duct that can then be opened up with targeted investigations to confirm the NDT findings. The big advantage of using NDT methods is the reduced number of unnecessary openings carried out to what could be well grouted PT ducts. These significant findings highlight the importance of a multi technology approach to NDT, alongside trained inspectors.

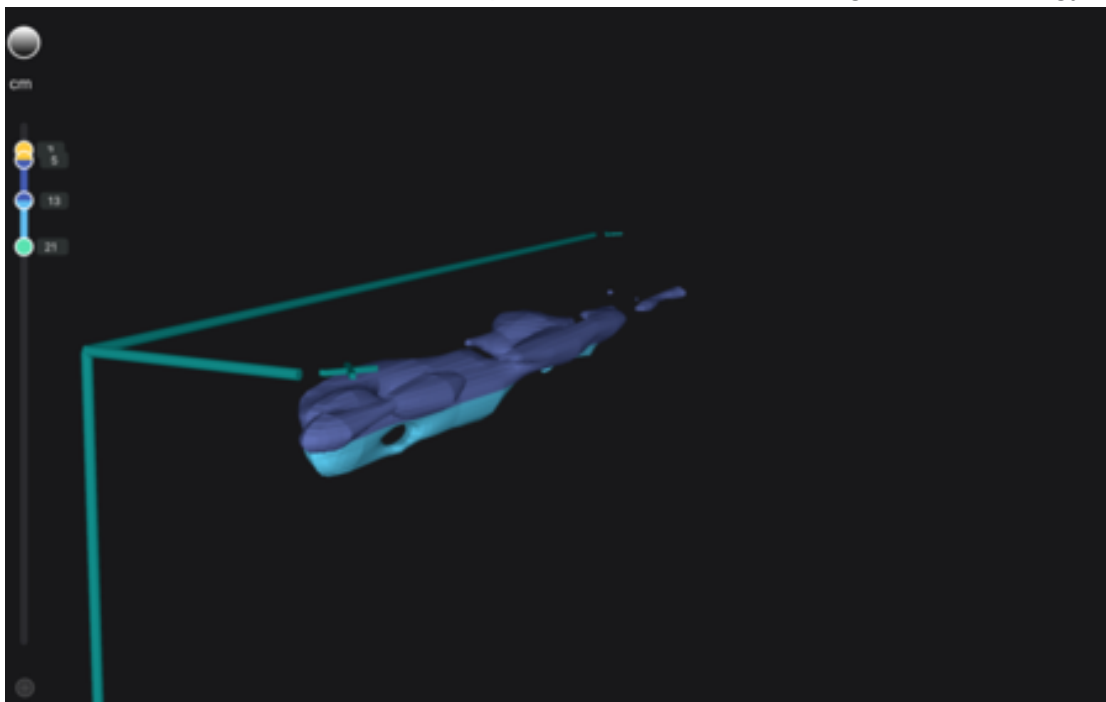
A 3D scan of the test area shown above appears to show voiding of a PT duct.
