Revealing hidden voids and unexpected findings on the post-tensioning ducts of concrete bridges

Screening Eagle uncovers surprising results with non-destructive testing on Huntingdon Railway Viaduct in the UK with National Highways

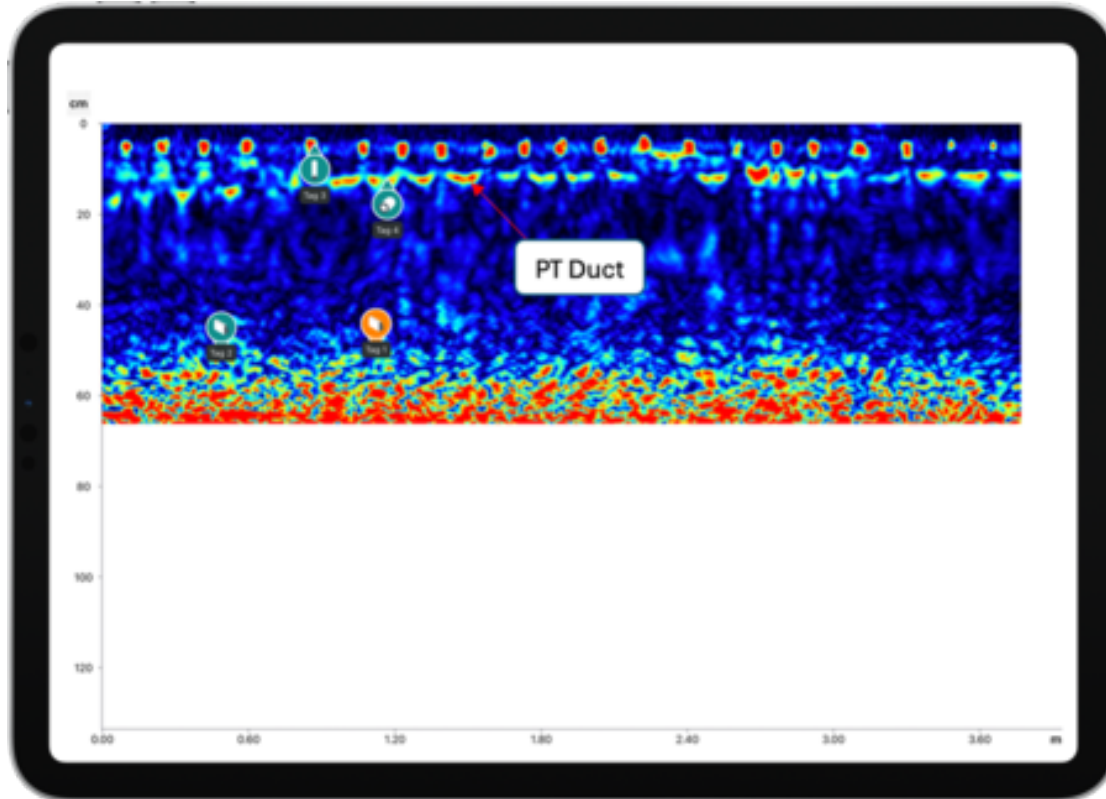
GPR Scan with Proceq GP8800 showing the path of the PT duct.

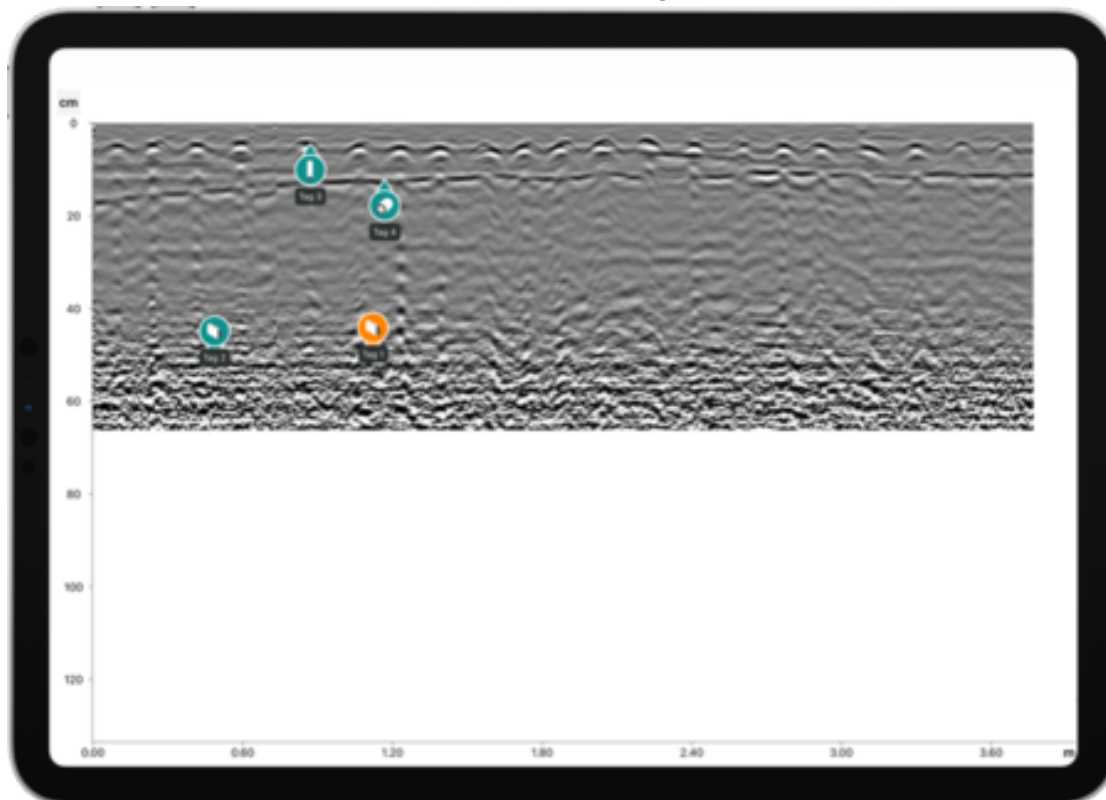
Radargram view showing double reinforcing bars above the PT duct (apart from the last 2 bars on the right.)

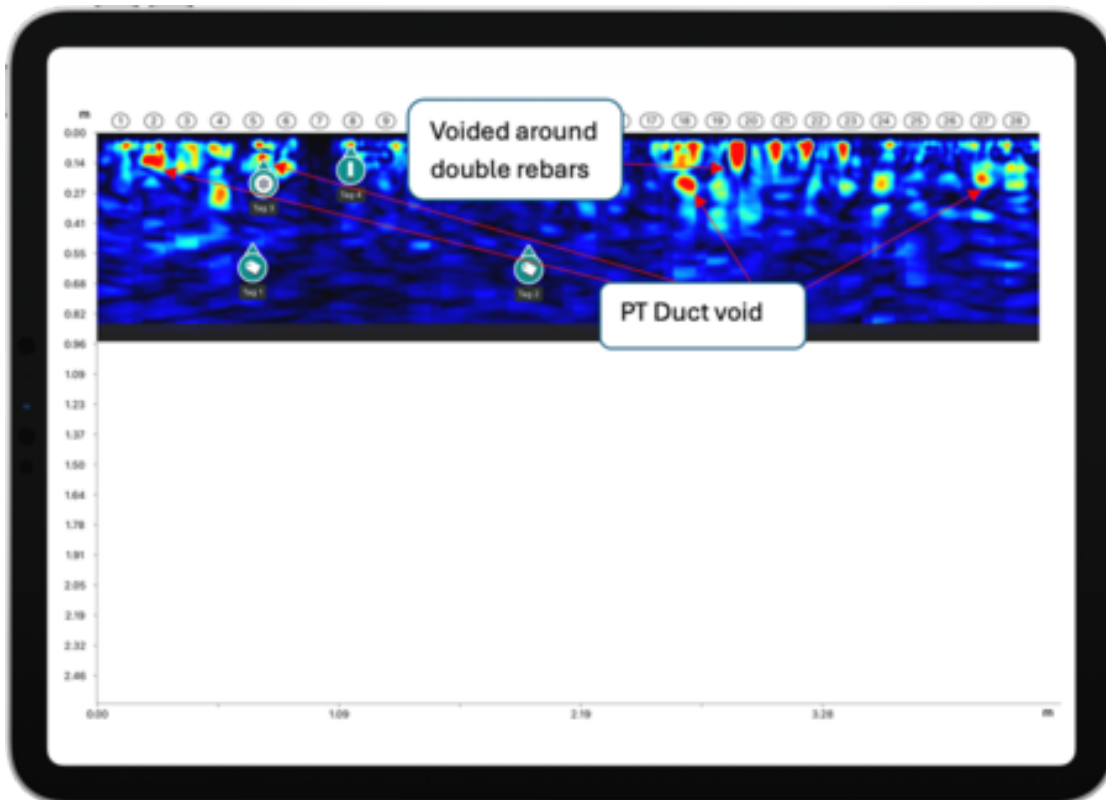
Results from the PD8050 showing localised voiding, taken over the same location as the GPR scans. Additionally the double rebars appear to have voiding around them.

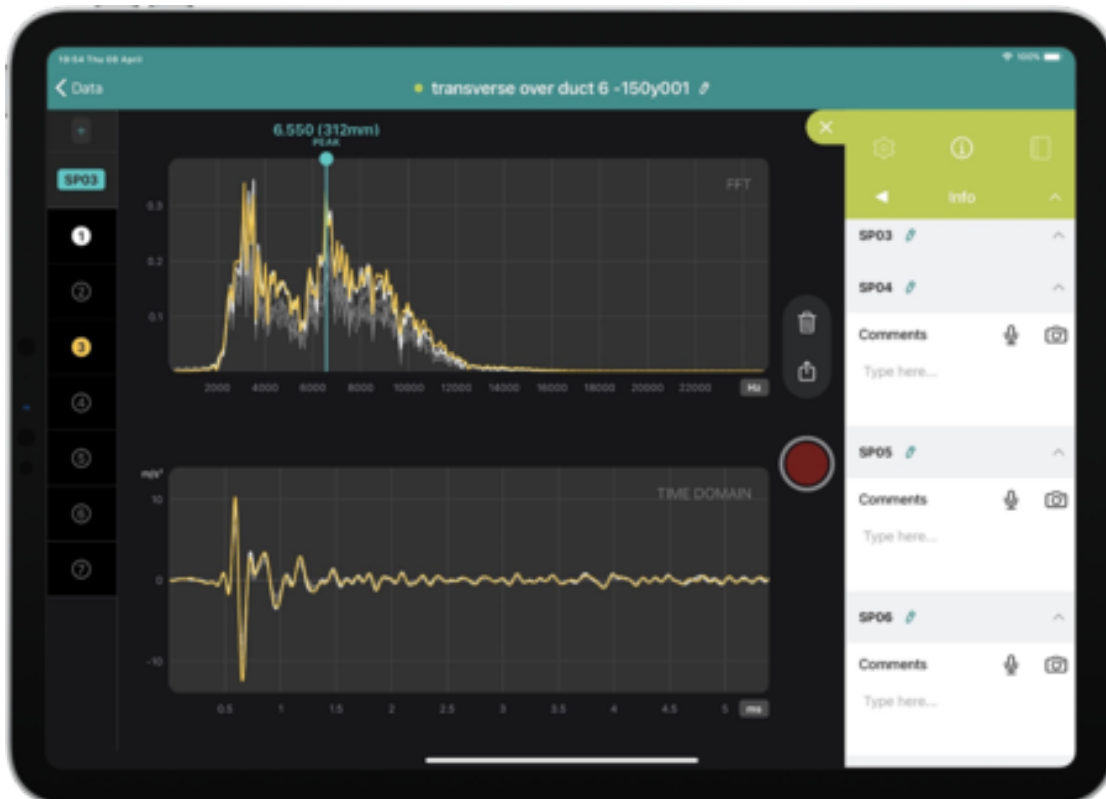
Another area was previously communicated as possibly being voided. Initial scans with GPR showed nothing, but the follow-up tests with the PD8050 and PI8000 both showed air voiding.

Air voiding as shown with Pundit PI8000 ultrasonic impact echo technology, taken in the same spot as the PD8050.

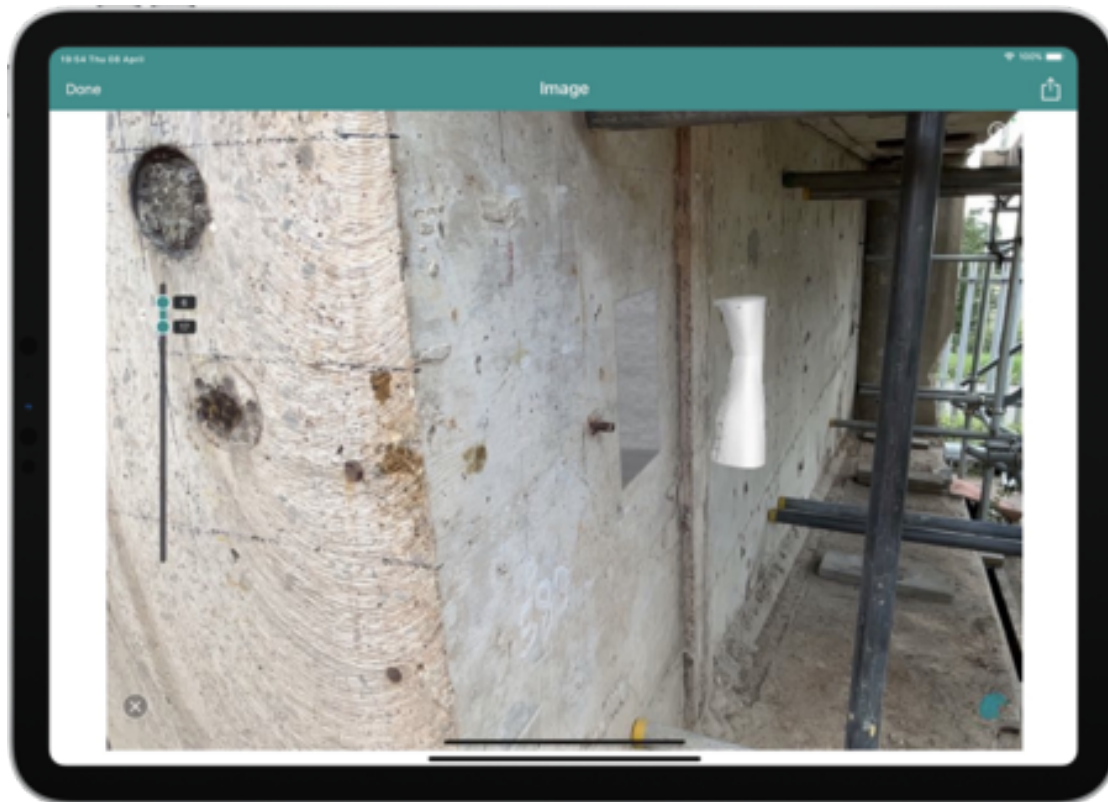
Augmented reality representation of the void taken with the Pundit PD8050 ultrasonic pulse echo technology.

The AR view above shows the possible shape of the void, which appears to be a duct of some type, or perhaps a grouting channel or drain. It is not metal, and does not appear to reflect EM waves from the GPR.

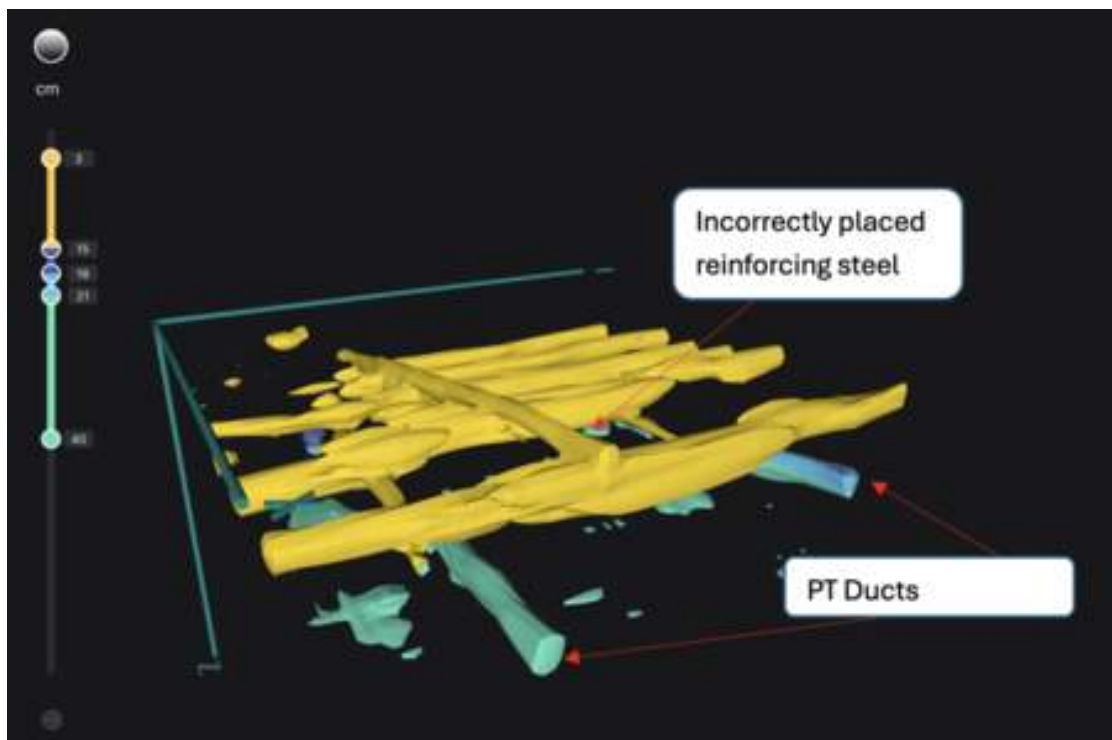
3D scan showing incorrectly placed reinforcing steel

As seen from the results, an unexpected transverse rebar was detected with the Proceq GPR. An incorrectly placed transverse rebar could lead to issues with corrosion due to low cover, or potential structural weakness. Above we can also see the 2 post-tension ducts below the steel reinforcing mesh. They travel from right to left, getting deeper.

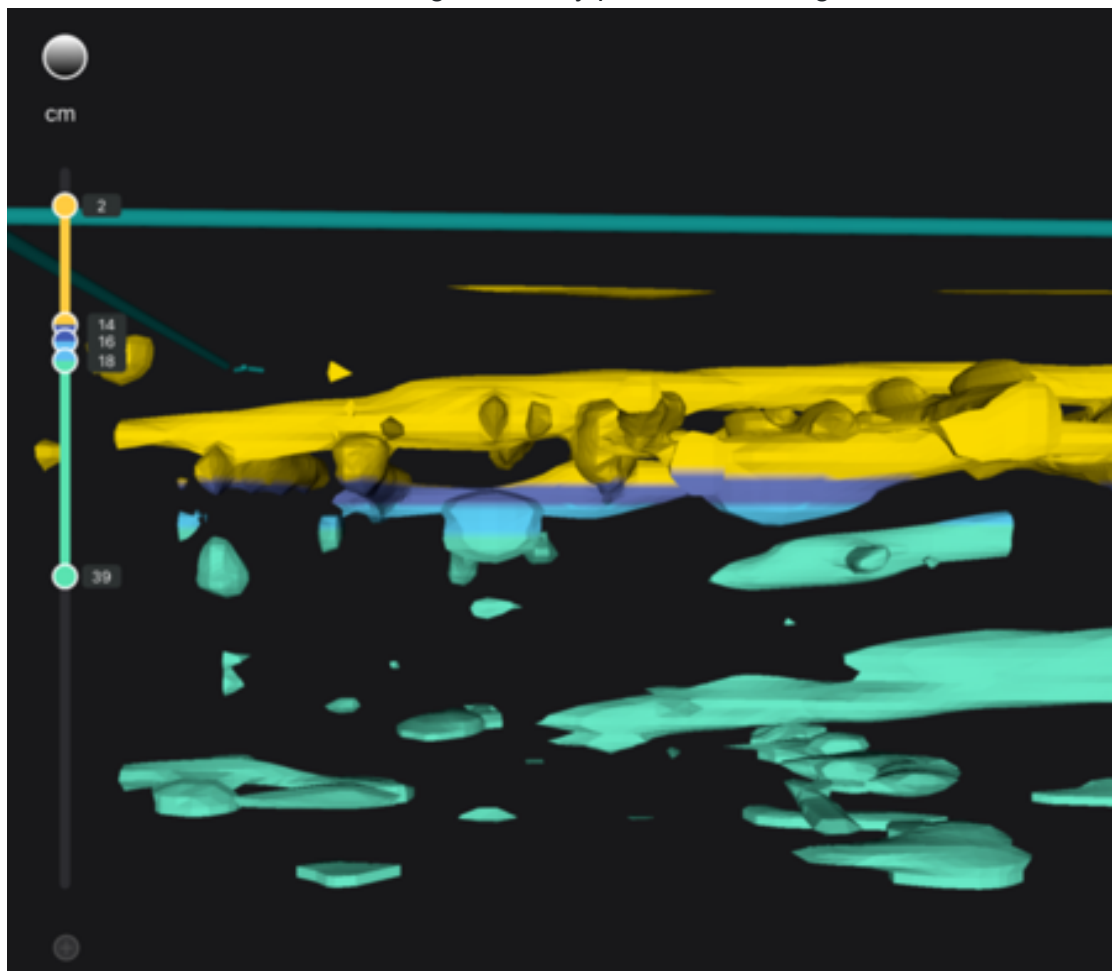
GPR Data displayed on the iPad revealing an incorrectly placed transverse reinforcing steel.

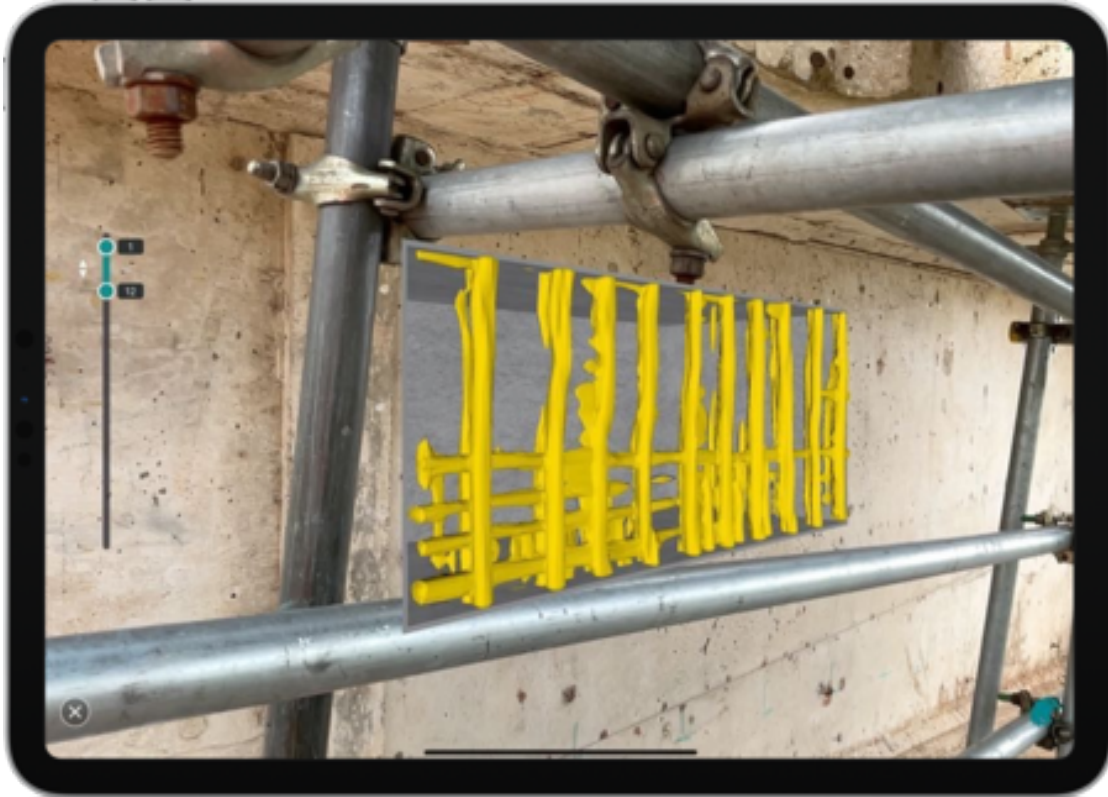
Augmented reality view of the GPR data results showing the rebar configuration with missing horizontal rebar at the top.

Oddly, the GPR data shows that there are no horizontal steel reinforcement over the top of the duct location. This is unlikely to be a design feature and is most likely a construction fault.

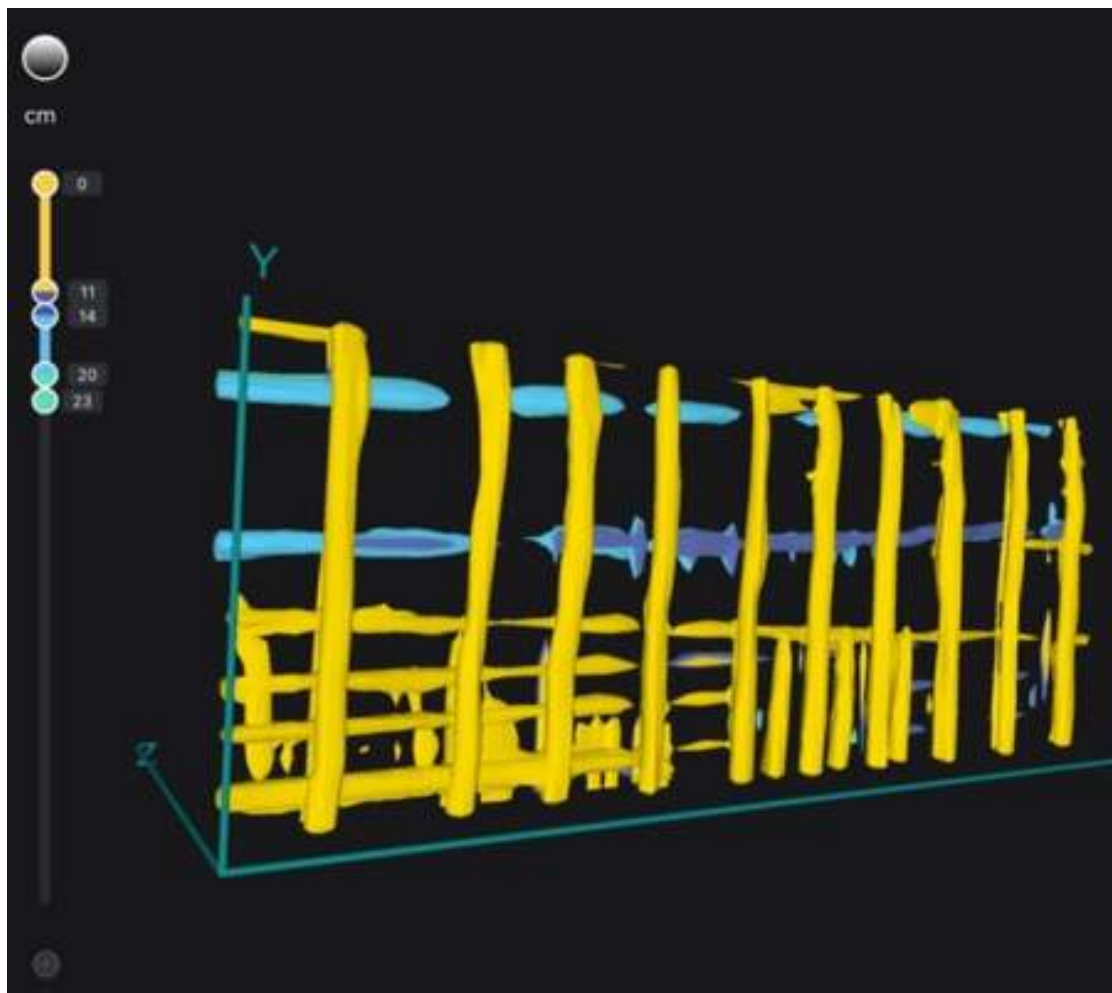
3D view showing PT Ducts sitting under location of missing horizontal reinforcement

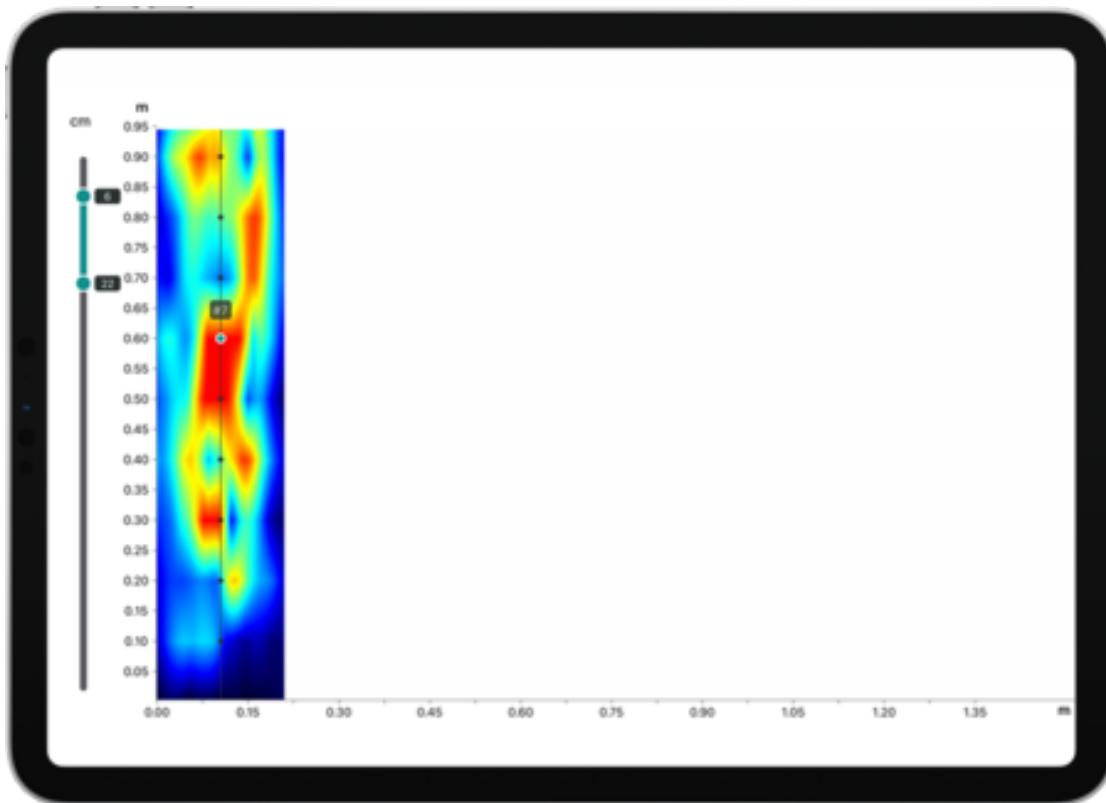
At the location below, PD8050 data clearly shows voiding inside the PT duct. This is the red are shown in the scan data.

The red areas indicate where air is present within the duct using UPE technology.

The PD8050 helps identify locations of the PT duct that can then be opened up with targeted investigations to confirm the NDT findings. The big advantage of using NDT methods is the reduced number of unnecessary openings carried out to what could be well grouted PT ducts. These significant findings highlight the importance of a multi technology approach to NDT, alongside trained inspectors.

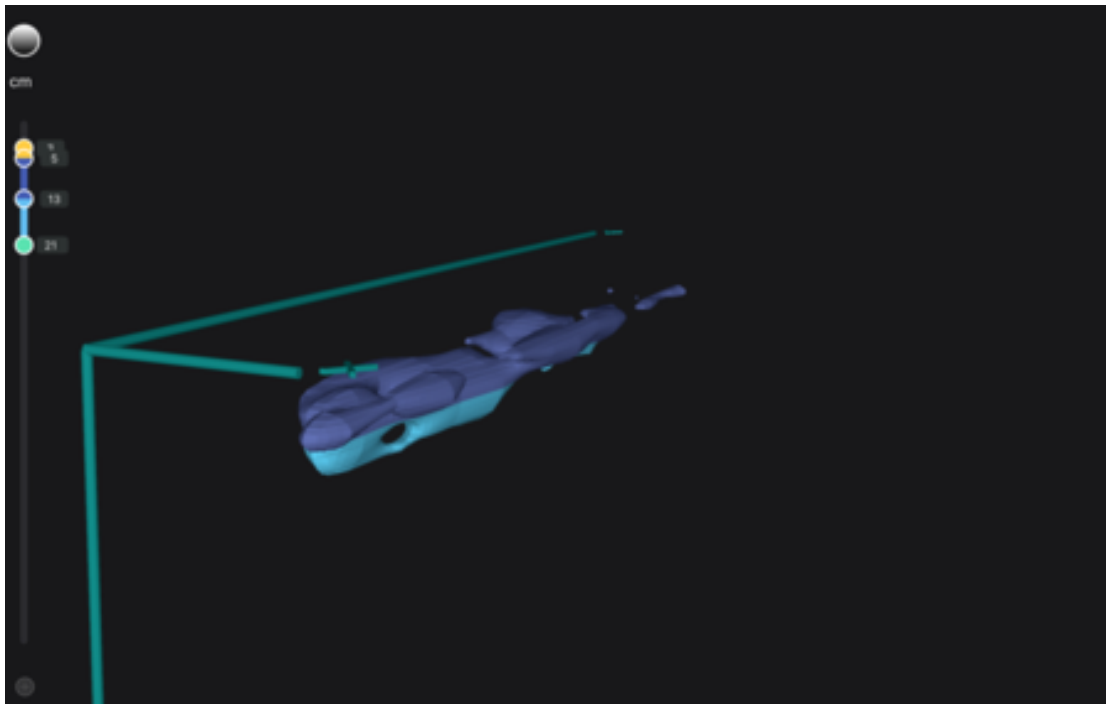
A 3D scan of the test area shown above appears to show voiding of a PT duct.
