How to use GPR and ultrasound to check the seepage points of new tunnels?

Non-destructive testing techniques for efficient seepage detection

Application Case

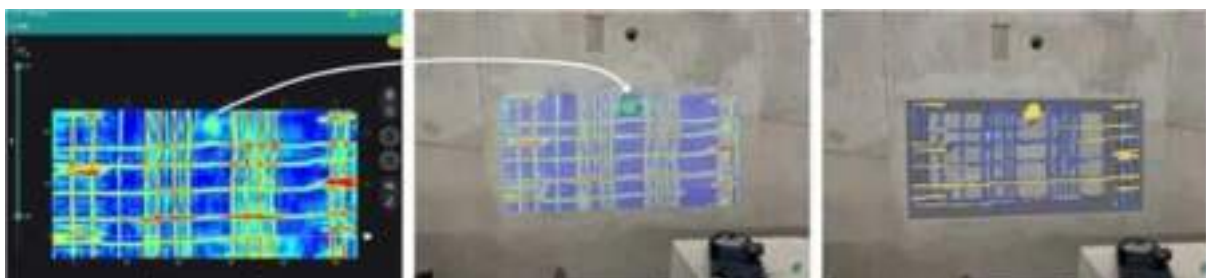
Area Scan Results of GP8100 GPR

On the left side of the above picture is the result of the regional scan, from which you can see that the transverse reinforcement is stirrup, arranged in approximately equal spacing in the vertical direction. Longitudinal reinforcement is the main reinforcement, in the horizontal direction, the middle area is a group of four arranged (close), in the two sides of the region is a single arrangement (sparse).

The middle and right pictures are the corresponding projection of the scanning results of the internal structure of the tunnel on the real scene. The real location and the corresponding scanning structure are completely integrated, which is convenient for data management and recording, and can provide fast and accurate positioning guidance for subsequent tunnel maintenance work.

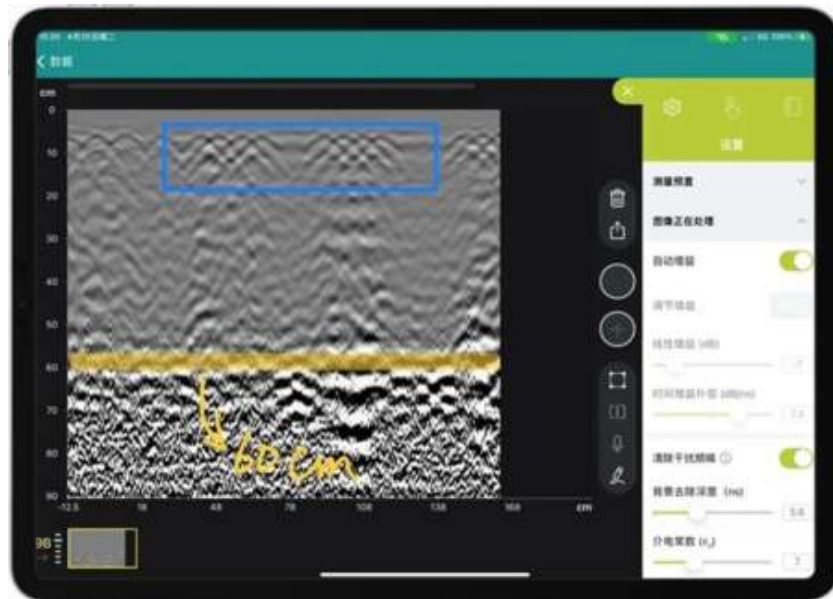
GP8100 radar cross section diagram

Judging from the radar cross section diagram, the inverted hyperbolic shape in the depth of 7 ~ 13 cm (blue frame) is mainly caused by the reflection of the double layer steel mesh signal. At the depth of about 60 cm (yellow mark line), the continuous plate reflection signal is mainly caused by the signal reflection of the initial branch of concrete (slab thickness). There is no obvious water-rich signal between the depth of steel bar and the base plate.

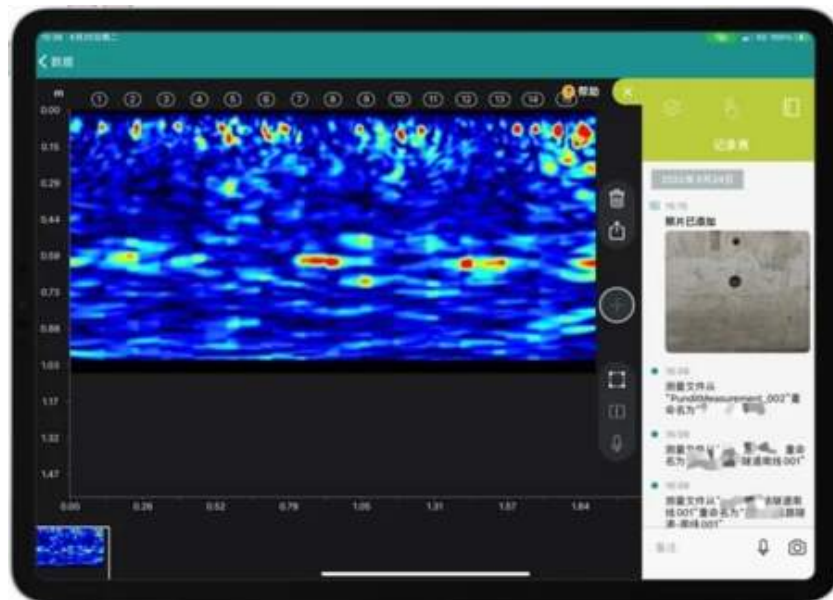
PD8050 Linear Scan Results

According to the results, the periodic steel bar distribution signal can be seen at the depth of about 7 cm in the shallow layer above, and the clear bottom plate reflection signal can be seen at about 59 cm in the 1-15 measuring line area. There is a part of discontinuity in the middle, which is due to the fact that the surface steel bar reflects a part of the ultrasonic signal, which leads to the deep target can not be detected. On the whole, the signal of the base plate can be reflected clearly (when ultrasonic imaging, it is not advisable to adjust the signal gain too much, otherwise it is easy to misjudge the hole or defect). Analysis of [GP8100](#) and [PD8050](#) results.

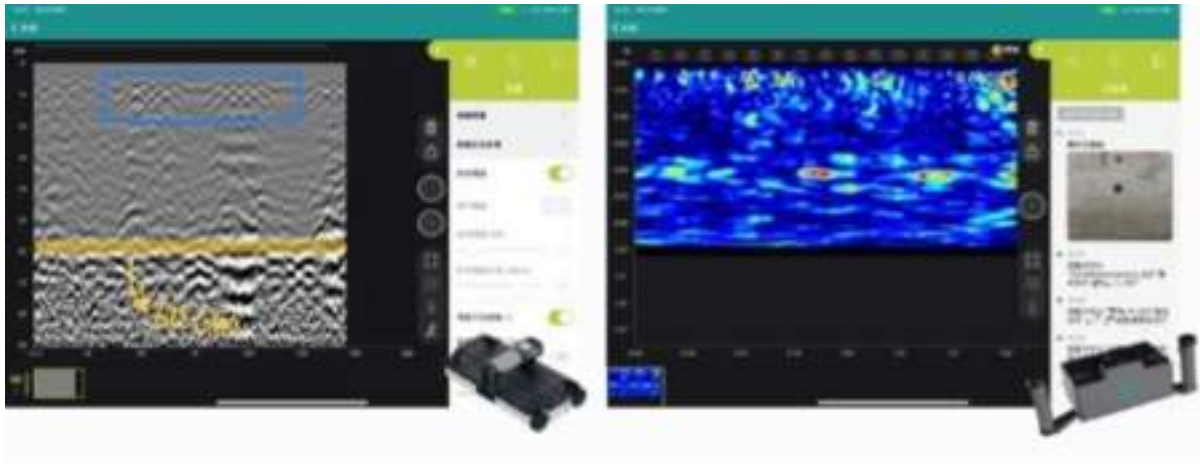
By analyzing the GP8100 linear view (left) and PD8050 linear view (right), we can see the shallow reinforcement signal and the continuous signal of the initial support base plate at the depth of 60 cm, and there is no obvious water-rich area between the reinforcement and the base plate. In summary, the construction quality of A area can be preliminarily judged, and there is no obvious water seepage.

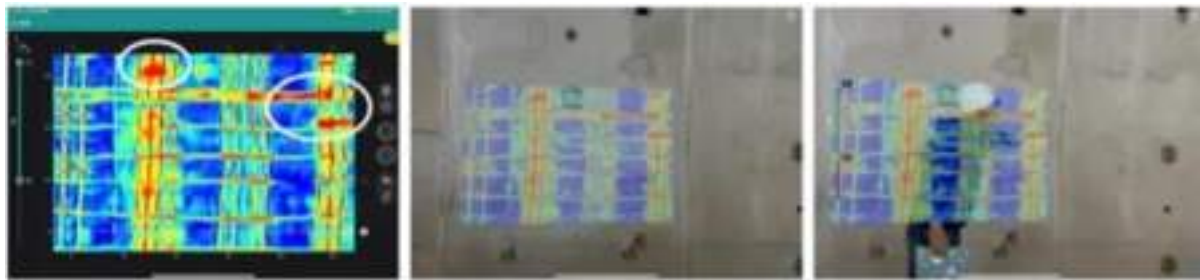
GP8100 Area Scan Results

First, the GP8100 is used for large area scanning. The left picture is the scan result of the area. The horizontal and vertical reinforcement distribution in the picture is similar to that in the A area, but in the area shown by the white circle, there is an obvious signal enhancement area after the reinforcement, which is suspected to be caused by water seepage. The middle and right images are AR structural projections of the scan results. By reducing the transparency of the structure image, the right engineer marks the suspected area for the later PD8050 test. To further verify why there is water seepage in the area, we select the 8th line in the radar area scan in the B area and the 9th line in the radar region scan in the A area for comparative analysis.

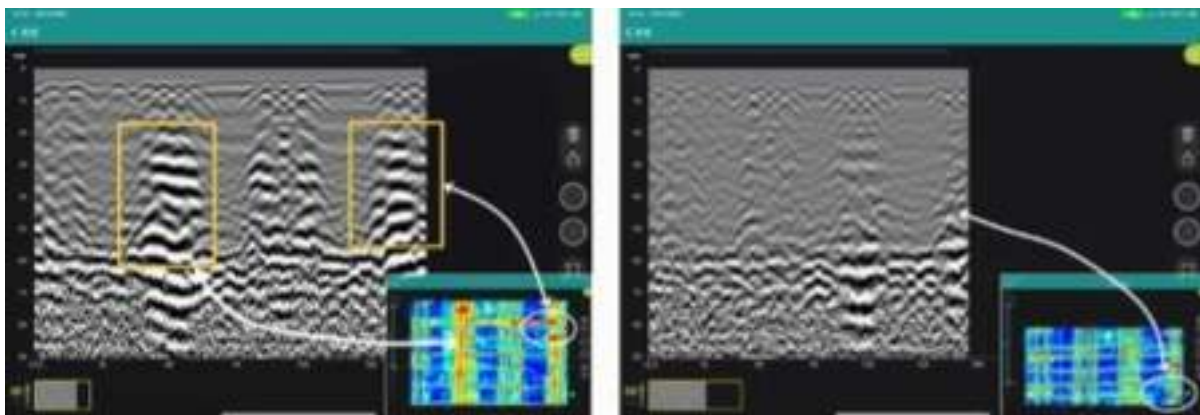
Comparison of Radar Line Scanning in Zone A and Zone B

Left is a section view of the 8th line in Area B and right is a section view of the 9th line in Area A. From the comparison of the two maps, there is no water enrichment or seepage in area A, and there is obvious water enrichment signal between steel bar and floor in area B.

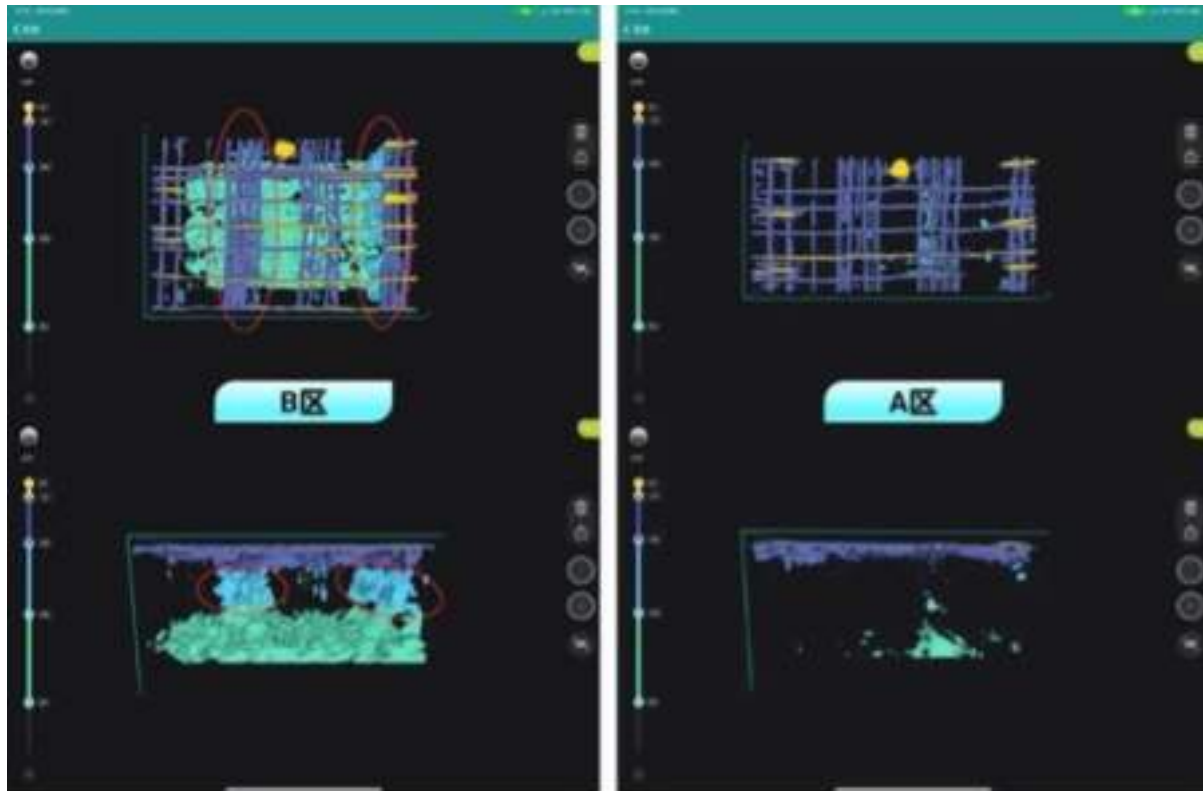
Through the radar AR structure observation in Zone B, it is also found that there is an obvious water rich signal and the possibility of water seepage between the steel bar and the bottom plate (shown in the red circle on the left). We then use PD8050 to find the reason of water seepage in this area.

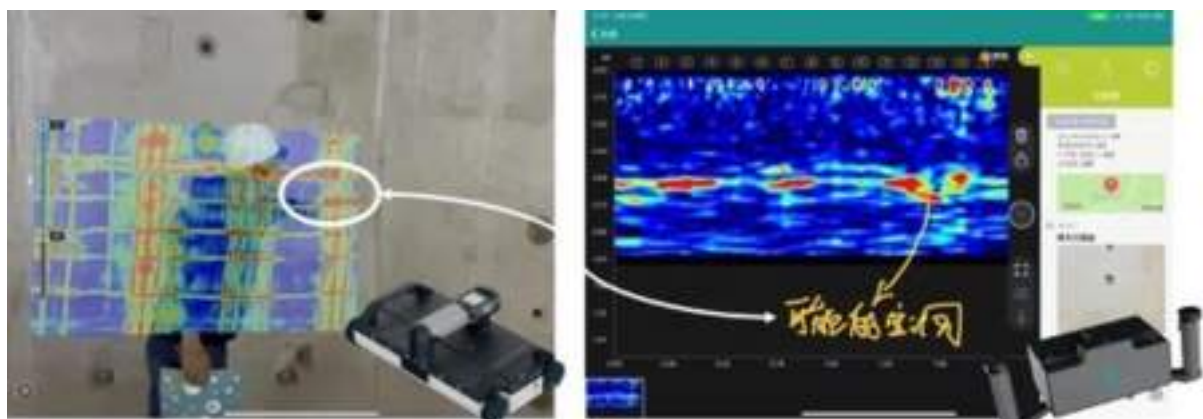
Linear Scan Results for PD8050

Above (right) is a linear scan view of the PD8050. At about 1.4m in the horizontal direction, there is a clear cavity reflection signal behind the initial support floor (about 65-73cm depth), and its actual position also corresponds to the previous radar scanning results (left), which further determines that there may be a cavity here, resulting in water seepage.

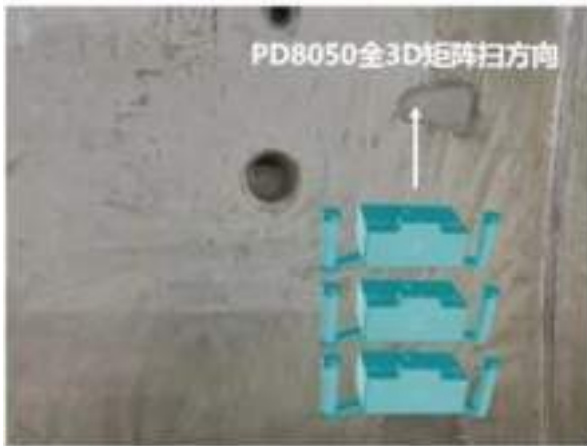
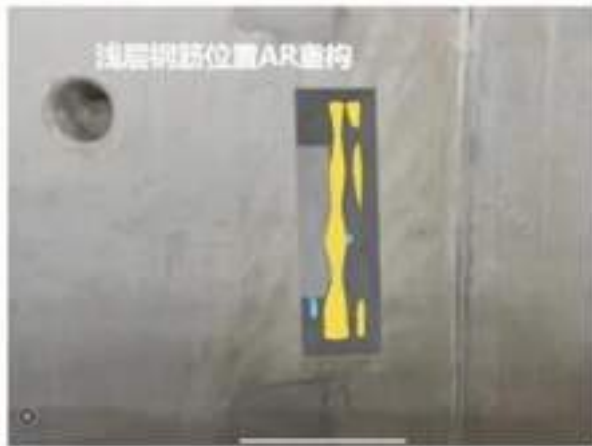
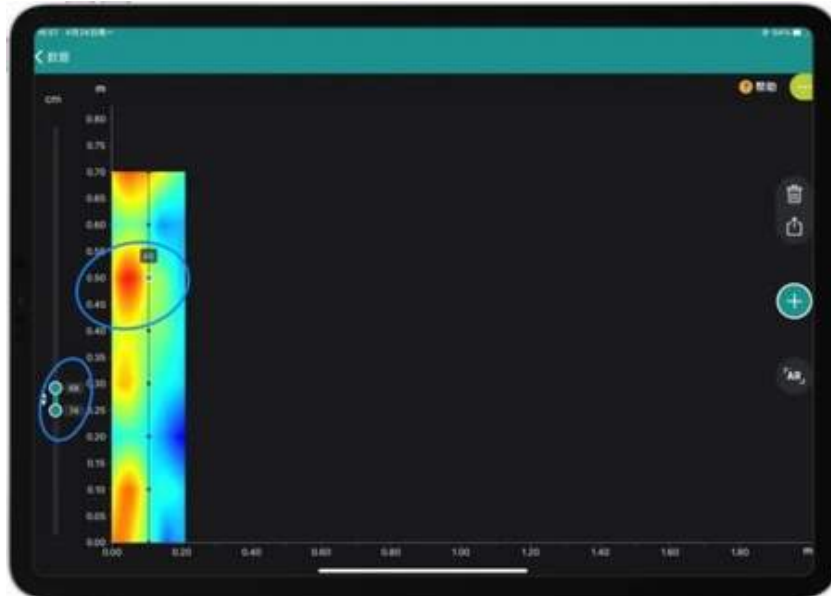
In response to the above results, we continued to perform a full 3D matrix scan of the area using the PD8050, and reconfirmed the results of the presence of voids at the depth of 68-74 cm.

The void position behind the base plate, with a depth of about 68-74 cm (shown by the blue circle in the figure)

According to our test feedback, the construction team saved and shared all the electronic data to the reporting objects, and formulated a correction plan for Area B on the spot.
