How to use GPR and ultrasound to check the seepage points of new tunnels?

Non-destructive testing techniques for efficient seepage detection

Application Case

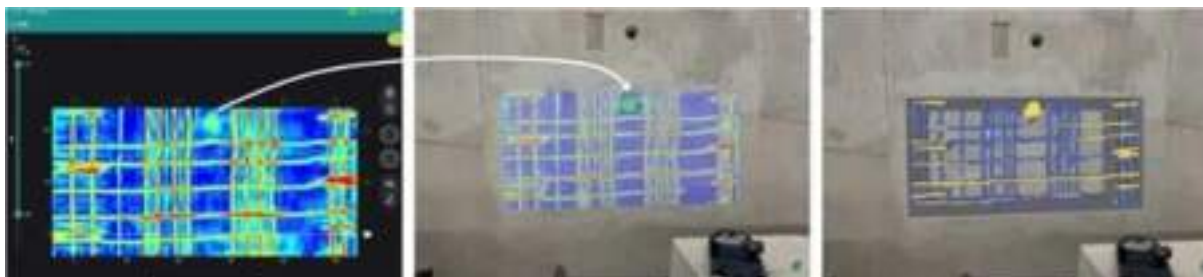
Area Scan Results of GP8100 GPR

On the left side of the above picture is the result of the regional scan, from which you can see that the transverse reinforcement is stirrup, arranged in approximately equal spacing in the vertical direction. Longitudinal reinforcement is the main reinforcement, in the horizontal direction, the middle area is a group of four arranged (close), in the two sides of the region is a single arrangement (sparse).

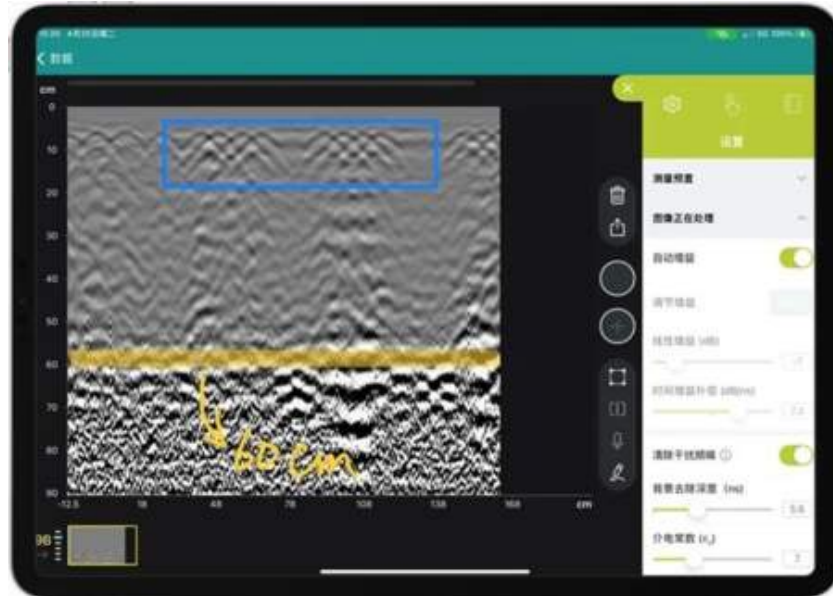
GP8100 radar cross section diagram

Judging from the radar cross section diagram, the inverted hyperbolic shape in the depth of 7 ~ 13 cm (blue frame) is mainly caused by the reflection of the double layer steel mesh signal. At the depth of about 60 cm (yellow mark line), the continuous plate reflection signal is mainly caused by the signal reflection of the initial branch of concrete (slab thickness). There is no obvious water-rich signal between the depth of steel bar and the base plate.

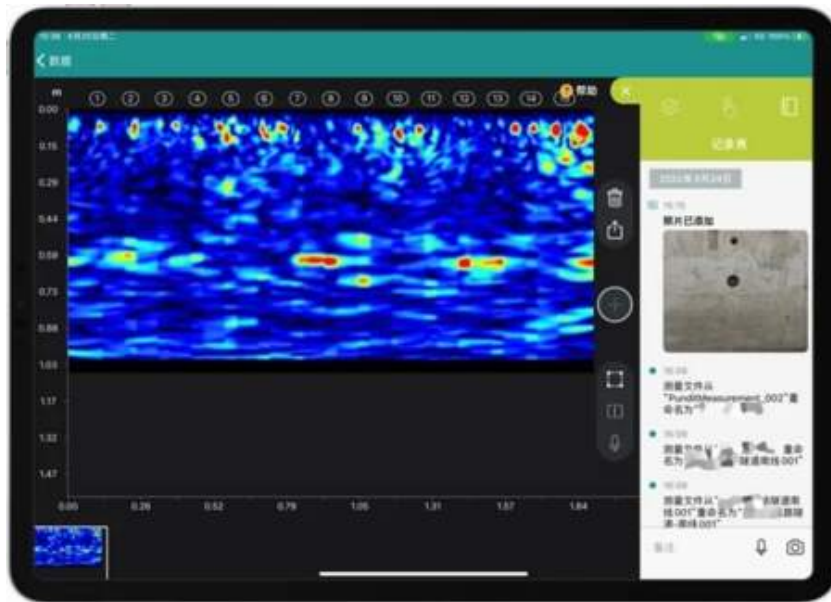
PD8050 Linear Scan Results

According to the results, the periodic steel bar distribution signal can be seen at the depth of about 7 cm in the shallow layer above, and the clear bottom plate reflection signal can be seen at about 59 cm in the 1-15 measuring line area. There is a part of discontinuity in the middle, which is due to the fact that the surface steel bar reflects a part of the ultrasonic signal, which leads to the deep target can not be detected. On the whole, the signal of the base plate can be reflected clearly (when ultrasonic imaging, it is not advisable to adjust the signal gain too much, otherwise it is easy to misjudge the hole or defect). Analysis of [GP8100](#) and [PD8050](#) results.

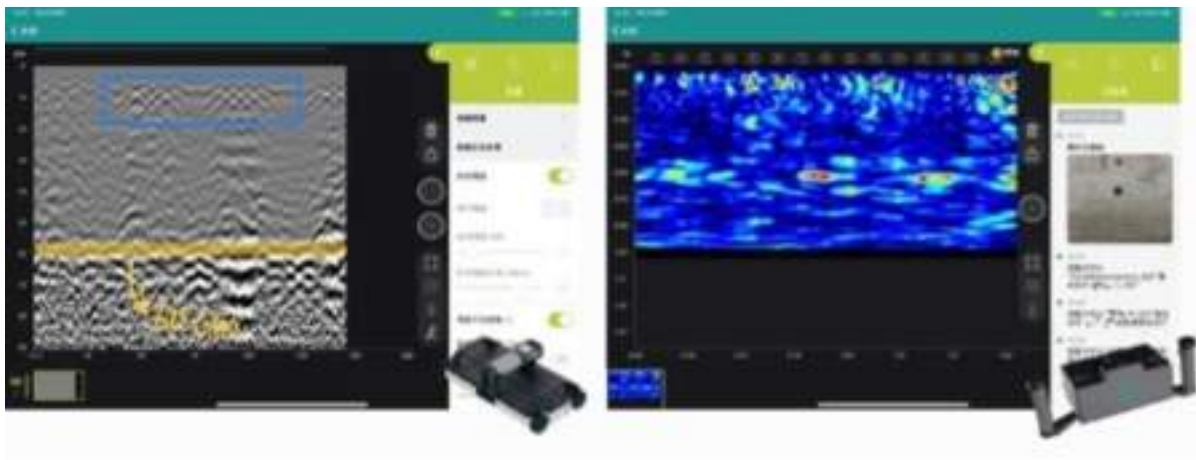
By analyzing the GP8100 linear view (left) and PD8050 linear view (right), we can see the shallow reinforcement signal and the continuous signal of the initial support base plate at the depth of 60 cm, and there is no obvious water-rich area between the reinforcement and the base plate. In summary, the construction quality of A area can be preliminarily judged, and there is no obvious water seepage.

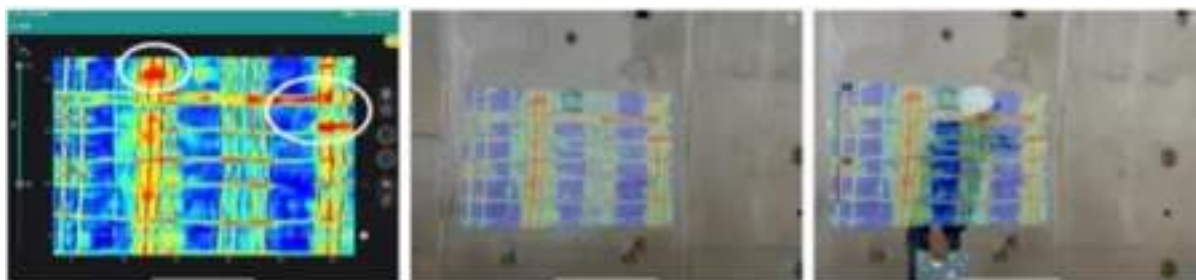
GP8100 Area Scan Results

First, the GP8100 is used for large area scanning. The left picture is the scan result of the area. The horizontal and vertical reinforcement distribution in the picture is similar to that in the A area, but in the area shown by the white circle, there is an obvious signal enhancement area after the reinforcement, which is suspected to be caused by water seepage. The middle and right images are AR structural projections of the scan results. By reducing the transparency of the structure image, the right engineer marks the suspected area for the later PD8050 test. To further verify why there is water seepage in the area, we select the 8th line in the radar area scan in the B area and the 9th line in the radar region scan in the A area for comparative analysis.

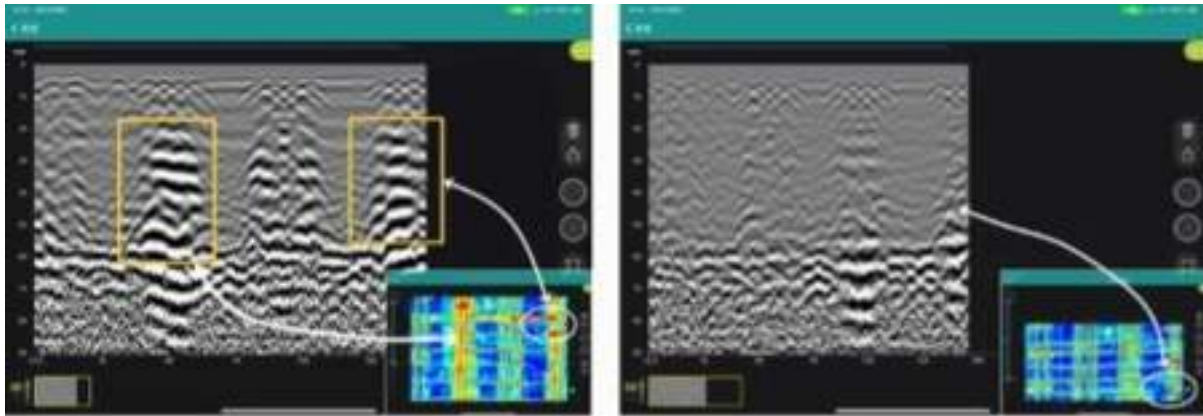
Comparison of Radar Line Scanning in Zone A and Zone B

Left is a section view of the 8th line in Area B and right is a section view of the 9th line in Area A. From the comparison of the two maps, there is no water enrichment or seepage in area A, and there is obvious water enrichment signal between steel bar and floor in area B.

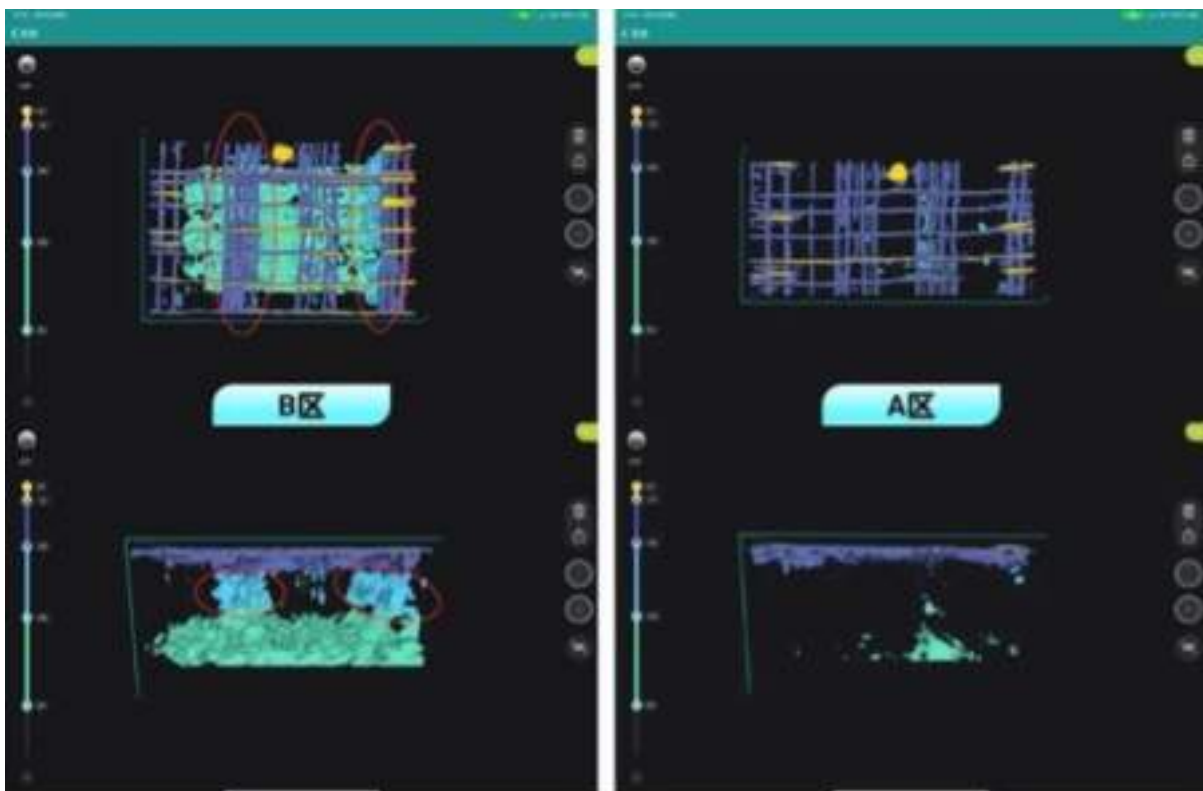
Through the radar AR structure observation in Zone B, it is also found that there is an obvious water rich signal and the possibility of water seepage between the steel bar and the bottom plate (shown in the red circle on the left). We then use PD8050 to find the reason of water seepage in this area.

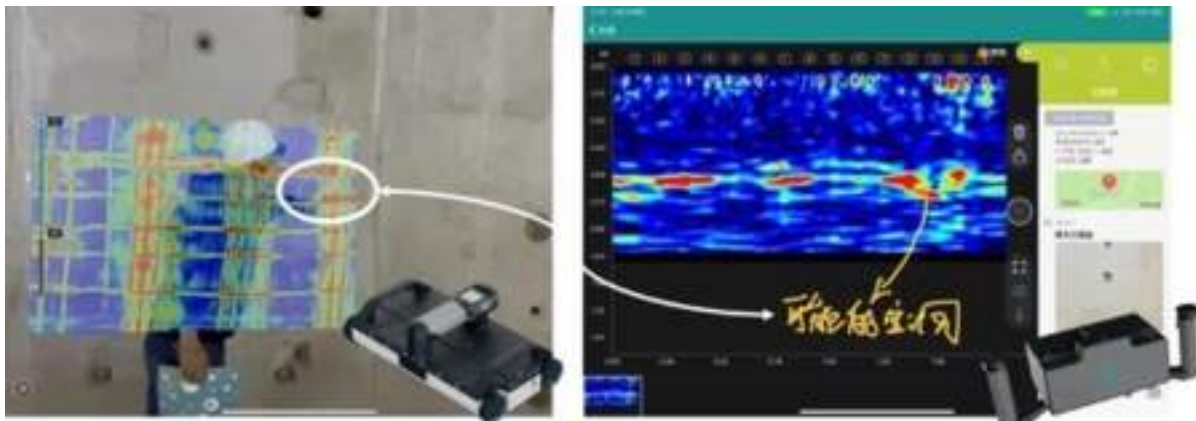
Linear Scan Results for PD8050

Above (right) is a linear scan view of the PD8050. At about 1.4m in the horizontal direction, there is a clear cavity reflection signal behind the initial support floor (about 65-73cm depth), and its actual position also corresponds to the previous radar scanning results (left), which further determines that there may be a cavity here, resulting in water seepage.

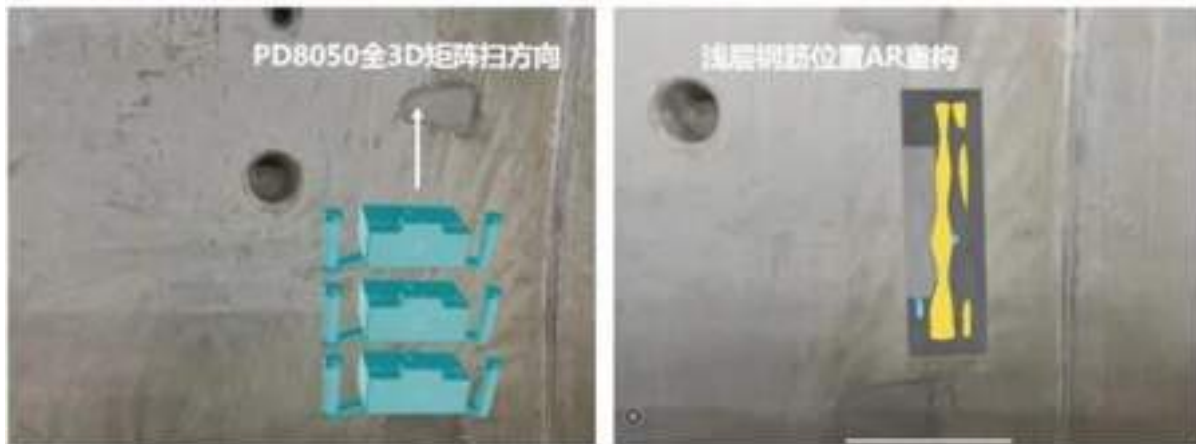
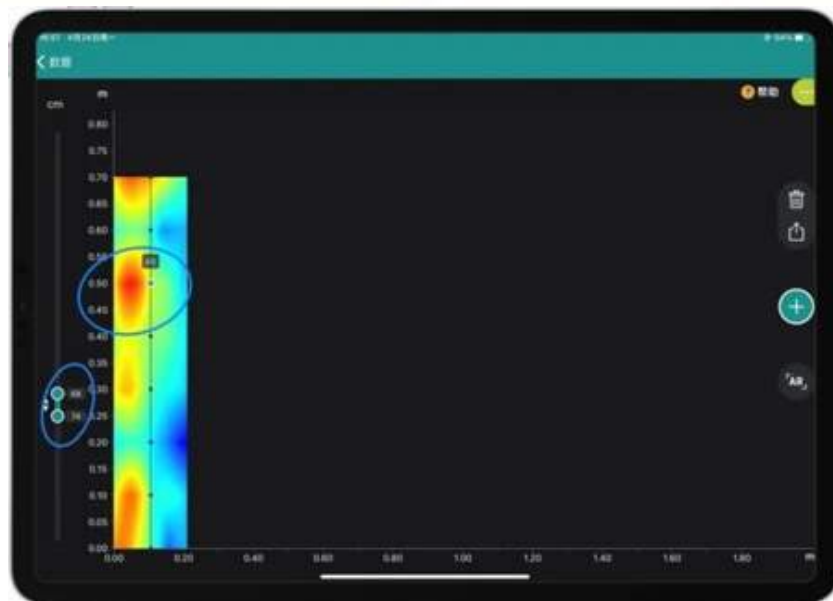
In response to the above results, we continued to perform a full 3D matrix scan of the area using the PD8050, and reconfirmed the results of the presence of voids at the depth of 68-74 cm.

The void position behind the base plate, with a depth of about 68-74 cm (shown by the blue circle in the figure)

According to our test feedback, the construction team saved and shared all the electronic data to the reporting objects, and formulated a correction plan for Area B on the spot.
