# Non-Destructive Subsurface Mapping and Condition Assessment of a large Highway Bridge

## Comprehensive Bridge Deck and Waterproofing assessment with multichannel GPR

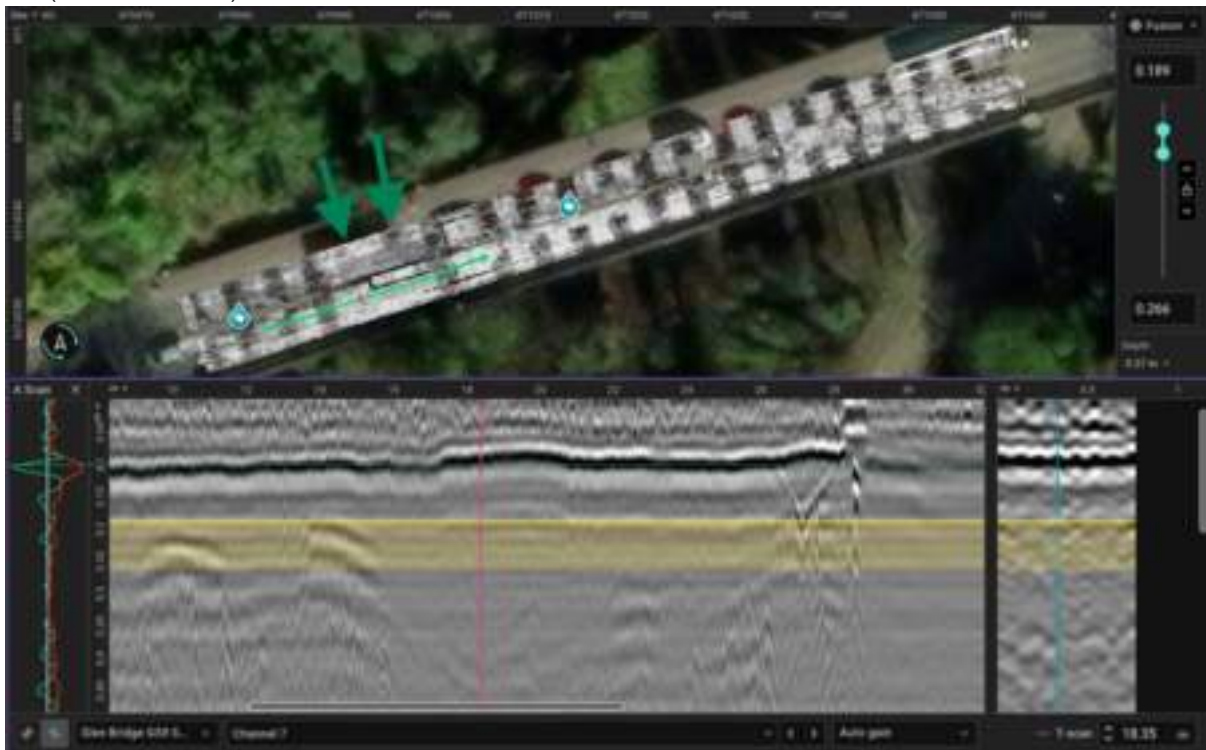
Fig.1 Overview of 1st layer reinforcement

- **First Layer (Depth: 150mm–200mm):** Laid out in rectangular panels at 4m centers. Longitudinal bars sit uppermost, directly resting on transverse post-tensioning strands beneath. This suggests the rebar panel likely sat directly on the PT tendon ducts during the original concrete pour.
- **Second Layer (Depth: ~300mm):** A secondary reinforcement mat was successfully mapped.

- **Structural Anomalies:** Identified localized areas where the first-layer steel mat sits significantly deeper (300mm–350mm) over the transverse tendons.

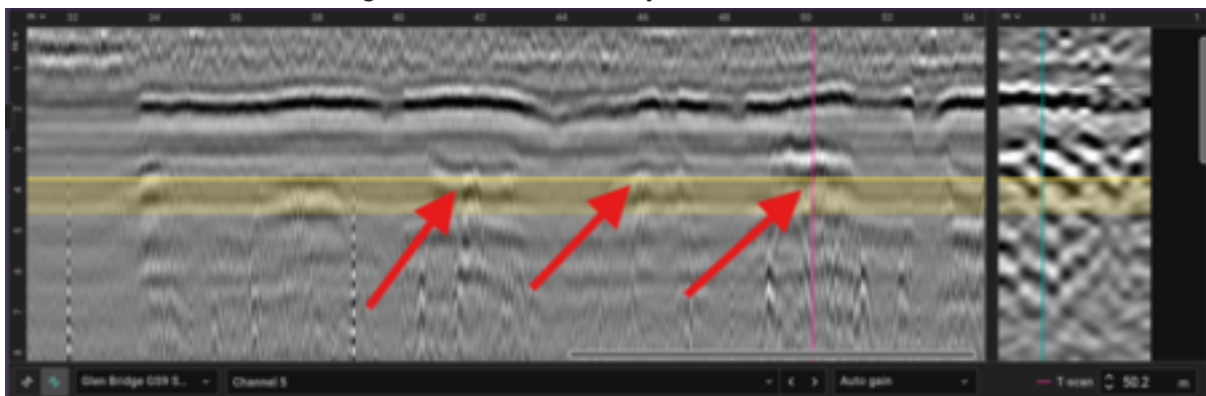
Fig.2 possible PT strands

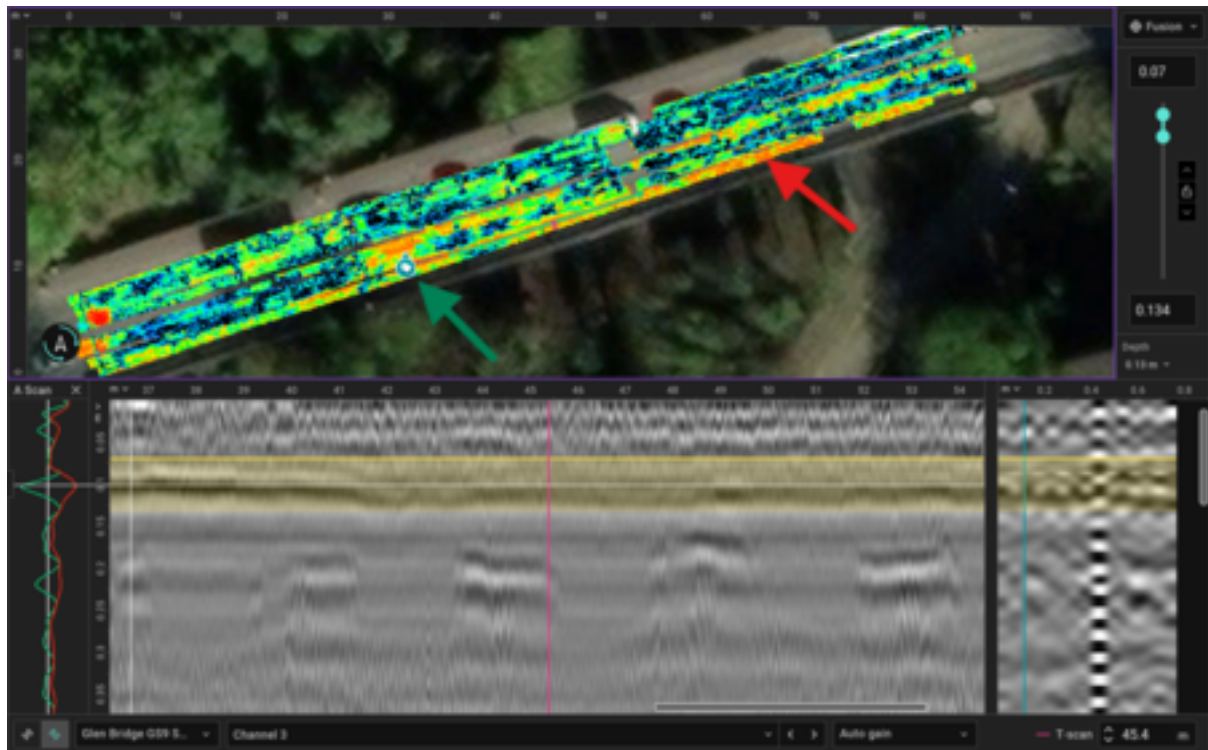
- **Waterproofing Boundary Mapping:** Evaluated the signal strength at the asphalt-concrete boundary. Low-amplitude reflections (orange/green zones, Fig.3) indicated dry, intact waterproofing, while high-amplitude/high-dielectric reflections (red zones, Fig. 3) pointed to water accumulation and potential debonding.
- **Rebar and PT Mapping:** Tracked the hyperbola reflections of the longitudinal and transverse steel to map the depth, spacing, and structural relationship between the rebar panels and underlying post-tensioning ducts.

- **Southwest Abutment Joint:** A major zone of water accumulation was identified. Due to the slope of the bridge, runoff is stopped hard at the expansion joint, leading to prolonged water saturation. Trial Pit 1 confirmed that this saturation has resulted in a poorly bonded waterproofing membrane.
- **Utility Trench Saturation:** High-amplitude dielectric responses highlighted a saturated zone running across the carriageway halfway along the span, coinciding with a transverse utility/comms cabling trench.
- **Healthy Zones:** The westbound carriageway and eastern sections exhibited low-amplitude reflections. Trial Pit 3 calibrated these areas as having fully intact waterproofing and dry underlying concrete.

Fig.3 Low amplitude response shown in orange, high amplitude higher dielectric response in red

1. Targeted Waterproofing Repair: Execute localized waterproofing replacement on the southwest end of the bridge, focusing on the high-saturation zone up to the easternmost boundary.
2. Drainage Remediation: Address the drainage path hard-stop at the southwestern abutment joint to prevent future pooling and premature bond failure.
3. Local Concrete/Steel Investigation: Perform a localized, non-destructive follow-up or localized breakout to evaluate the suspected reinforcement degradation.

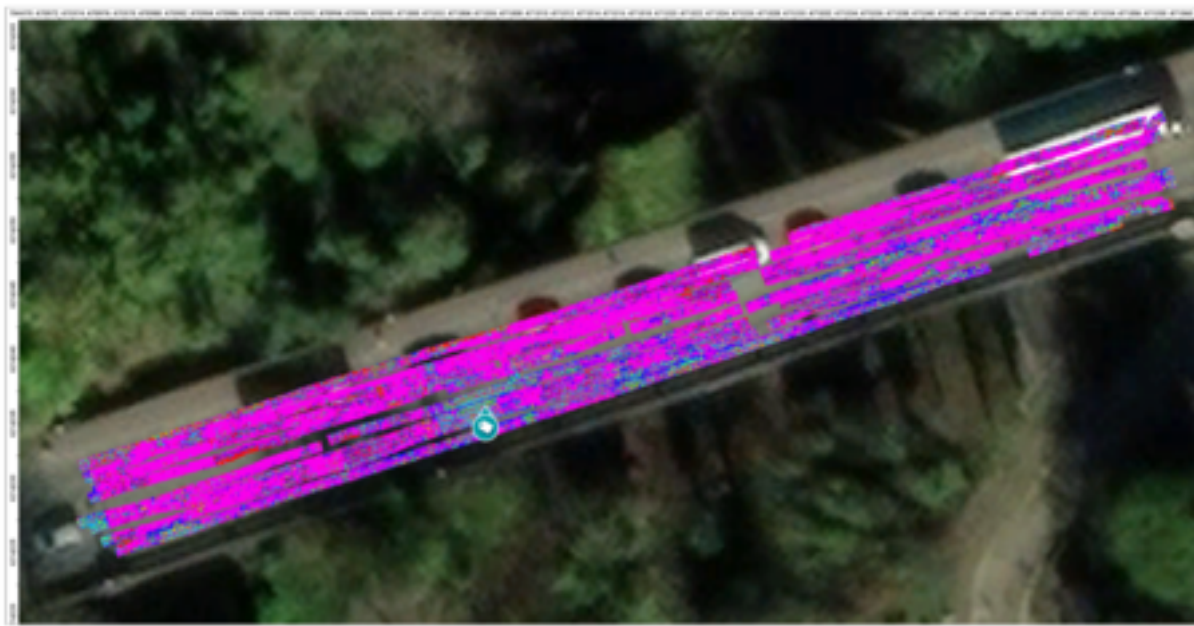
Fig.4 Waterproofing layer
