Inspecting dock road slab structures with ground penetrating radar

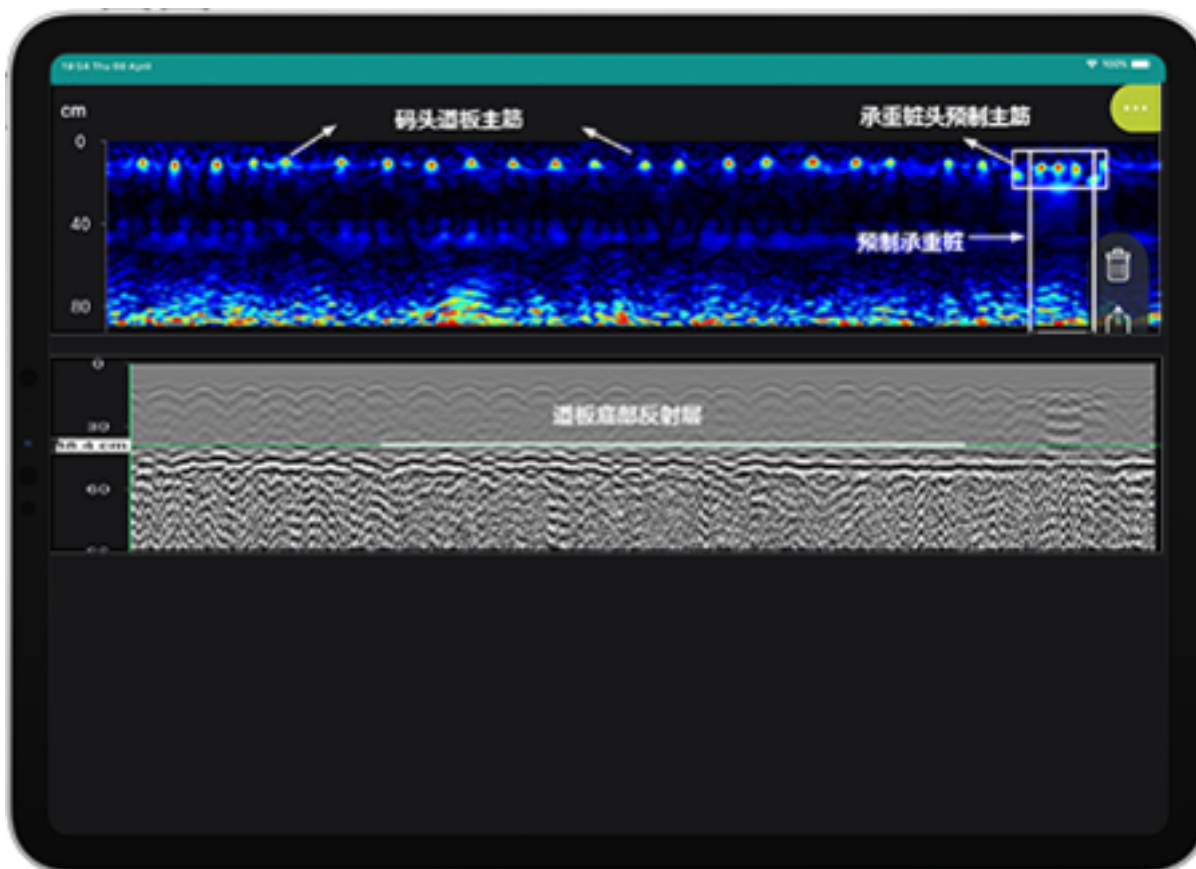
The radar map of the Road Plate detected by GP8000

As can be seen from the figure, the GP8000 can clearly detect the health of the debut plate structure: the main rib is clearly visible, the bottom reflection is clear and continuous, flat, and there is no large-scale spalling and damage at the bottom.

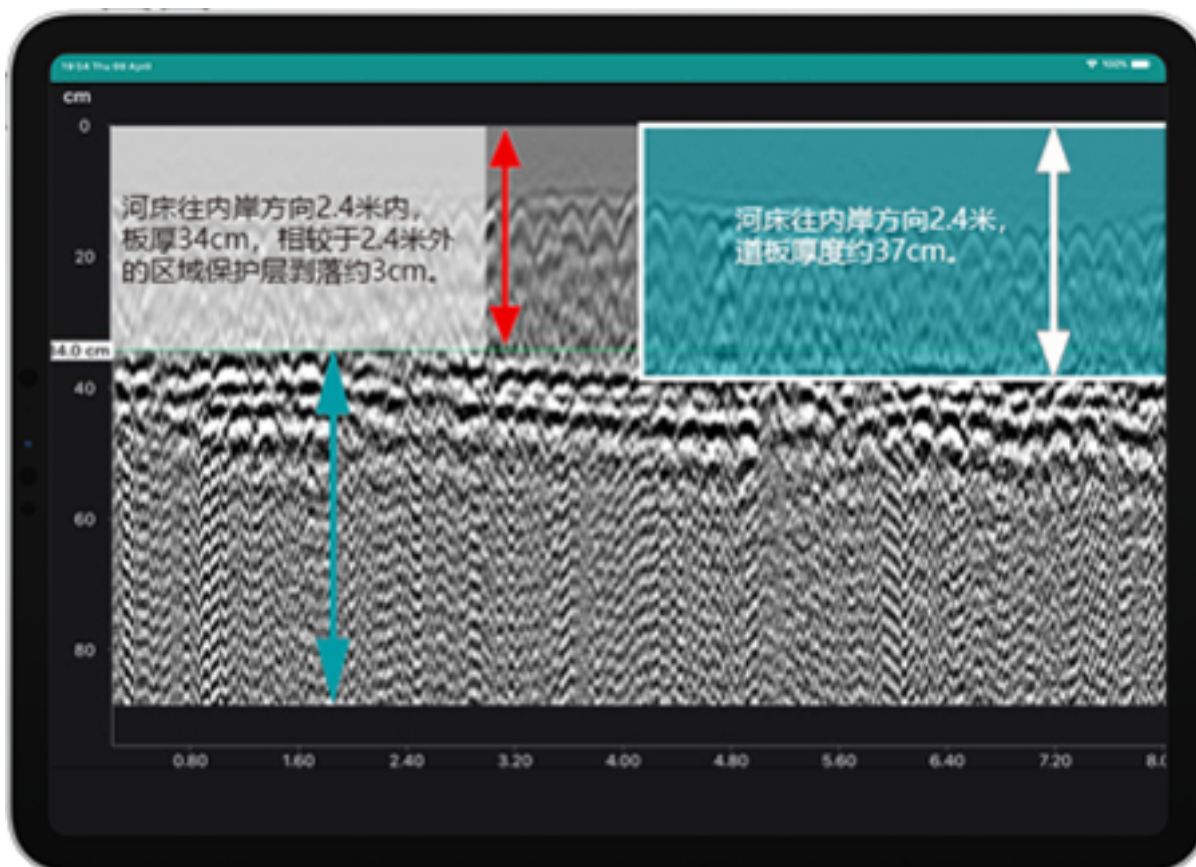
Suspected damage to the road plate detected by GP8000

Through the GP8000 radar checking test, it is not difficult to find that the thickness of front plate where riverbed is within 2.4 meters to the inner bank is about 34cm; and the thickness of back plate where the riverbed is 2.4 meters away from the inner bank is about 37cm. that means the protective layer of the front plate is reduced by about 3 cm.

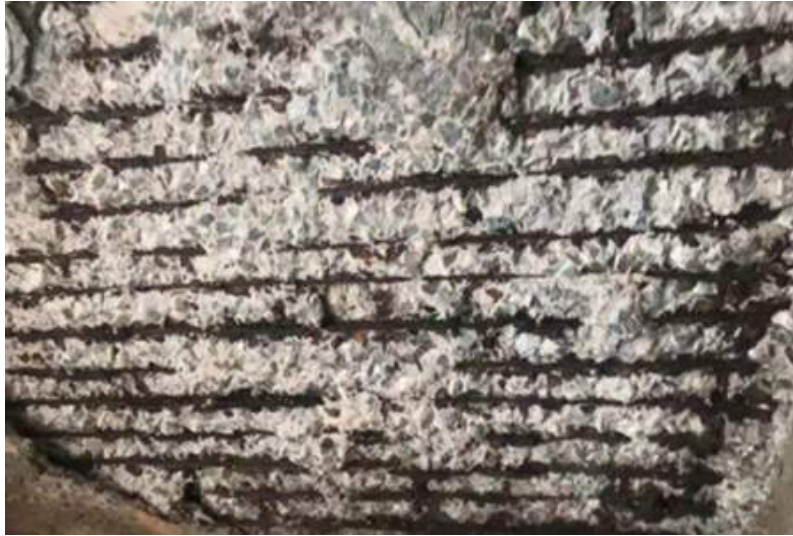
Rusting and peeling areas (front plate)

During the dry period, the field conditions verified by the inspectors coincided with the response of the [GP8000](#) GPR detection signal. Due to the impact of the water wave, the front road plate is attacked by moisture and ions for a long time, resulting in the long-term corrosion activation state of the steel reinforcement inside the concrete. This caused the concrete protective layer to corrode and crack, peeling, resulting in the exposed steel bar, which in turn aggravates the damage of the steel bar and the lack of bearing capacity of the road plate.

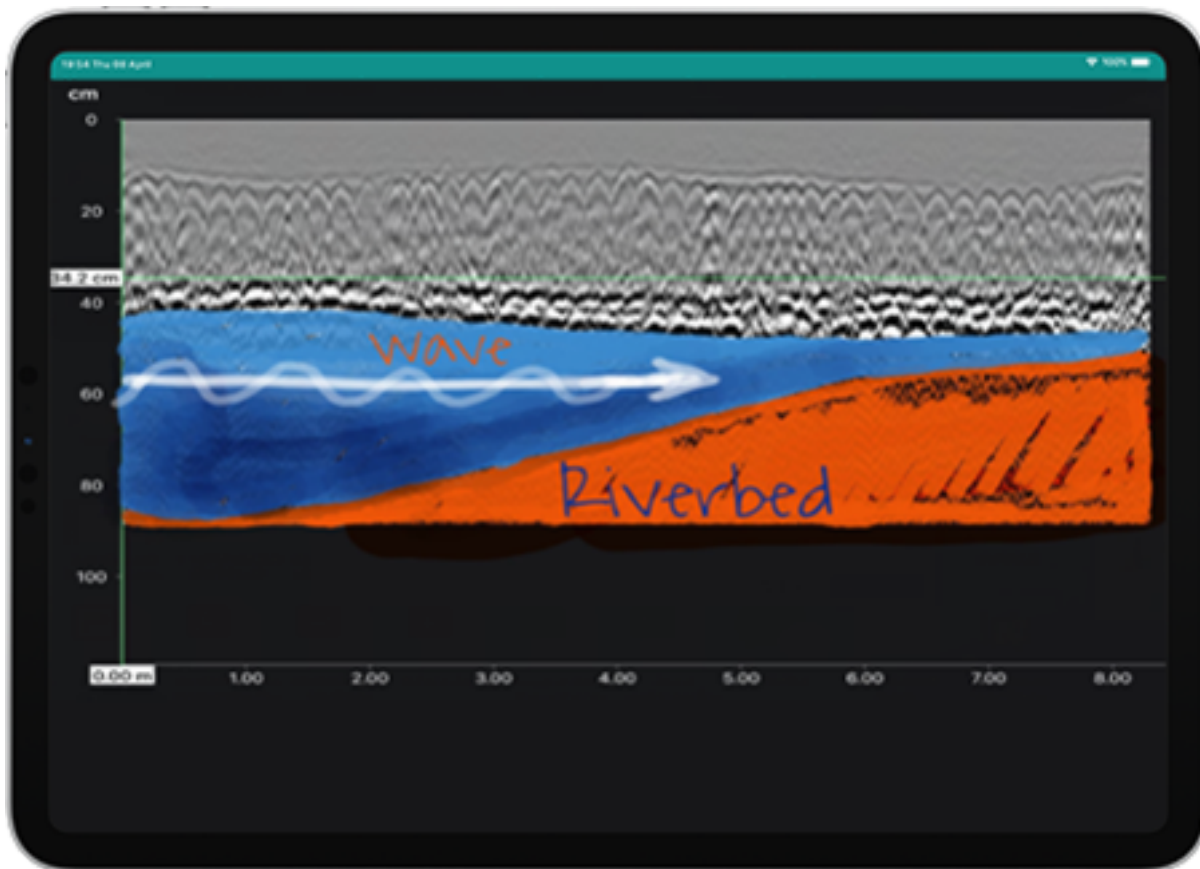
Cross-sectional view of water wave erosion
