工作人员正推着GS9000探地雷达在桥面上进行探测

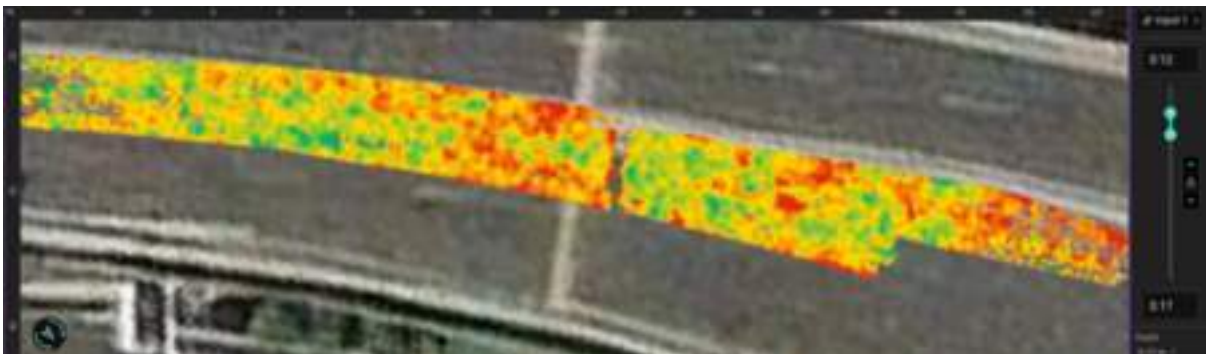
GPR 探测结果最重要的输出是劣化图，红色区域为劣化可能性区域，它是基于顶部钢筋的振幅衰减得出，符合 ASTM D6087 标准。

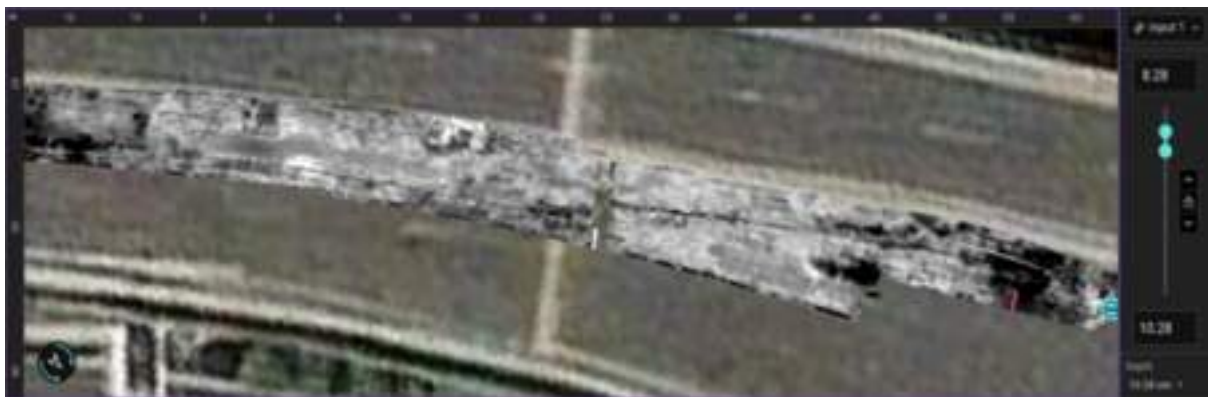
沥青混凝土 (A/C) 层之间的界面缺陷（分层）
