工作人员正推着GS9000探地雷达在桥面上进行探测

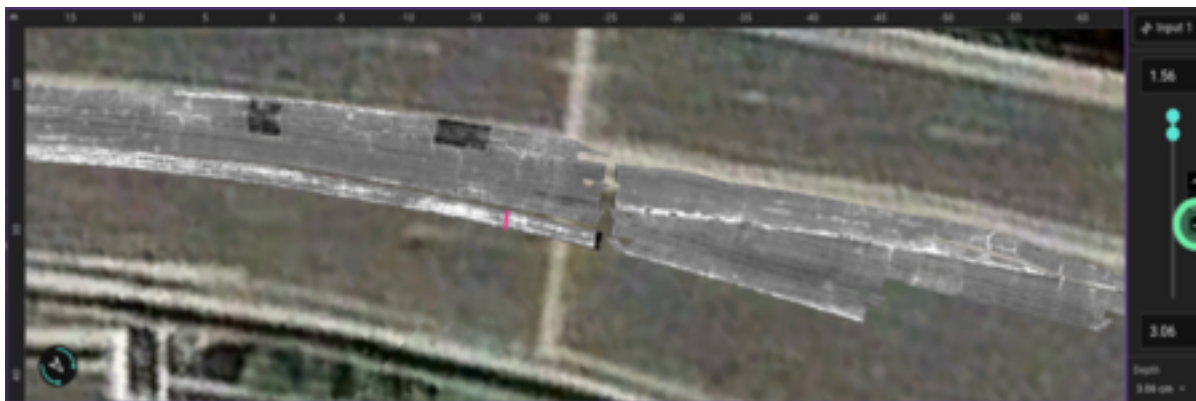
沥青层的主要表面缺陷（裂缝）

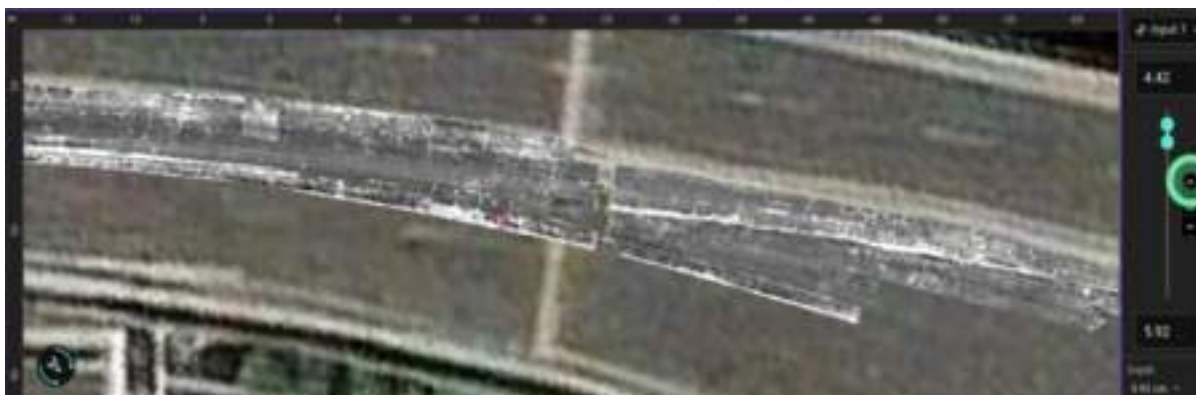
在沥青层内 4 至 6 cm深处发现了延伸的表层缺陷

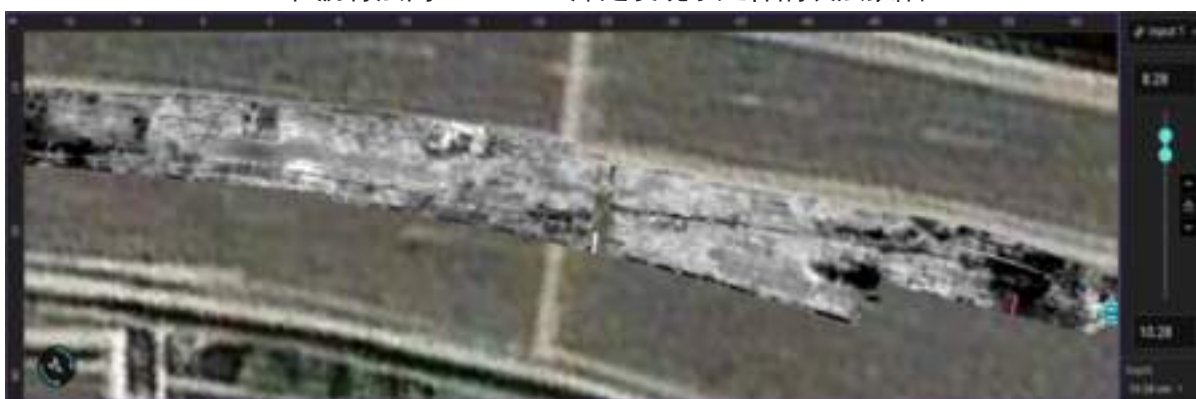
沥青混凝土 (A/C) 层之间的界面缺陷（分层）
