# Time-critical investigation and testing of a precast concrete beam using Ultrasonic Pulse Velocity (UPV)

## Overview

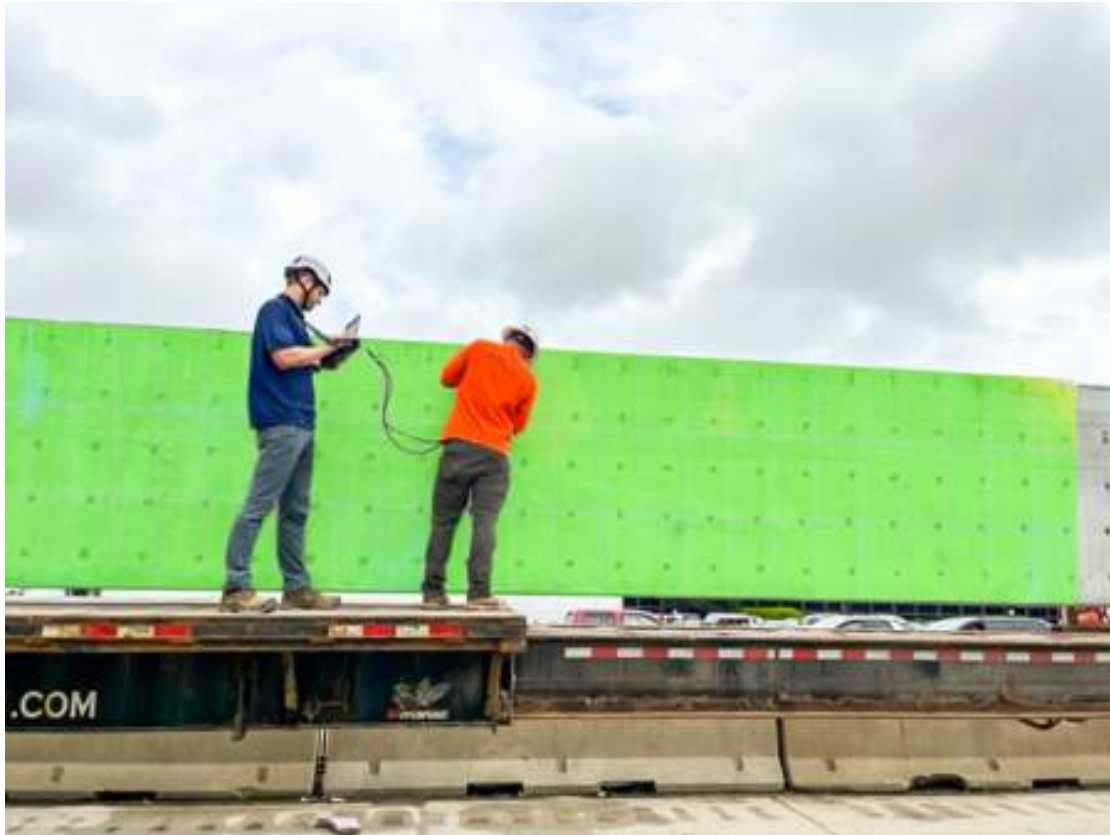
Typically performed in “direct transmission,” the transducers are set on opposite sides of a structural member with a known cross-sectional thickness. However, to assess the potential presence of a longitudinal discontinuity, “indirect transmission” measurements were taken by placing the transducers on the same face of the structural member at a fixed separation distance. If a discontinuity or cold joint was present, the transducers measuring across the longitudinal discontinuity would correspond to a reduction in the signal strength and decreased pulse velocity readings.

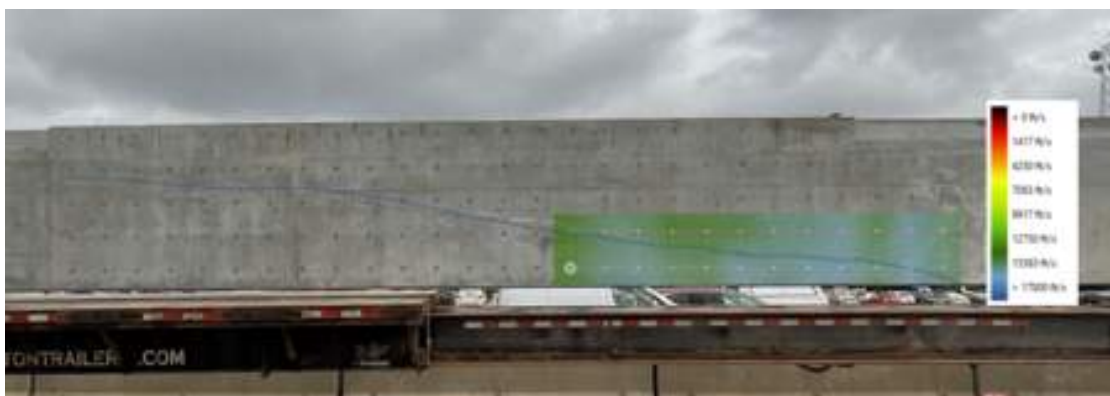
As a control test area, Durability Engineers' performed UPV on 12 ft by 2 ft direct transmission grid through the width of the beam (1.5 ft). The velocity readings ranged from 14,865 ft/s to 16,145 ft/s with an average 15,730 ft/s. This direct UPV testing was done to determine the baseline velocity of the concrete and to calibrate the measurements for indirect UPV testing.

The results are shown superimposed on a photograph of the beam. Note that the blue dashed line shows the location of the presumed cold joint and the small white circles are the measurement positions.

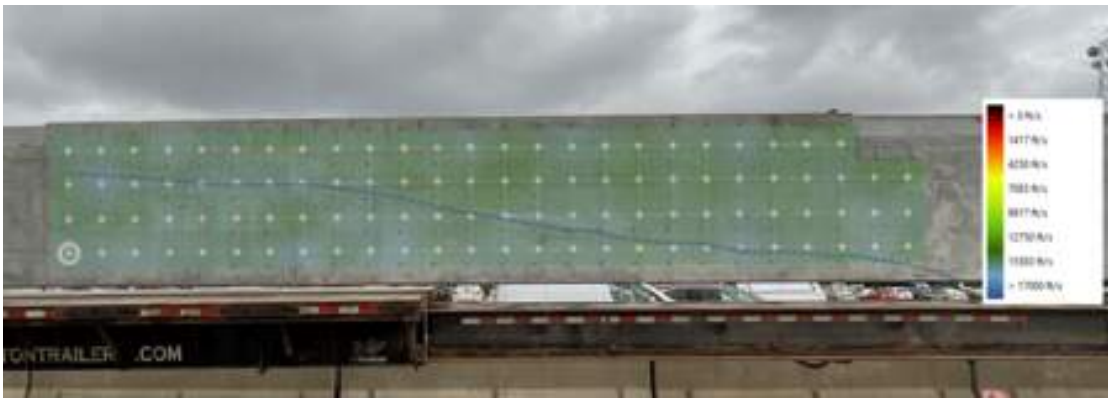
To evaluate the presence of a potential discontinuity, UPV was performed on a 26 ft by 5 ft grid on the South face of the beam with a 1 ft transducer spacing. Indirect velocity readings ranged from 14,390 ft/s to 16,555 ft/s with an average 15,440 ft/s (results are shown superimposed on a photograph of the beam). A 12 ft by 3 ft indirect transmission grid was also performed on the North face of the beam with a 1 ft transducer spacing. These indirect velocity readings ranged from 14,205 ft/s to 16,420 ft/s with an average 15,480 ft/s.

It was clear from the results that the velocities were similar throughout the measurement grid and do not indicate discrepancies or areas of weakness. Therefore, the UPV measurements indicated the beam has been placed monolithically and did not suggest the presence of a cold joint or discontinuity.
