## Detecting possible voids behind PT cable anchors

This application note describes how to inspect a new multistorey concrete building with post-tensioned floor slabs.

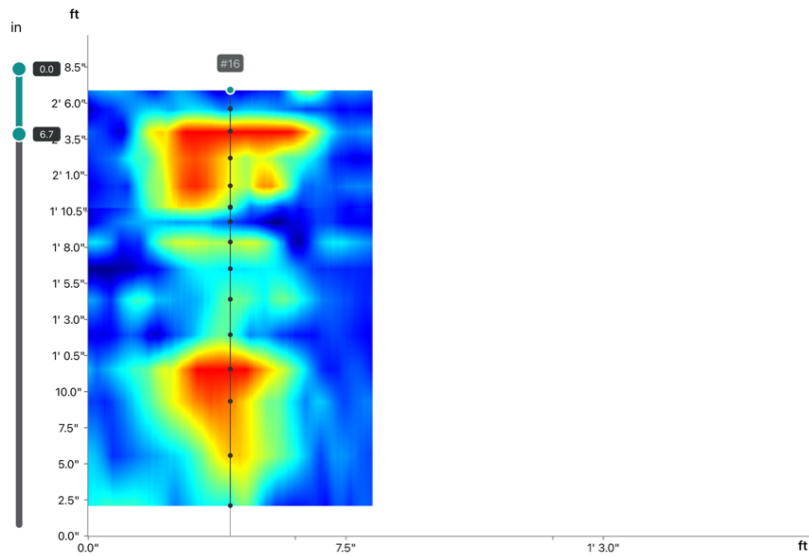
The contractor experienced several instances of the PT cable anchor being pulled into the concrete when the tensioning force was applied. It was suspected that the congested rebar configuration led to voids in the concrete behind the anchors.

Figure 1 – Stripe scan of problem area showing strong reflection from discontinuity in the concrete around the PT cable.

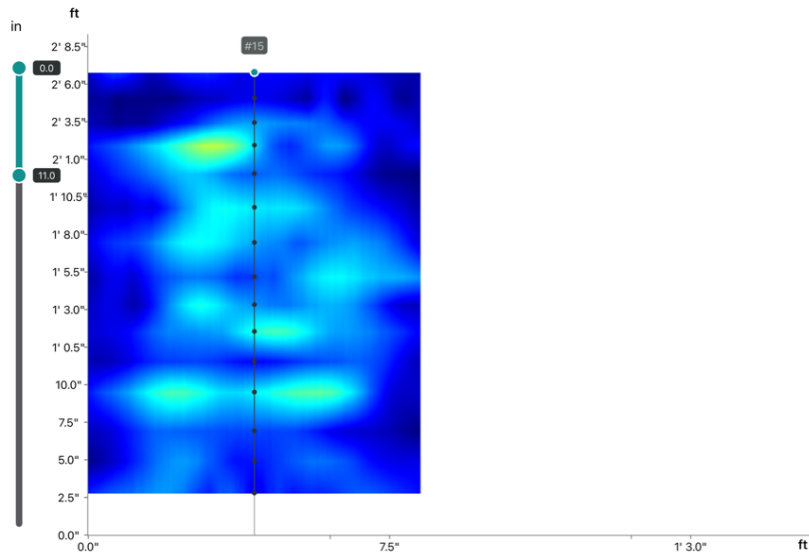
Figure 2 – Stripe scan of good area with lack of strong reflections indicating solid concrete around the PT
