工作人员正推着GS9000探地雷达在桥面上进行探测

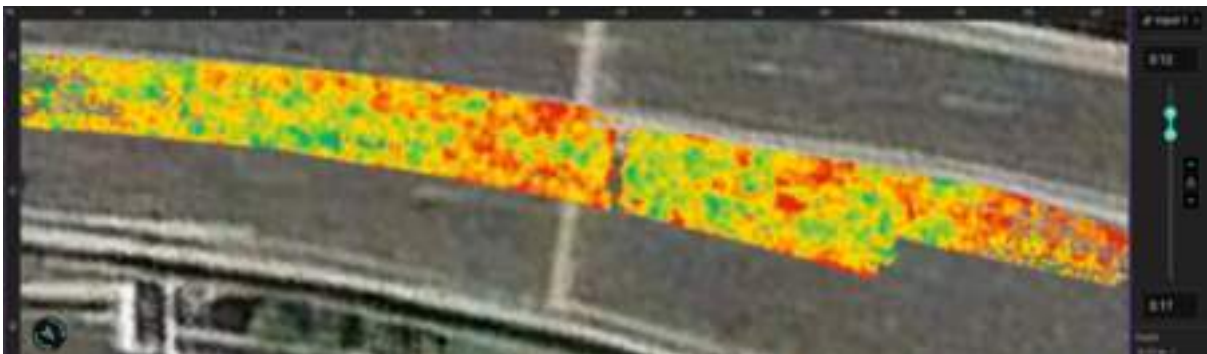
GPR 探测结果最重要的输出是劣化图，红色区域为劣化可能性区域，它是基于顶部钢筋的振幅衰减得出，符合 ASTM D6087 标准。

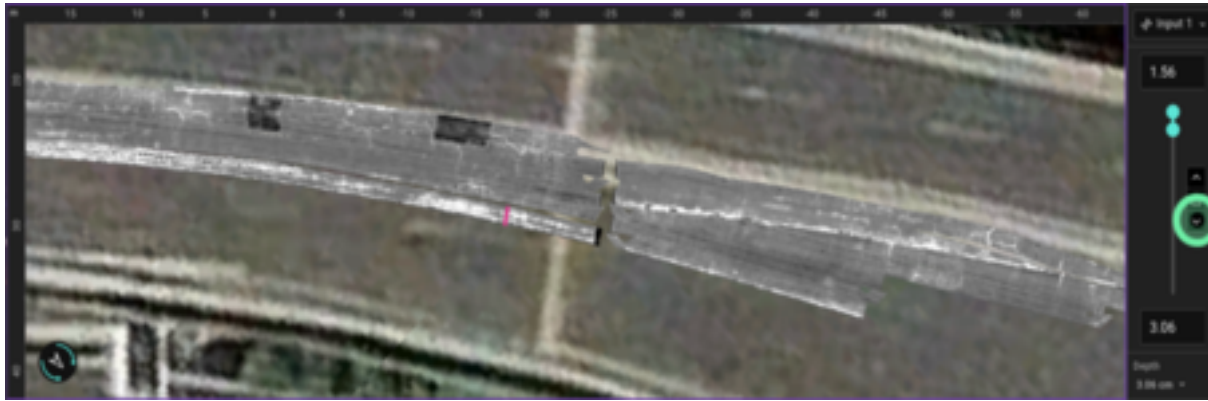
沥青层的主要表面缺陷（裂缝）

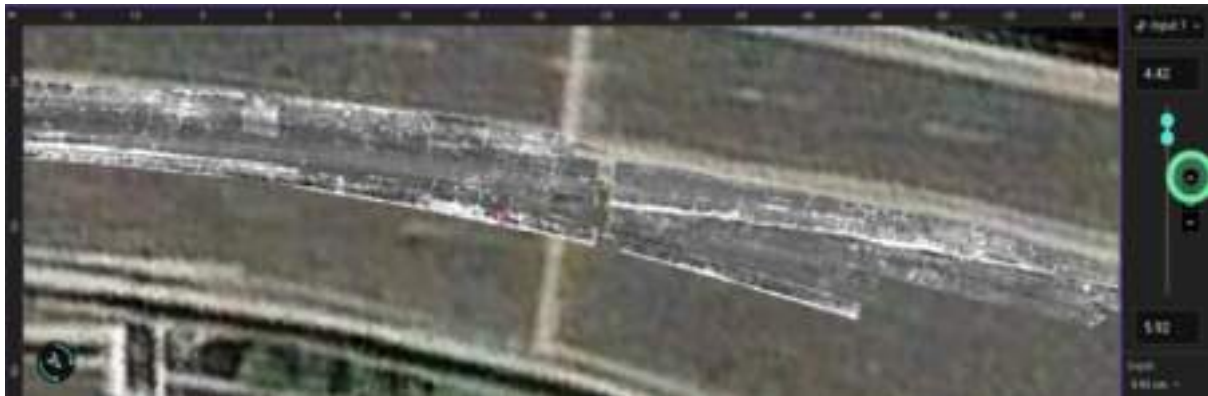
在沥青层内 4 至 6 cm 深处发现了延伸的表层缺陷
