Scanning urban roads with Multichannel GPR to accurately identify hidden problems

Detecting subsurface defects and voids in high traffic areas

A transportation hub in China, with heavy traffic, had previously undergone numerous repairs. Regular inspections were now crucial to assessing its health and ensuring smooth urban traffic flow.

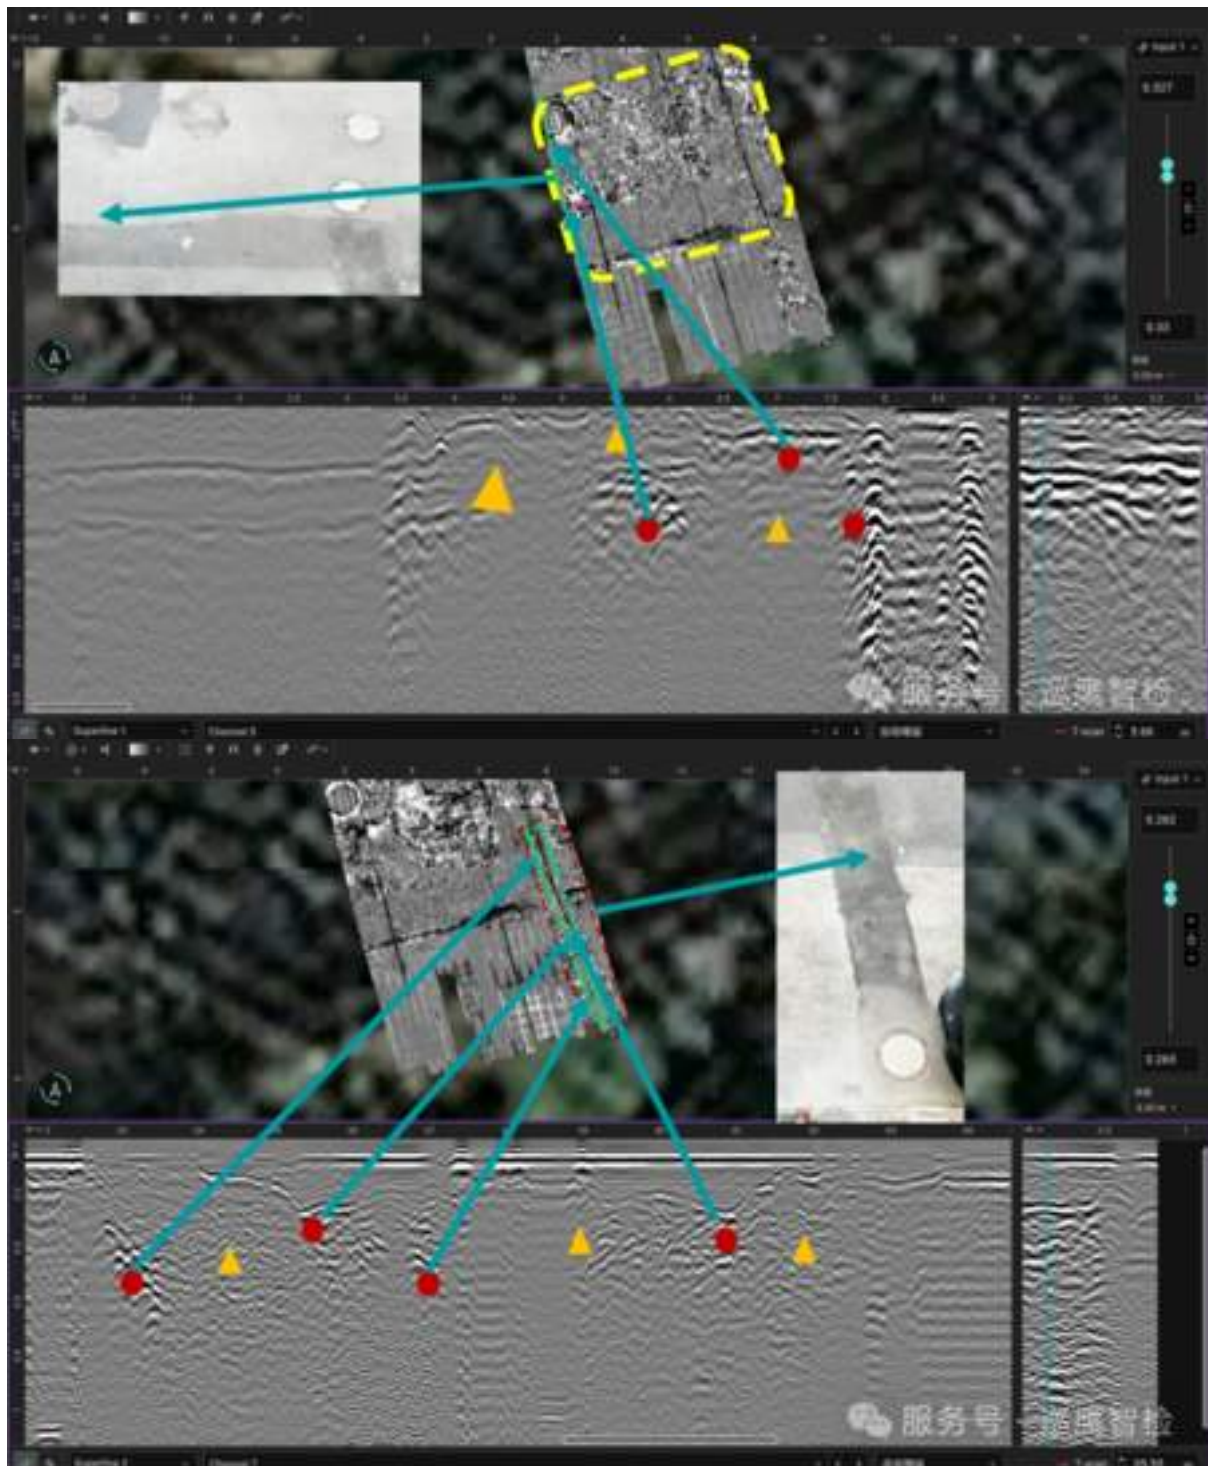
As shown in the video above, at a depth of 8 cm, large areas of typical void signals (characterized by high amplitude and clear boundaries) and non-dense signals (characterized by being messy and discontinuous) began to appear, and were mainly distributed within a depth of 60 cm.

Yellow triangle indicates: non-dense signal Red circle indicates: short signal

This suggests that there may be extensive voids and severe decompression beneath the road. However, no obvious delamination of the road structure was detected in the radar signal. Combined with on-site photos, this area may have undergone multiple damage and repairs, with poor results.

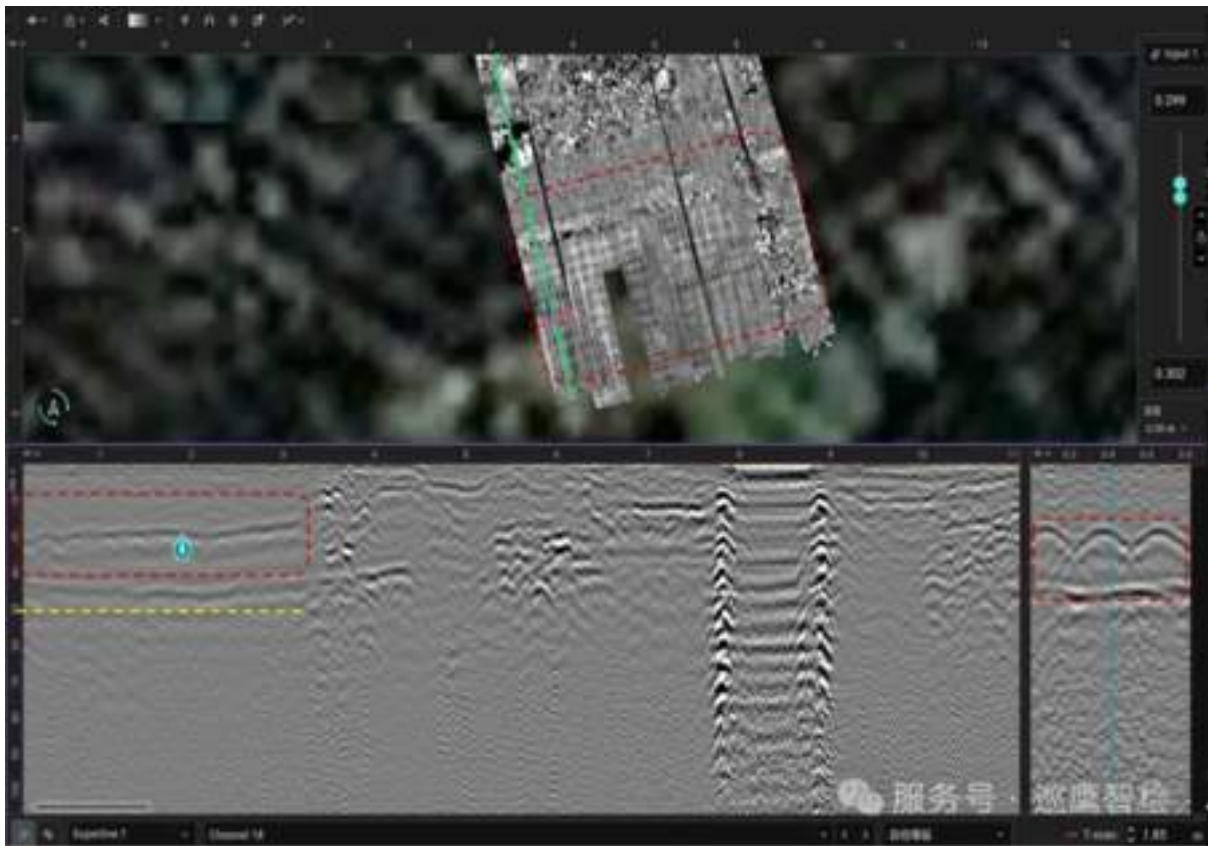
Furthermore, the depth slice and radar B-scan images clearly show the presence of a crisscrossing mesh of steel bars in the red framed area of the inspection area, buried approximately 30 centimeters deep. A clear layered reflection signal is visible approximately 42 centimeters below the mesh (marked by the yellow dashed line).

Based on comprehensive judgment, during the construction of this area, a layer of concrete about 10 cm thick may have been laid first, and then the steel mesh was laid.

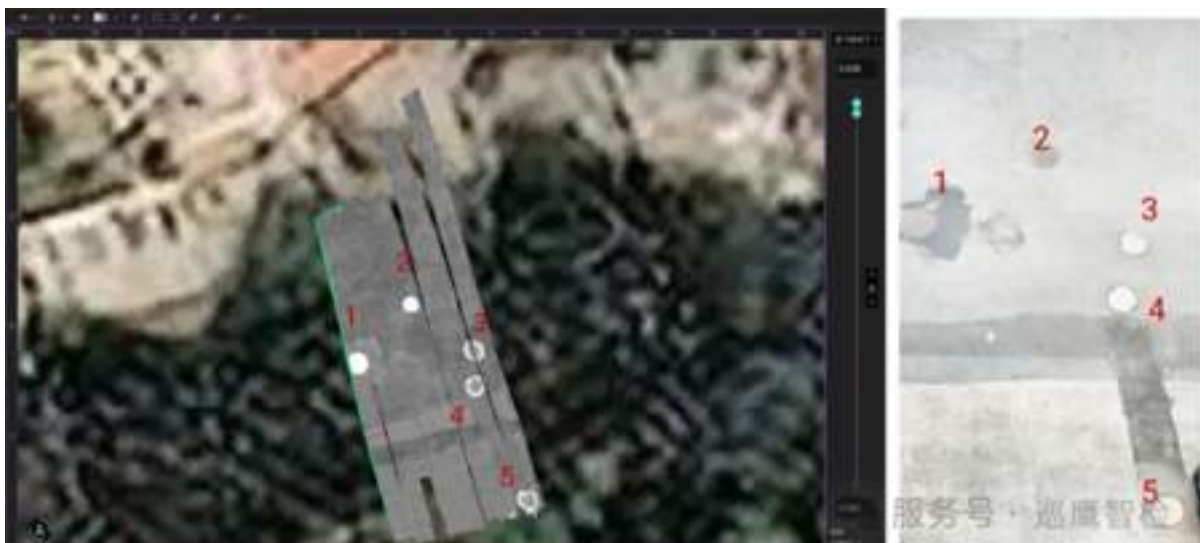
The radar depth slice clearly showed five circular reflections, which, when compared with on-site photos, were confirmed to be reflections from five municipal manhole covers. Manhole covers 1 and 2 were metal, while covers 3 through 5 were concrete (shown as hollow on the radar image).

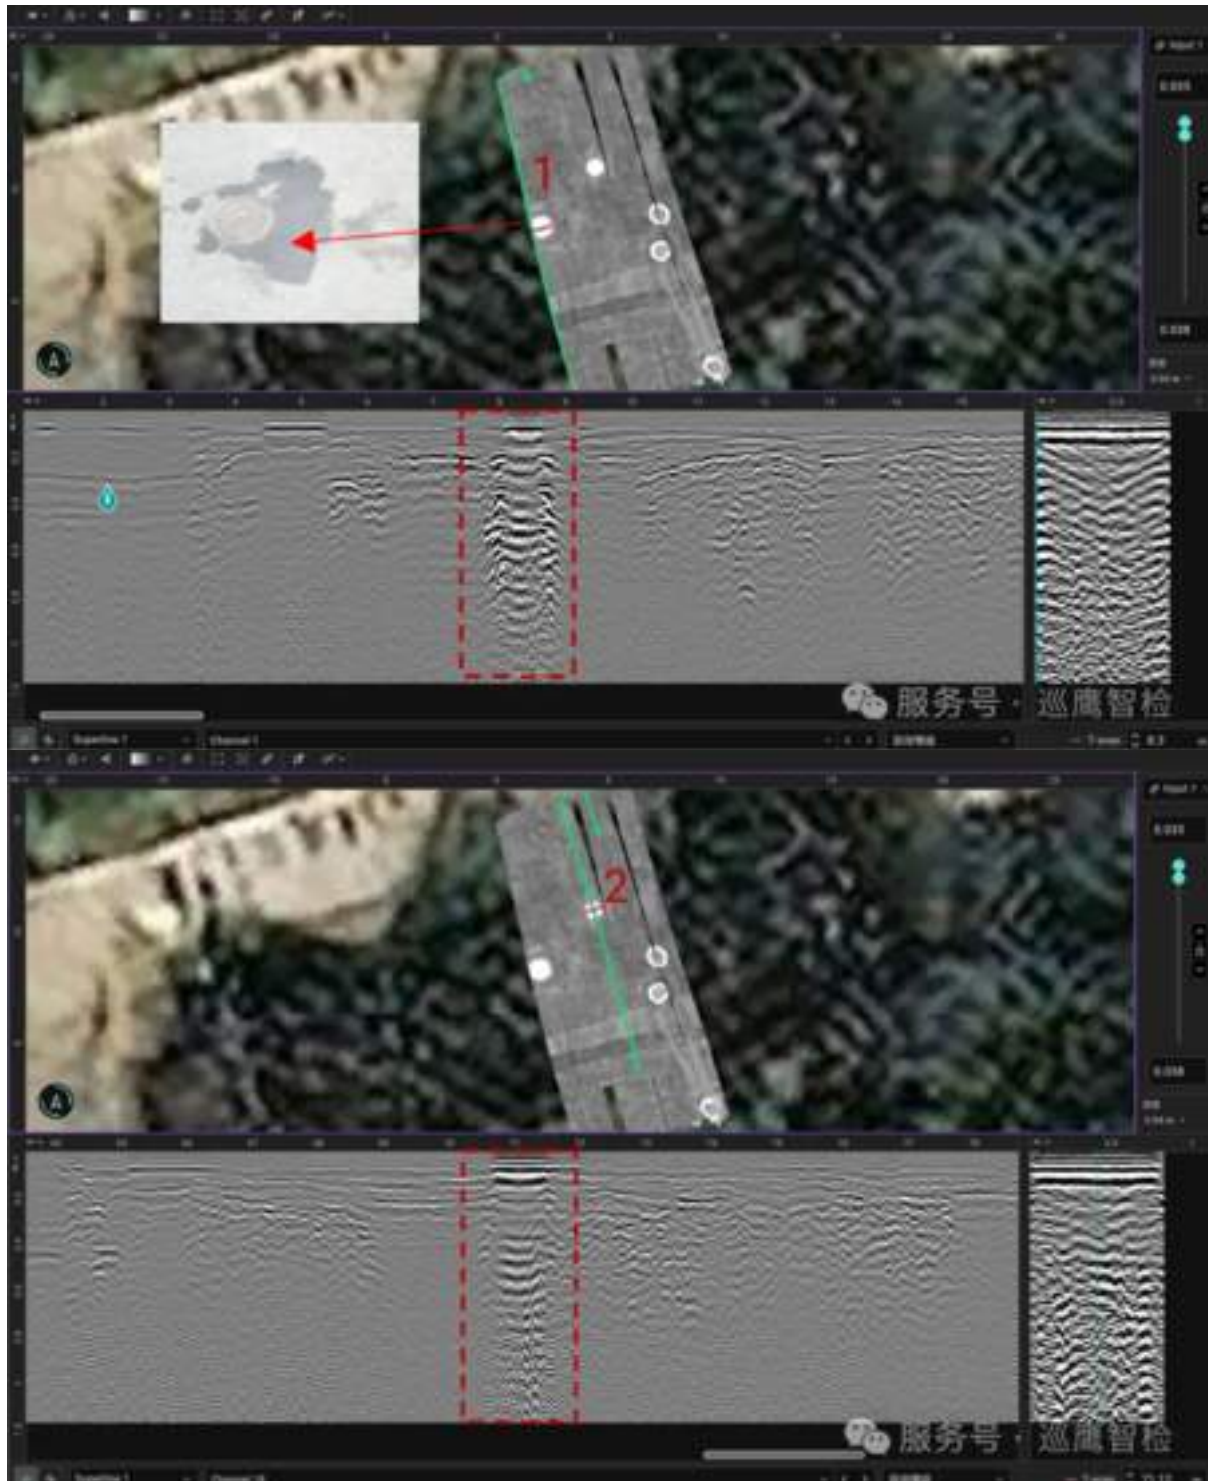
By observing the radar B scan images of manhole covers No. 1 and No. 2, it was found that their reflected signals showed significant multiple reflection oscillation effect in the depth direction, which is a typical feature of metal manhole covers.

However, unlike cover No. 2, cover No. 1 exhibited a strong reflection signal around its edges. Combined with on-site photos showing signs of repair and new construction around cover No. 1, the inspection team concluded that there may be a void or defect beneath cover No. 1, indicating that the well had been damaged and that repairs had not met expectations. For concrete manhole covers No. 3 to 5, their radar B scan images did not show multiple reflection oscillations.

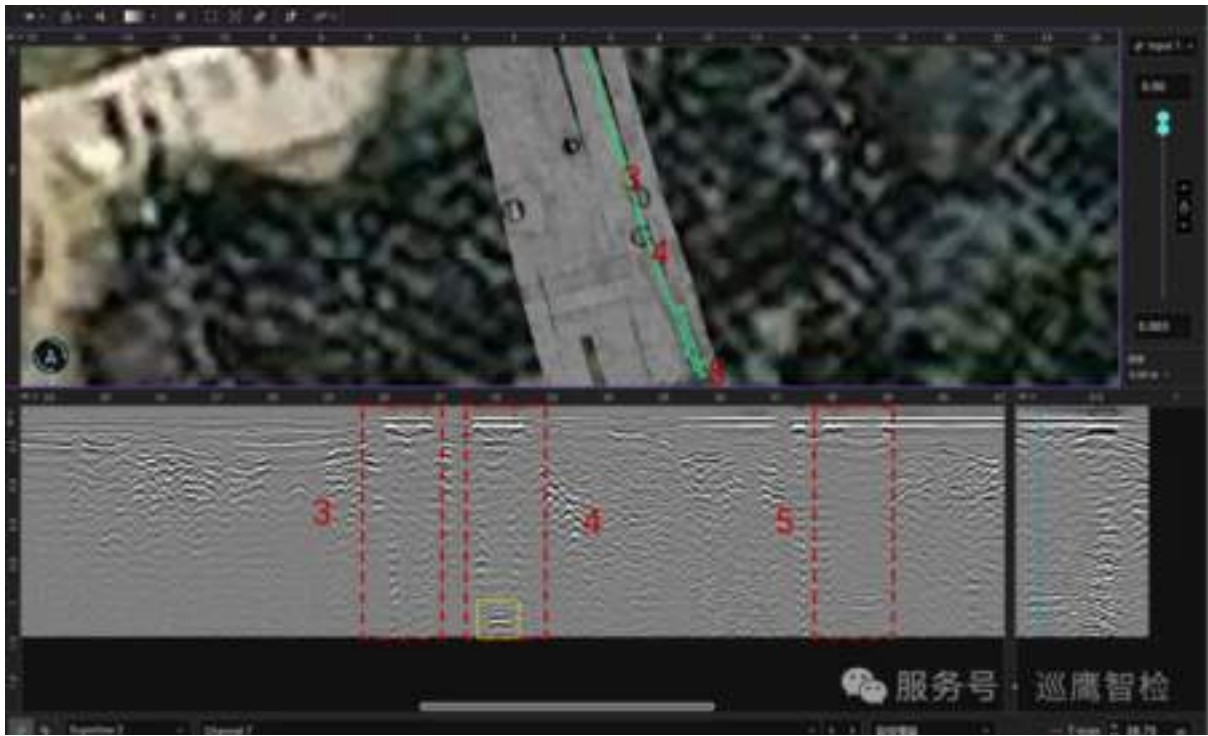
A strong reflection signal (marked in yellow) is detected deep below the No. 4 manhole cover, presumably originating from the shaft floor. The depth was calculated using the radar signal's two-way travel time, which was recorded at 18.6 nanoseconds. Substituting this into the following depth calculation formula yields an estimated depth of 2.79 meters.

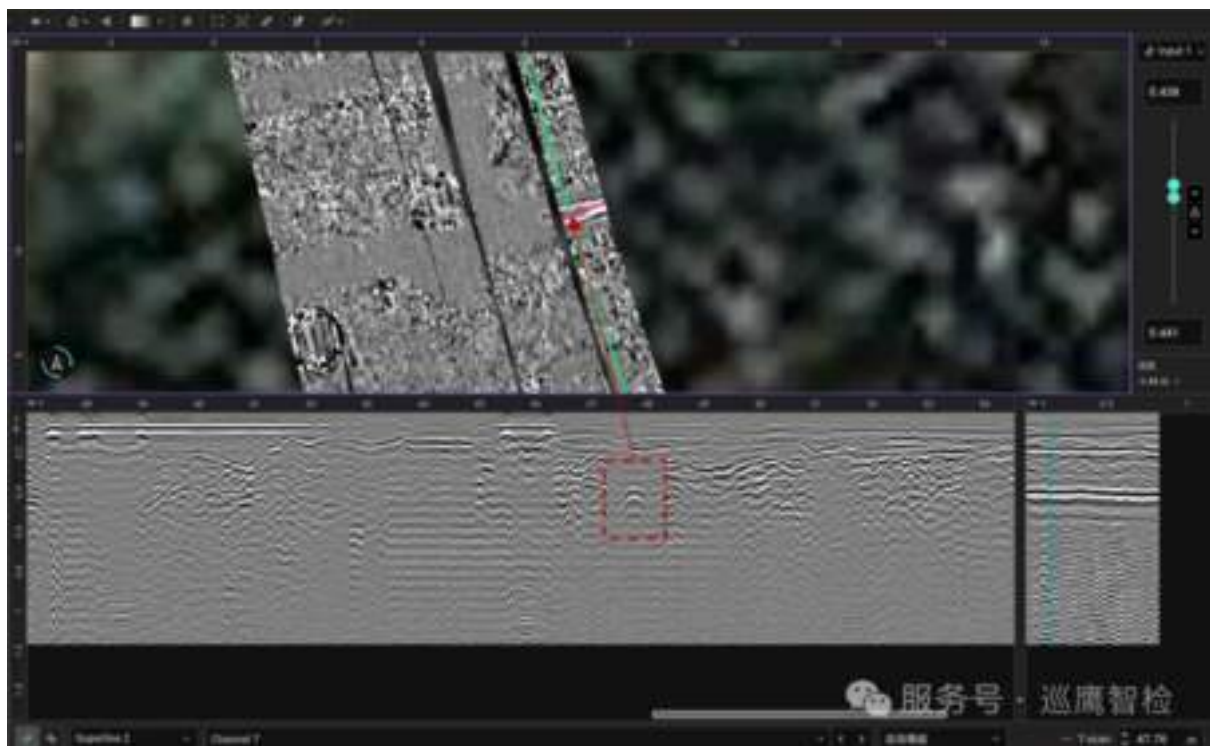
In terms of underground pipeline detection, radar B scan and depth slice showed that there was a reflection signal from a metal pipe at a depth of about 40 cm.

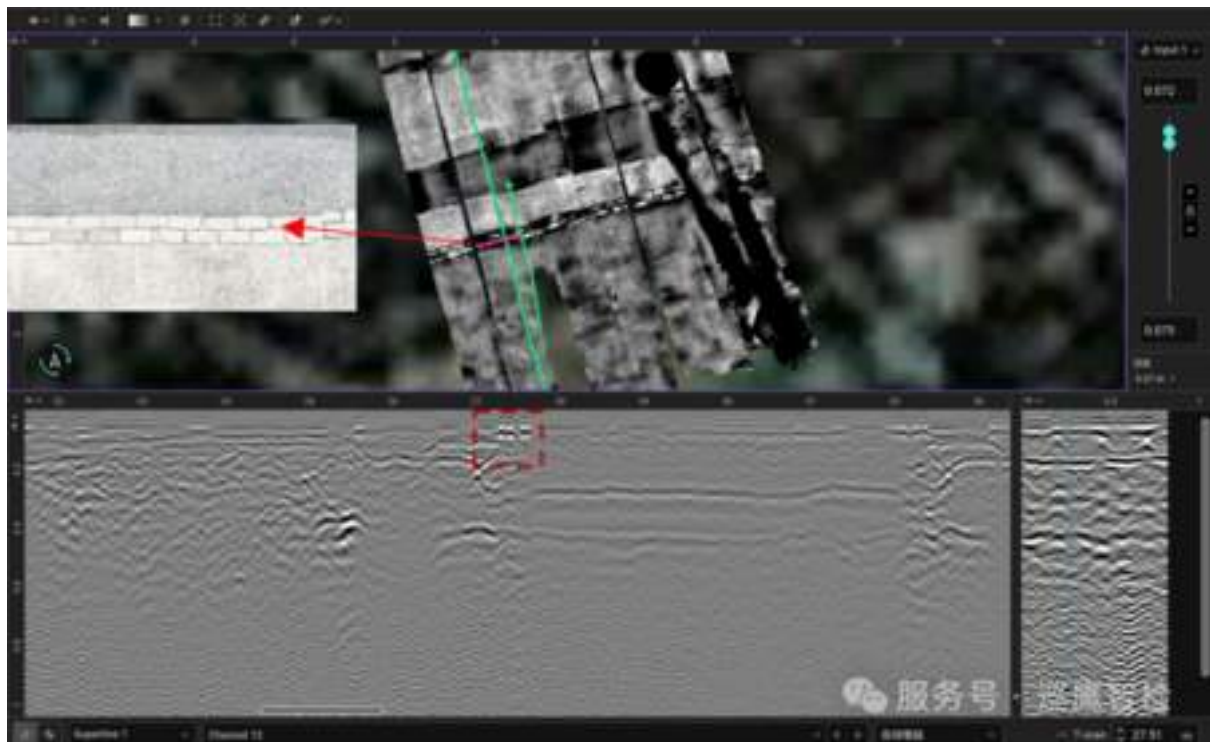
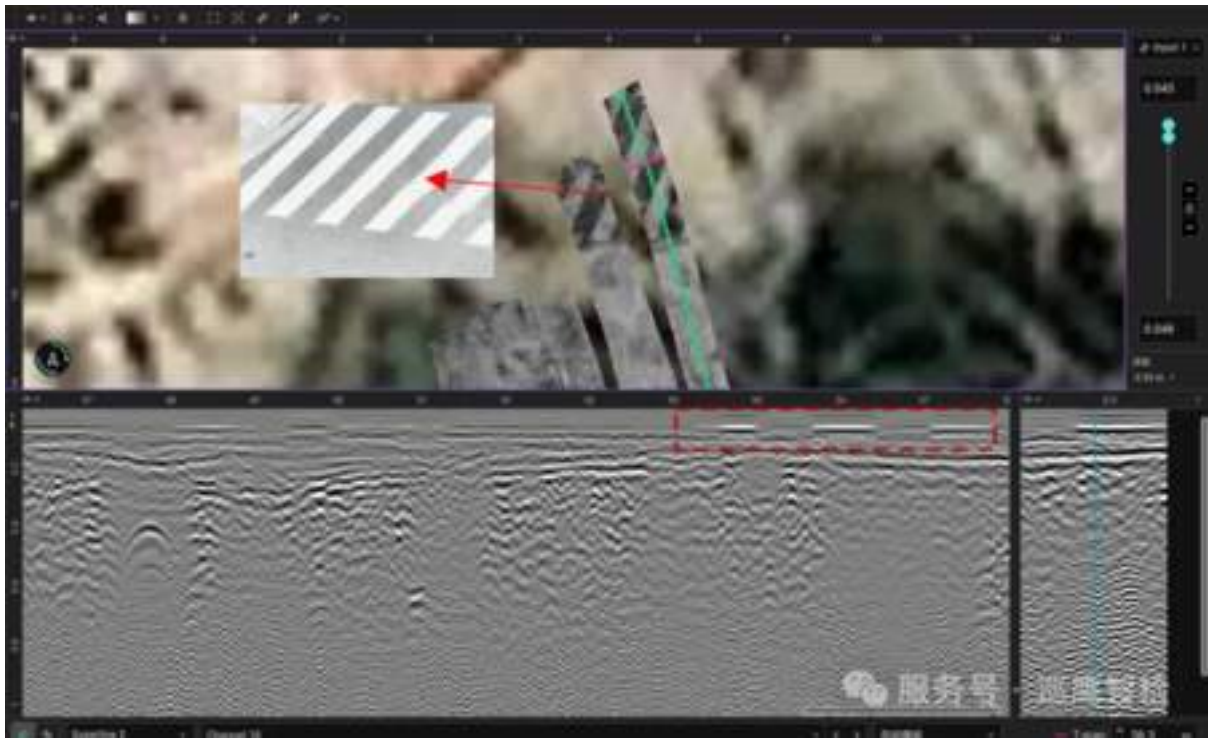
In addition, the depth slice and radar B-scan image also clearly showed several obvious reflection signals. After on-site comparison, it was confirmed that the reflection sources were bricks and zebra crossings.
