Identifying Potential Damage to PT Ducts on the Theodore Roosevelt Bridge, Florida

Explore the non-destructive testing methods used to locate and inspect post-tension ducts and tendons in bridges

The purpose of this project was to use non-destructive testing to locate PT tendon distresses identified with a permanent structural health monitoring system.

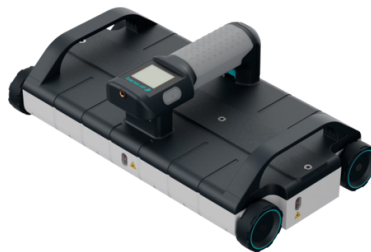
Screening Eagle has three versions of concrete GPR, but the GP8100 was primarily used in this project. This device has 6 antennas for larger area coverage and single pass C-scans (called superline scans) that allow for easier interpretation (Figure 2). C-scans allow visuals through the concrete depth, starting at the surface and slicing through the thickness.

Figure 2. Proceq GP8100
GPR
