# Non-destructive Testing of a Shotcrete Wall

- [FPrimeC Solutions](#) was hired by a Shotcrete Contractor to verify the quality and integrity of shotcrete on or around a cold joint that was formed during the shotcrete construction.
- The [Pundit PD8050](#) and [Proceq GP8100 GPR](#) were used to assess the shotcrete wall.
- The team were able to provide the client with a precise percentage of the area affected by anomalies and quantify the degree of improvement after the injection program.

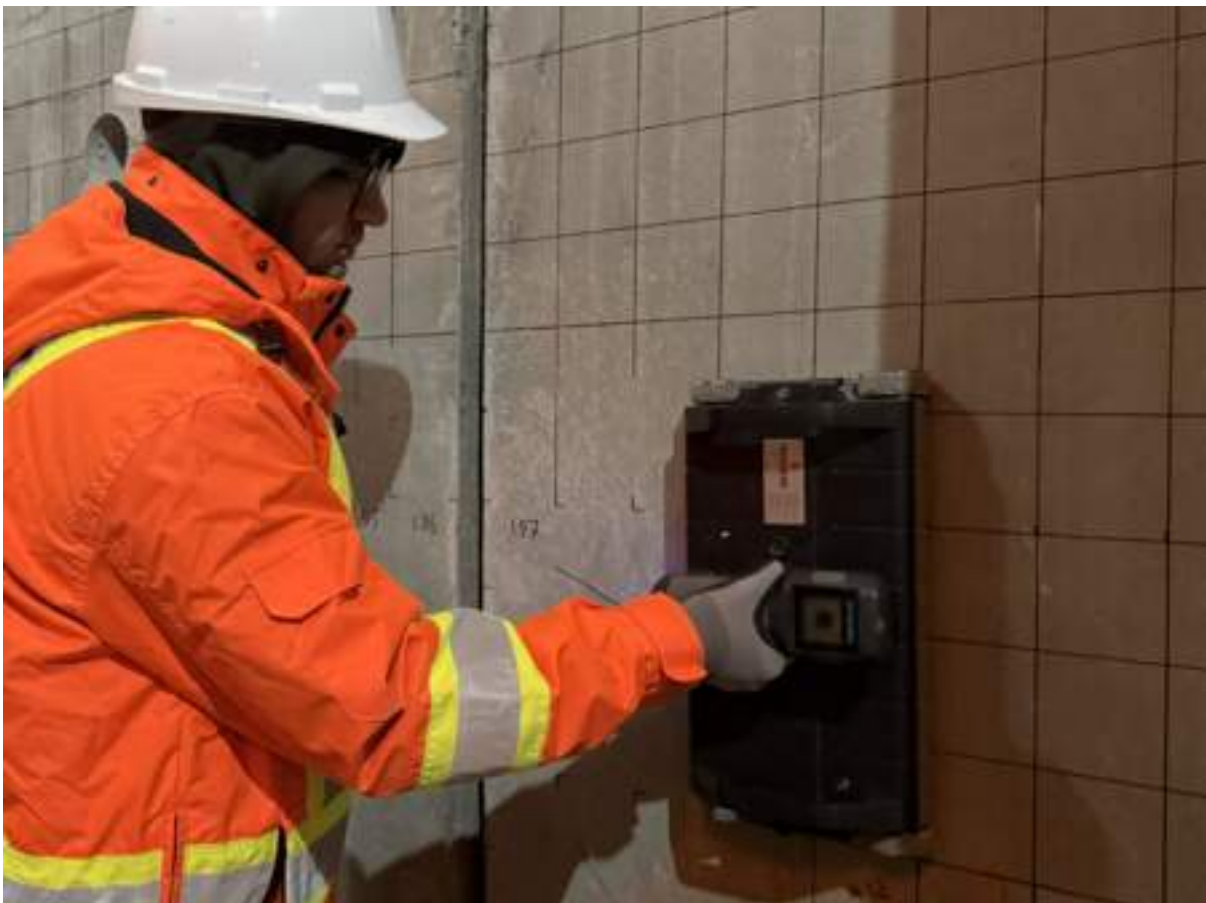
The goal was to monitor the change in acoustic response: voids and cracks show high-intensity reflections, while successfully grouted areas allow the signal to pass through, indicating a monolithic structure.

**Visual Proof of Repair:** Post-repair UPE B-scans showed a significant reduction in reflection intensity from the previously identified anomalies. This provided visual and mathematical evidence that the grout had effectively filled the voids and cracks.
