Initial Field Testing of GPR for External Duct Void Detection

Testing GPR Accuracy on External Wax-Filled Tendon Ducts

Project Summary

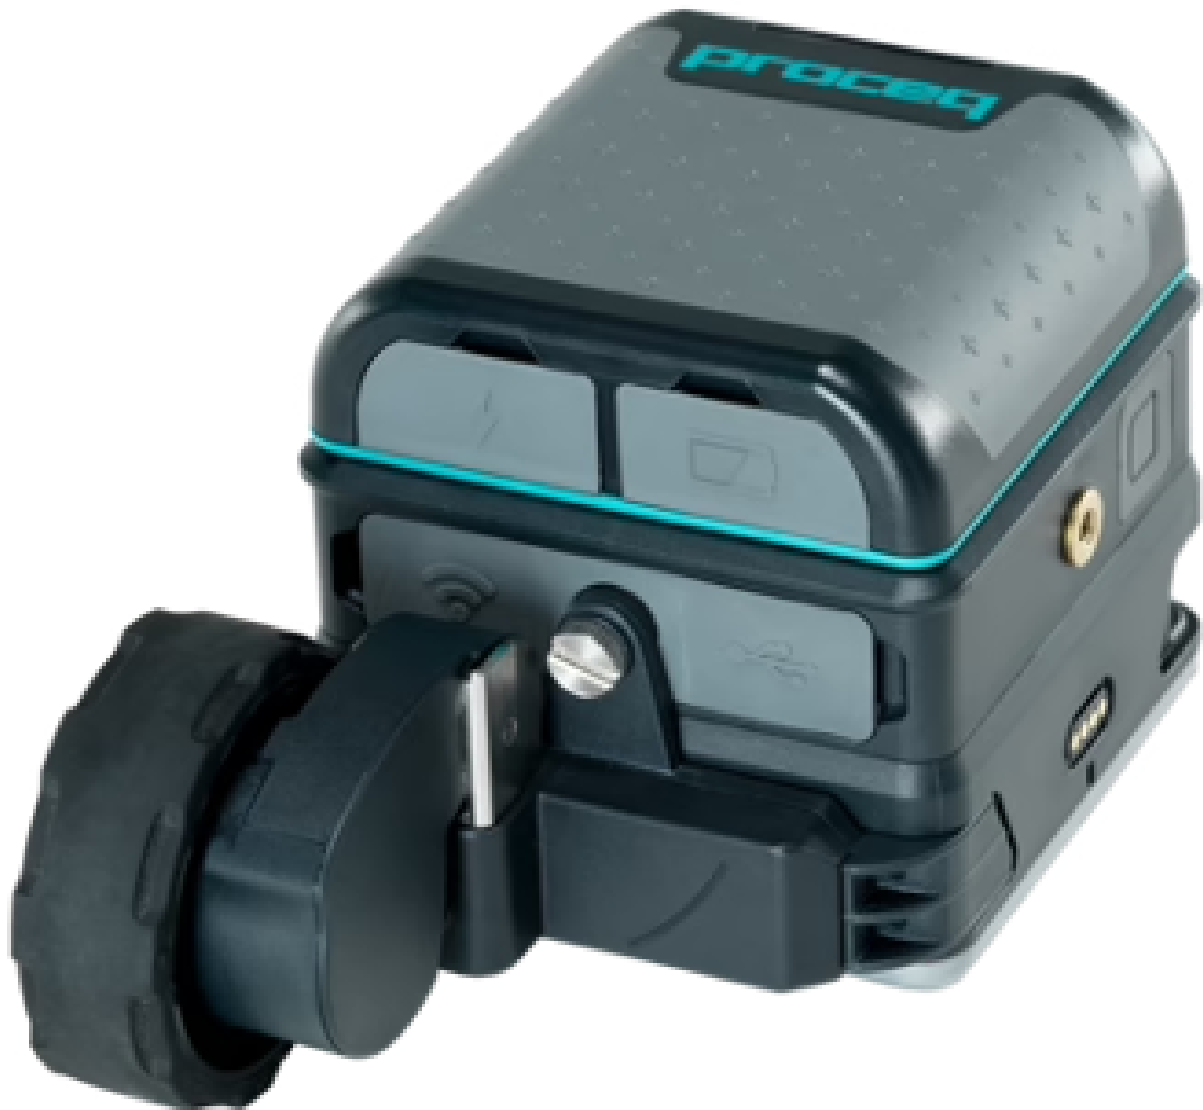
Proceq has several types of GPR, but the GP8800 (Figure 2) is the only one whose design can accommodate the limited size of the ducts. The footprint of the GP8800 is only 3x3 inches with a modular encoder wheel. This device uses a step frequency continuous waveform with a bandwidth of 400 – 6000 MHz which achieves a high-resolution image capable of detecting smaller defects in the duct.

Figure 2: Proceq GP8800

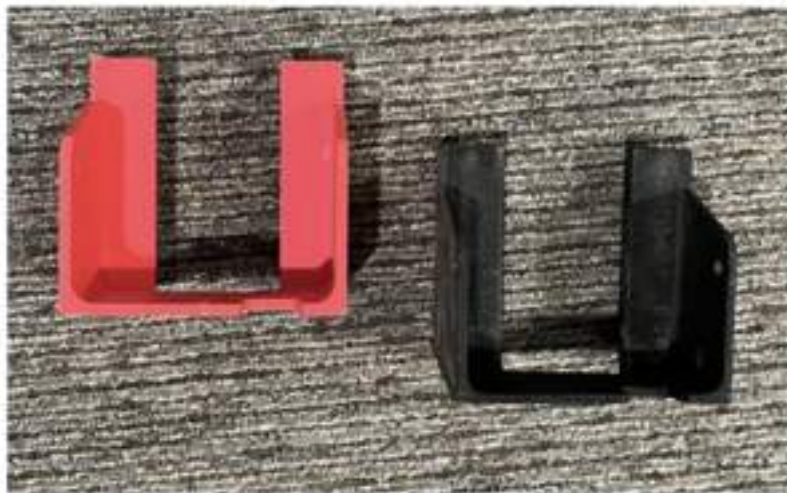
The GP8800 has a flat bottom which is excellent for most circumstances. However, when on a curved surface like the ducts, a saddle fixture is needed to keep the device properly seated (Figure 4). This custom saddle was designed by Bridgology for different sized PT ducts which can be easily 3D printed for each PT duct configuration (Figure 3). The key feature of this design is the opening at the bottom that allows the center of the GP8800 to consistently contact the duct and give the radar wave a normal incident angle. If this were to be attempted by hand, there would be excessive and inconsistent noise in the data. There is also a sleeve that goes on the wheel to improve contact with the duct and make up for the gap created with the offset wheel on a round surface.

Figure 3: PT duct saddle

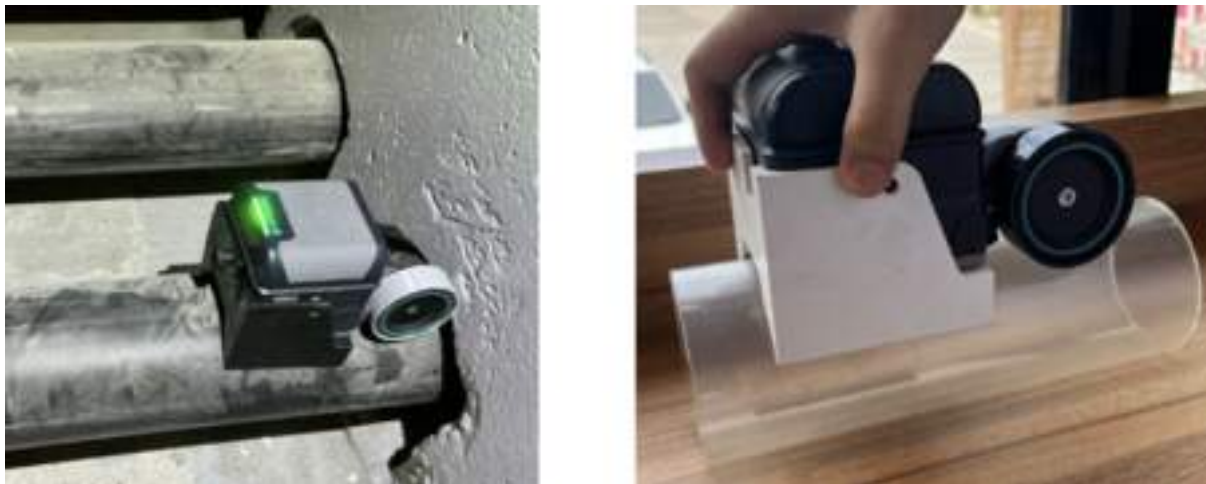
Figure 4: Saddle positioning in the field

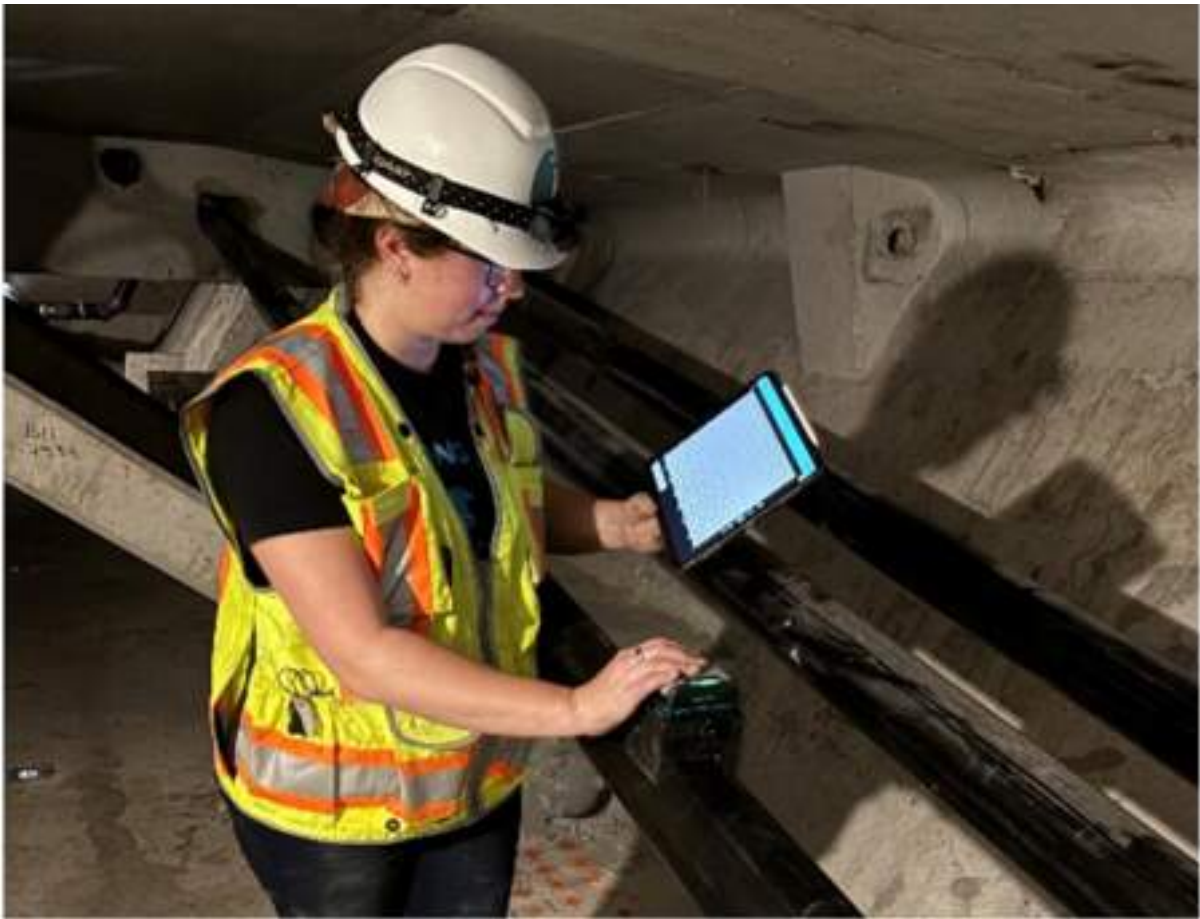
The in-field procedure was relatively simple. Once collection points and data labeling are organized, the procedure is simply to collect GPR data along the duct at key angles (Figure 5). There is nothing technical going on in the field. The hardest part is simply moving around the obstacles present in the beam. Although, if there is a significant void, it is noticeable on the scan and can be marked directly on the duct. There were also instances where the device had to be carefully lifted over joints in the duct. Figure 6 shows the results directly from the field with no processing.

Figure 5: Collecting data

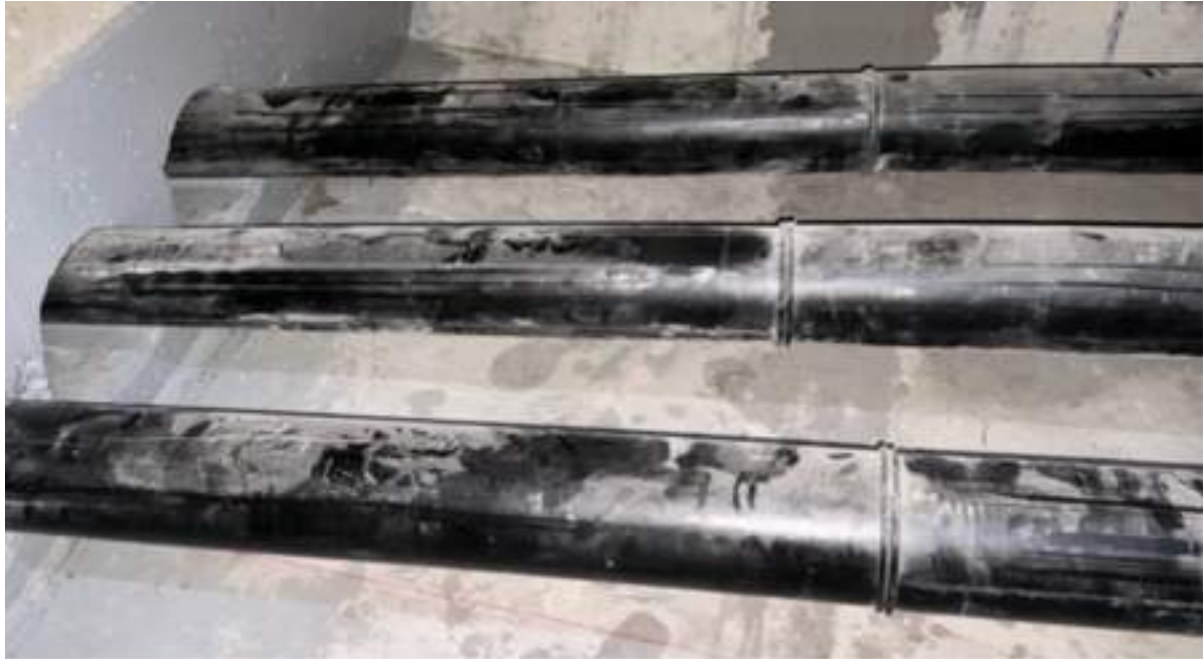
For this pilot field test with a prototype saddle, it took about 10 minutes to collect four lines of data on a 25-foot tendon. There were welded joints that needed to be carefully lifted over and the length inside the anchorages could not be scanned but the entire duct section was scanned and considered relatively quickly (Figure 7). There were difficulties maneuvering at times as the ducts change elevation or are blocked by obstacles (Figure 8). Higher ducts that require scaffolding or manlifts may have a harder time keeping the device on the duct and in line. There are also times the spacing was not sufficient, and the device could not fit. This could be helped by removing the battery and using a wired connection depending on the allowable space. Several of these issues can be addressed with adjustments to the procedure and saddle for future projects.

Figure 7: Anchorage and welding joints blockers

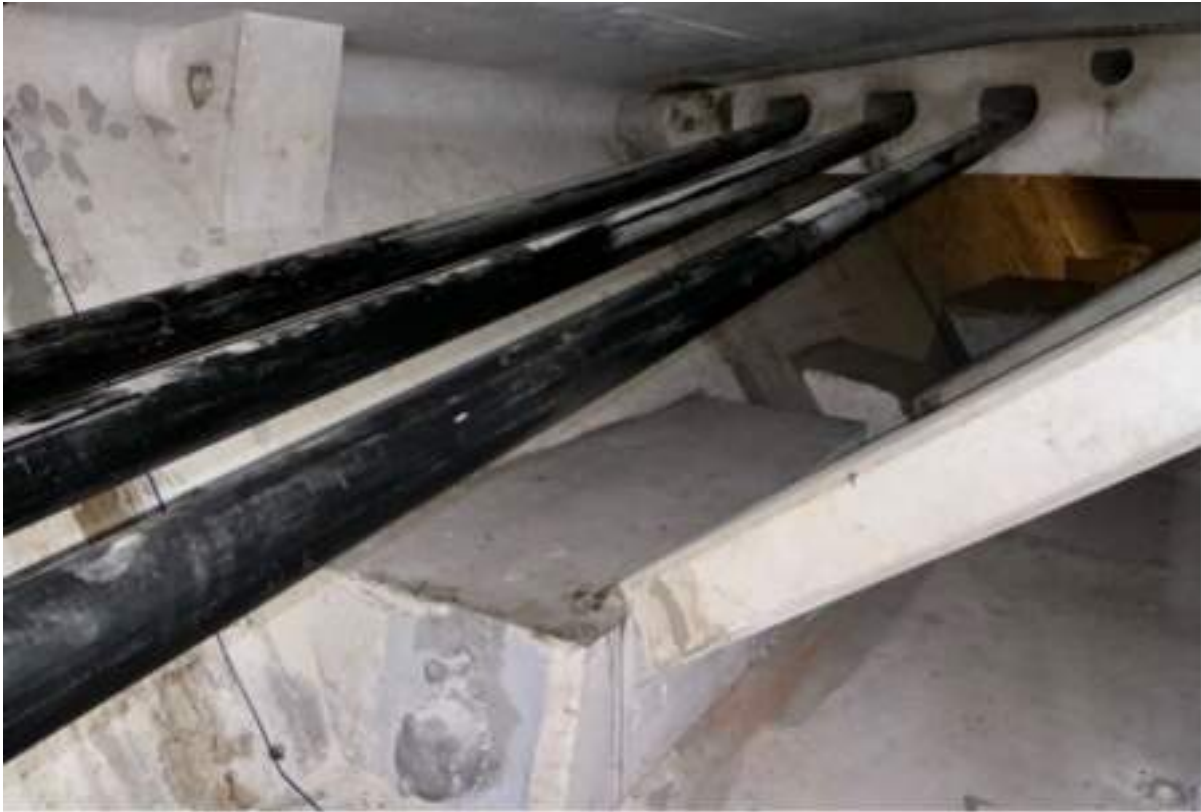
Figure 8: Obstacles around ducts
