Bolt inspection: Internal Defect Assessment & Data Management

This application note describes how to assess bolts on linear assets such as railway tracks.

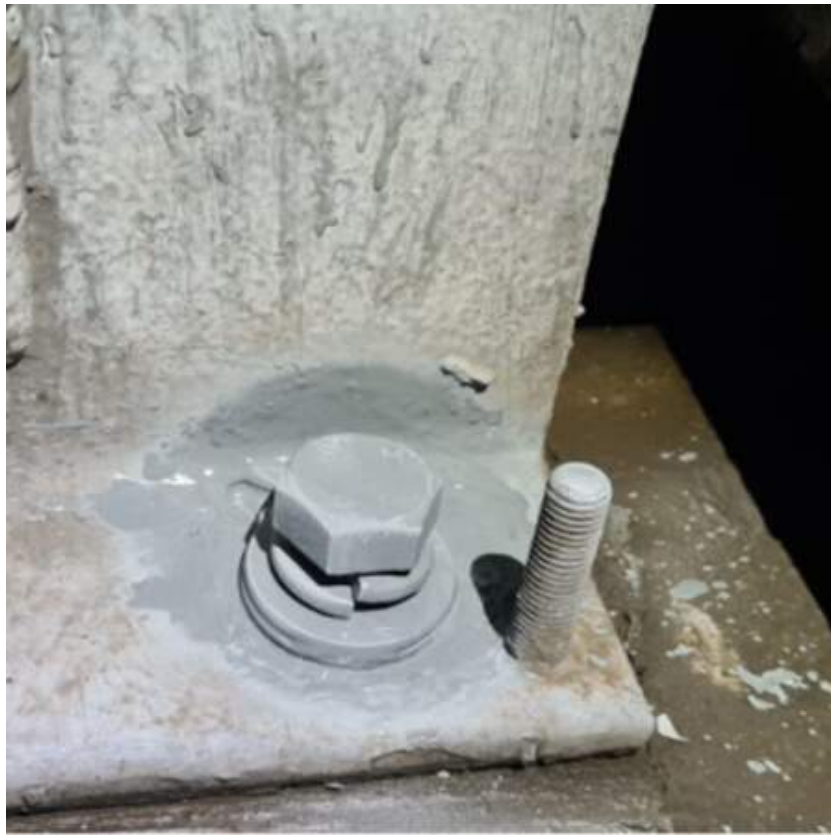
Bolt in-situ.

Causes of bolt failure in heavy industry include corrosion and overtightening. Failure starts from the weakest point, typically just beneath the bolt head. The result is that the bolt head is eventually sheared off, rendering the bolt useless. An inspection method is required to detect any defects as early as possible, before ultimate failure.

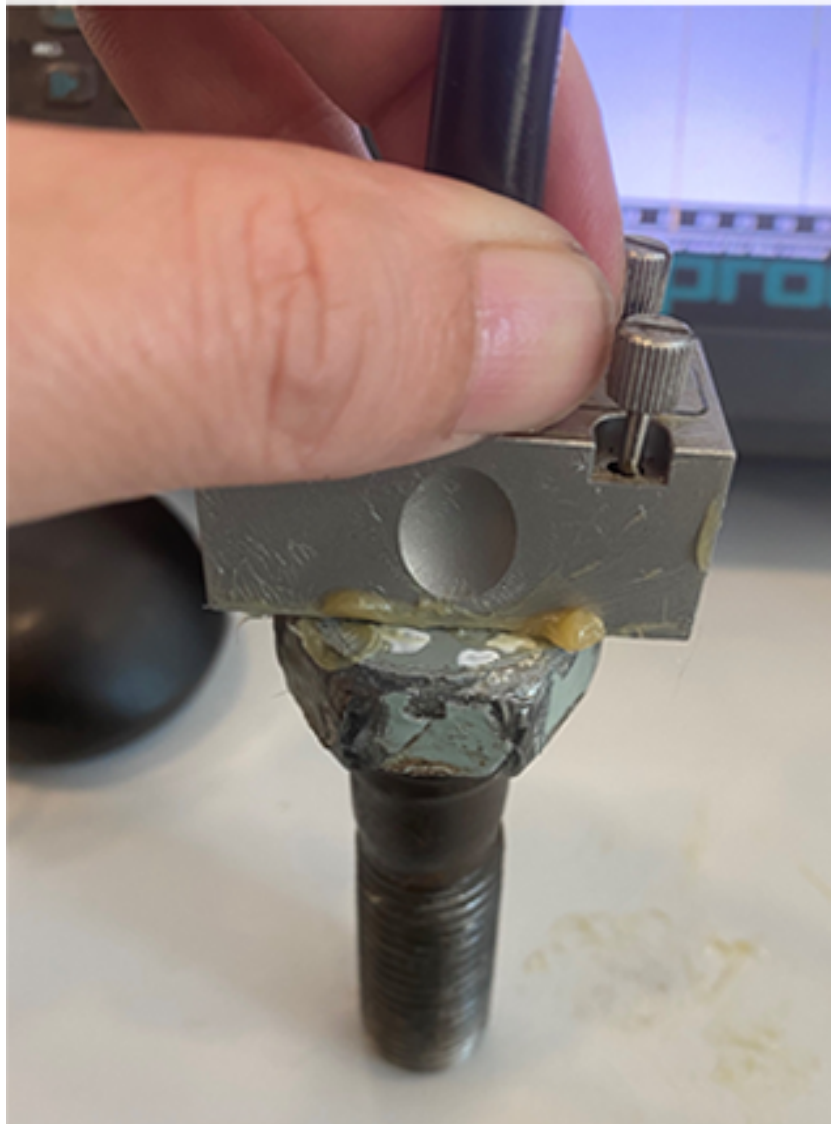
Phased array probe being held on a bolt. The bolt is ex-situ for the 'proof of concept' project but an identical testing method can be used with the bolt in-situ

The proposed solution is to use [ultrasonic technology](#) to non-destructively check the condition of the material, whilst not causing any damage or disturbance to the existing bolt. Two types of ultrasonic technology can be used. The first is conventional ultrasonic testing which provides the inspector an A-scan (amplitude-time plot) that must be interpreted by an expert. The second and more advanced option is phased array testing which provides the inspector with an image of the interior of the bolt. This is much easier to interpret, immediately on-site.

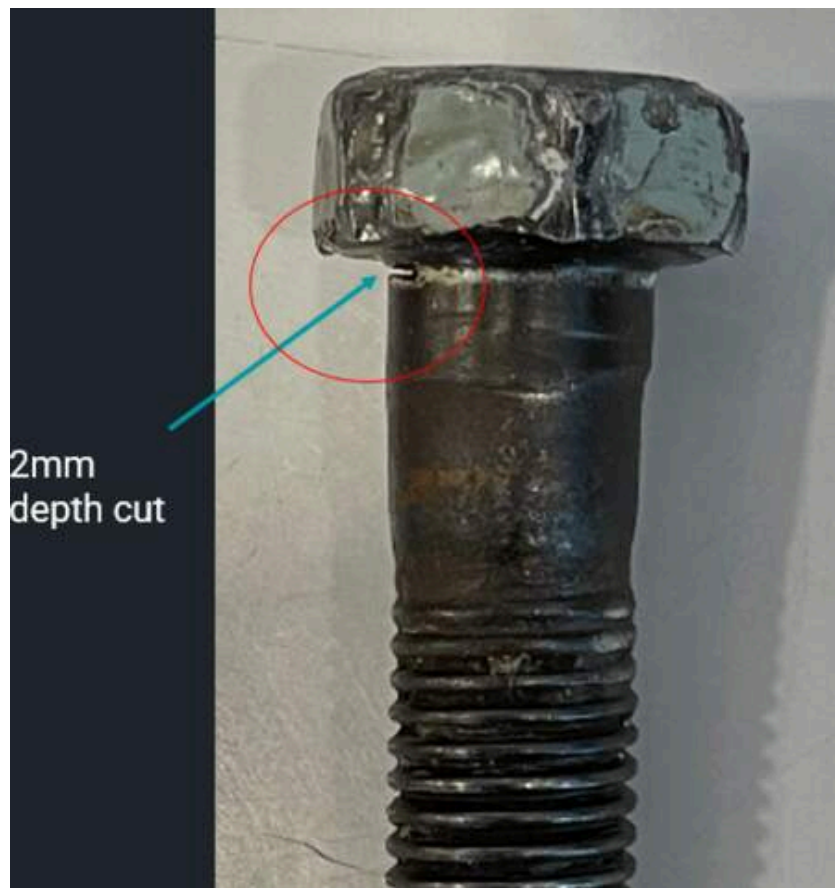
Bolt with a 2mm depth cut to simulate a defect.

To test out the proposed solution, a defect was simulated using a 2 mm cut, just beneath the bolt head. Phased array testing was used to get images from the two bolts - one with no cuts and one with the 2mm cut. In the images, the bolt threads and base of the bolt can be identified. And in the bolt with the 2mm cut, an additional indication is visible from the 2mm cut. Further tests were conducted and it was concluded that ultrasonic array technology is a suitable approach for testing and sentencing bolts on-site.

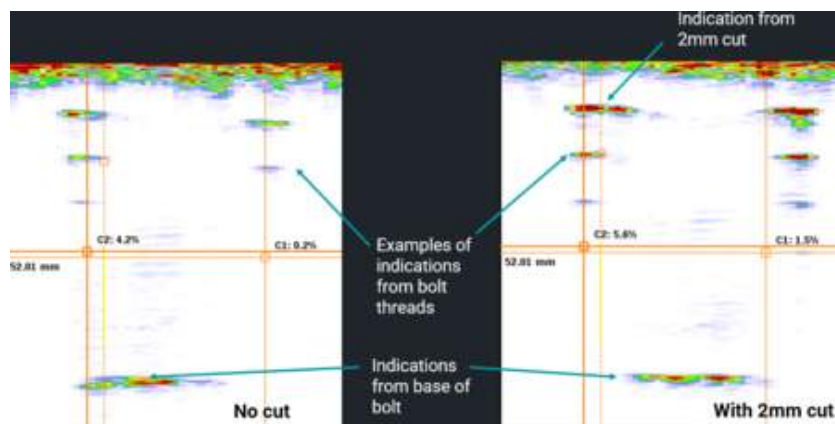
Phased array images from a bolt with no cut (left hand side)
and a bolt with a 2mm cut (right hand side)

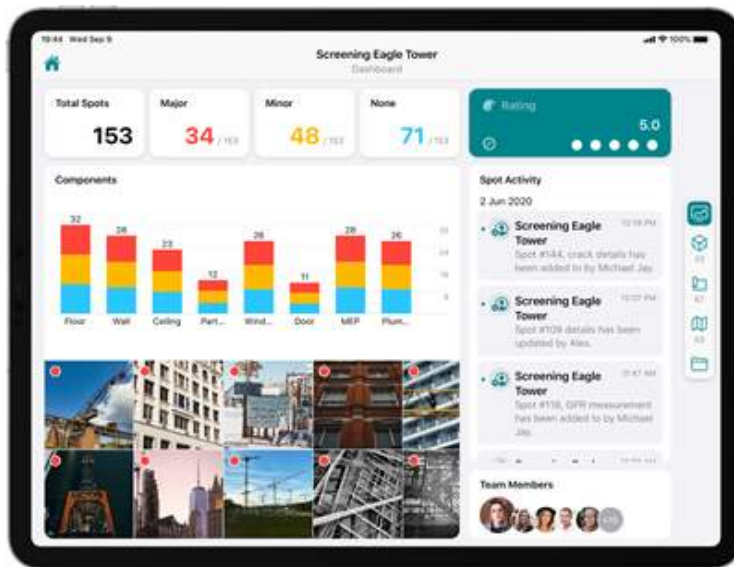
Screening Eagle Technologies' software platform [INSPECT](#) was used to log the inspection report together with the location of the respective bolt. The location of the bolt is automatically recorded using the iPad and other data such as photos and serial numbers can also be appended to the inspection report. Furthermore, a dashboard is available for a quick overview of the full condition of the asset e.g. how many bolts have been inspected, how many are likely to be damaged, and so on.
