Imagerie du béton : Comment l'approche multi-technologique facilite une inspection de classe mondiale

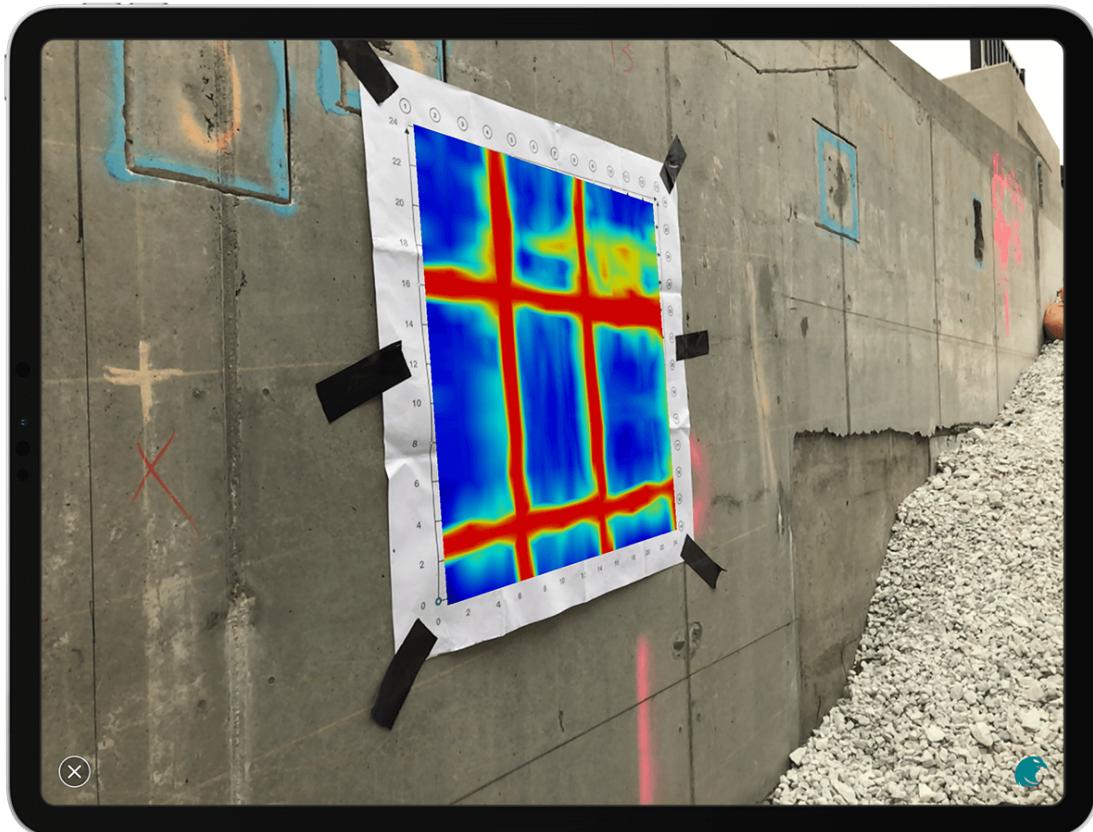
Proceq GP8000 results showing rebar and a large void (top right). The concrete was cored and the void was confirmed. It is an example of a consolidation void.
