## Imaging del calcestruzzo: Come l'approccio multi-tecnologico facilita l'ispezione di livello mondiale

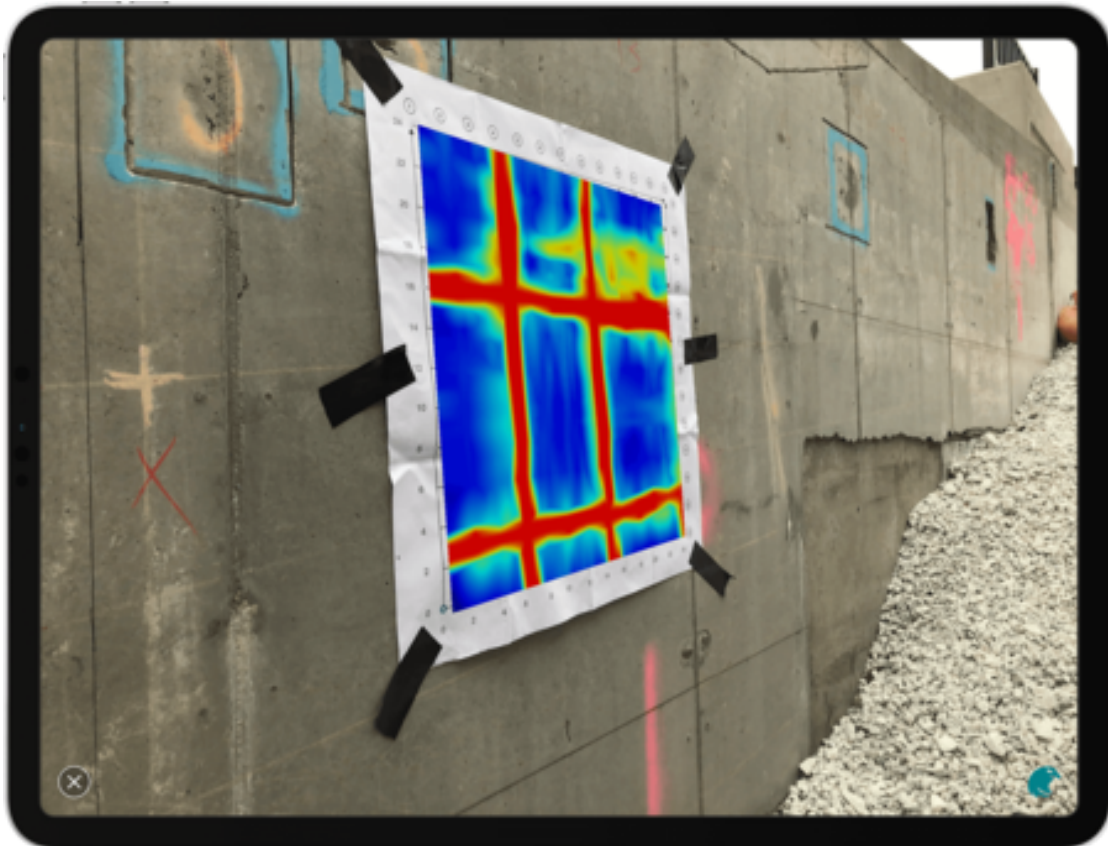
Proceq GP8000 results showing rebar and a large void (top right). The concrete was cored and the void was confirmed. It is an example of a consolidation void.
