Imagiologia do betão: Como a abordagem multi-tecnológica facilita a inspeção de classe mundial

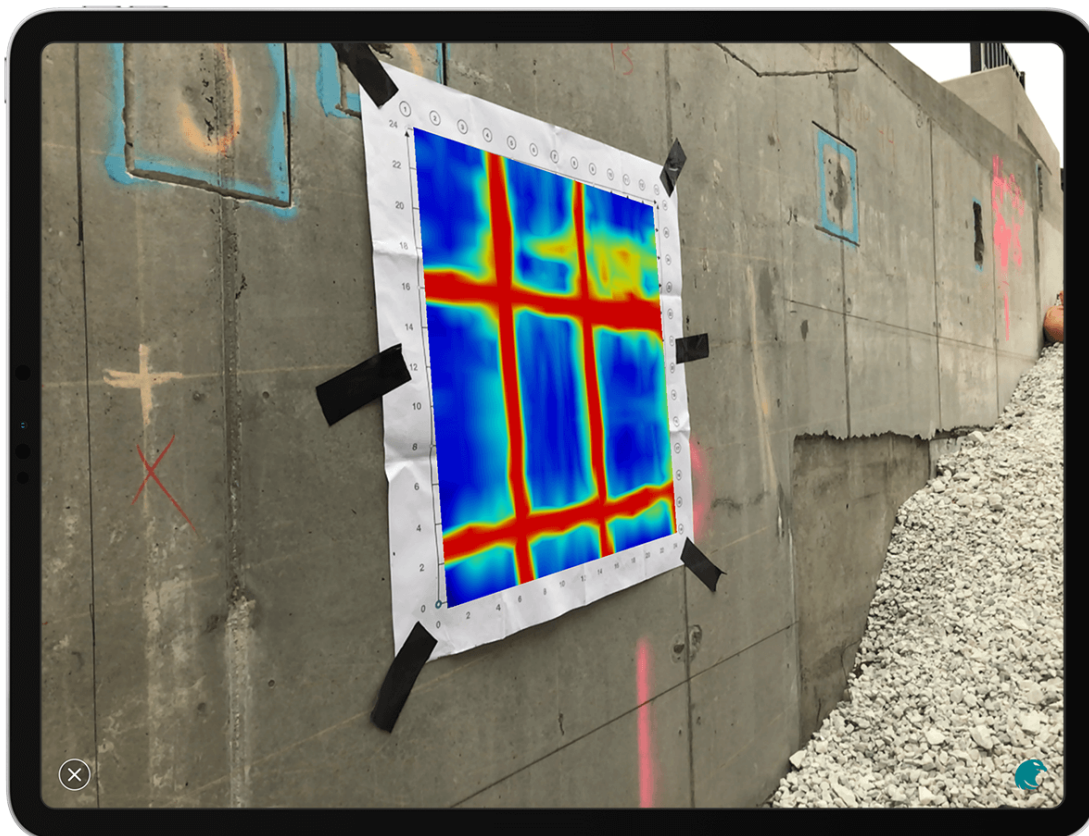
Proceq GP8000 results showing rebar and a large void (top right). The concrete was cored and the void was confirmed. It is an example of a consolidation void.
