Time-critical investigation and testing of a precast concrete beam using Ultrasonic Pulse Velocity (UPV)

Overview

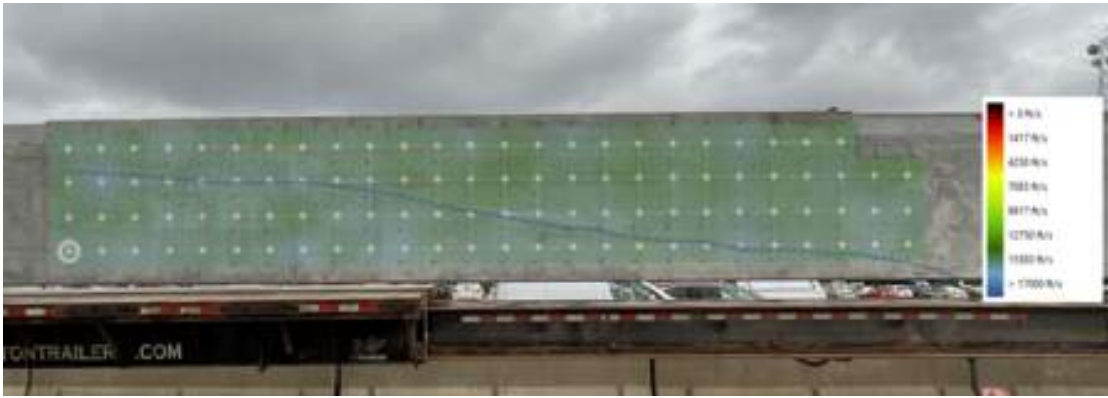
The results are shown superimposed on a photograph of the beam. Note that the blue dashed line shows the location of the presumed cold joint and the small white circles are the measurement positions.

To evaluate the presence of a potential discontinuity, UPV was performed on a 26 ft by 5 ft grid on the South face of the beam with a 1 ft transducer spacing. Indirect velocity readings ranged from 14,390 ft/s to 16,555 ft/s with an average 15,440 ft/s (results are shown superimposed on a photograph of the beam). A 12 ft by 3 ft indirect transmission grid was also performed on the North face of the beam with a 1 ft transducer spacing. These indirect velocity readings ranged from 14,205 ft/s to 16,420 ft/s with an average 15,480 ft/s.

It was clear from the results that the velocities were similar throughout the measurement grid and do not indicate discrepancies or areas of weakness. Therefore, the UPV measurements indicated the beam has been placed monolithically and did not suggest the presence of a cold joint or discontinuity.
