# Evaluation of Reinforced Concrete Dock Slab After Epoxy Resin Injection, Brazil

Due to cracking in the reinforced concrete dock slab caused by failures in the concrete curing process, the injection of epoxy material was evaluated to fill the cracks and maintain the structure within the design requirements.

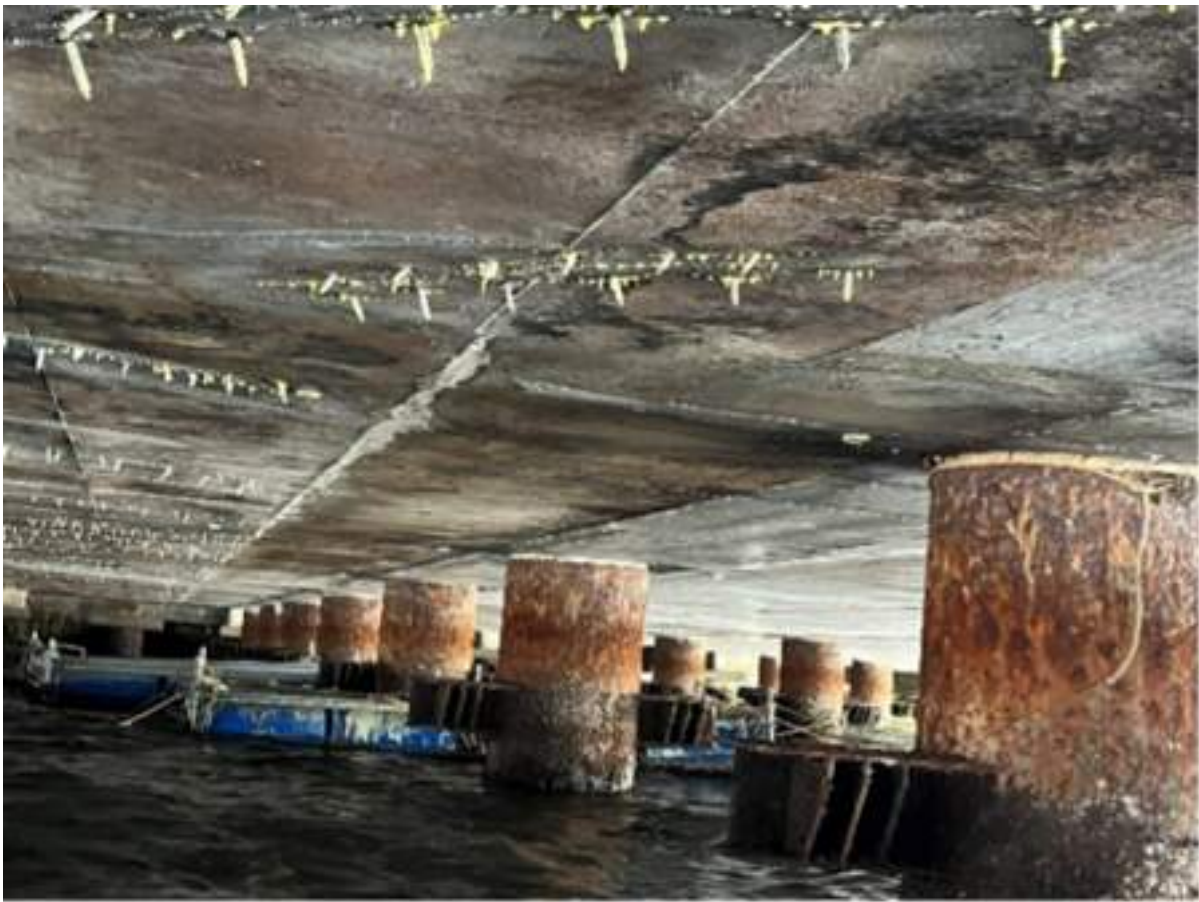
Due to the size of the slab and its position just above sea level, studying the tide chart was the first step to identify which days and times would be suitable for data collection from beneath the concrete slab using the technologies. Truly a race against time. Another time-demanding factor was the preparation of the slab's contact surface for equipment application.

It was necessary to remove the epoxy injection pins and, in some areas, sand the surface to enable transducer coupling for the ultrasonic tests. Marking the reading areas and even data collection with the Pundit PL200, Pundit PD8050, and GP8000 GPR technologies required physical endurance due to the access clearance of less than one (1) meter between sea level and the underside of the concrete slab. Using a simple boat anchored to the structure was the fastest way to access the reading areas.

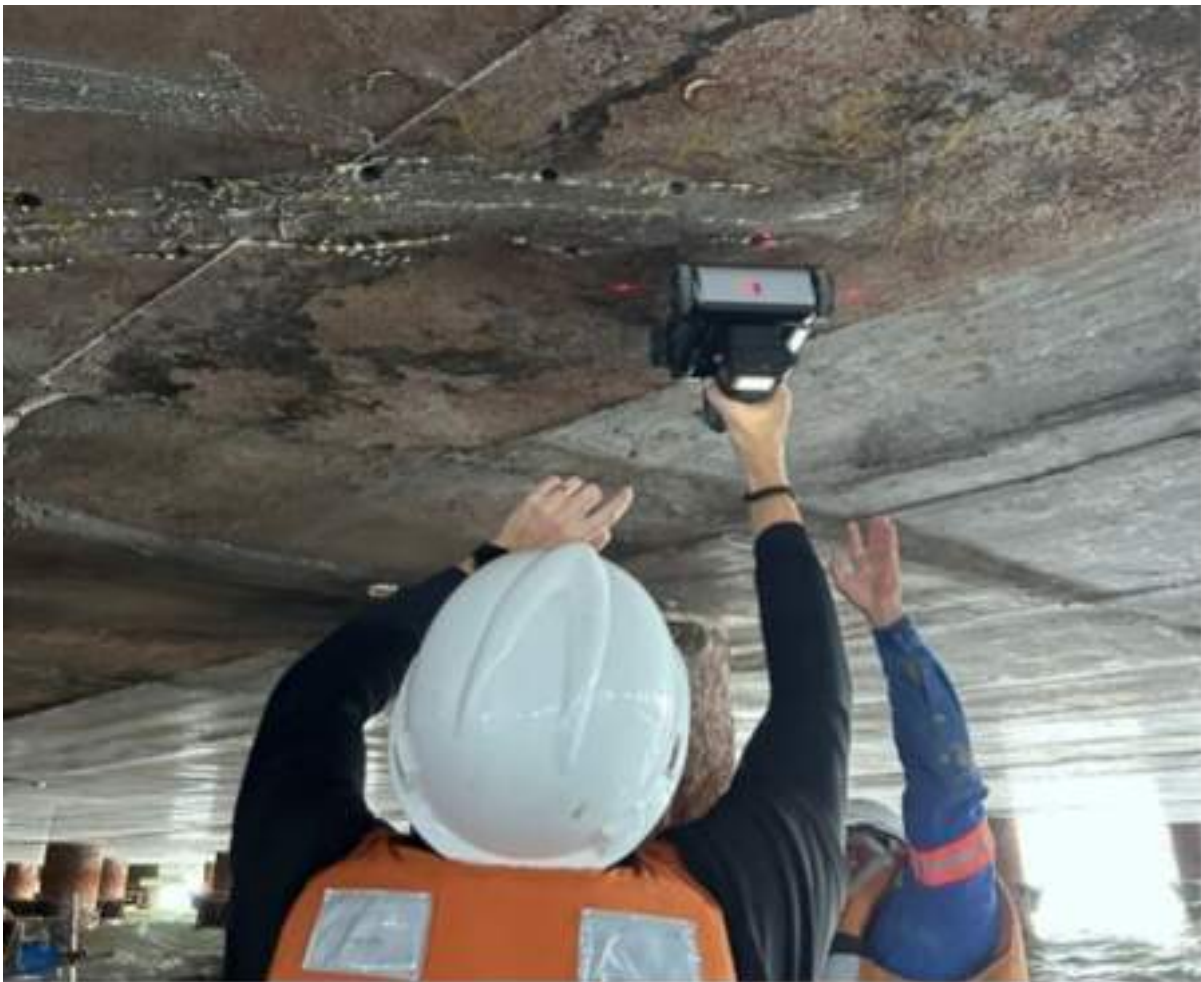
Each technology fulfilled its role in this challenging project. The application of the GP8000 GPR helped us locate the structure's rebar mesh, identify the best data collection areas for ultrasonic testing, and ensure coverage. Thanks to the GP8000's exclusive Stepped Frequency Continuous Wave (SFCW) technology, clear visualization of the structure's reinforcement was possible.

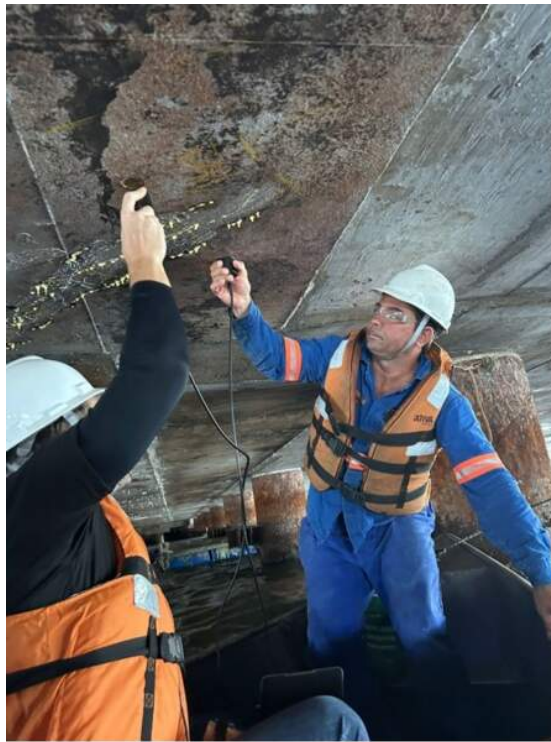
Using the Pundit PL200, it was possible to identify potential areas with inadequate epoxy injection filling through the surface ultrasonic pulse transmission. By analyzing variations in the ultrasonic wave propagation velocity between the Pundit PL200's transmitter and receiver transducers, we identified points where the epoxy injection in the concrete slab was correctly executed.

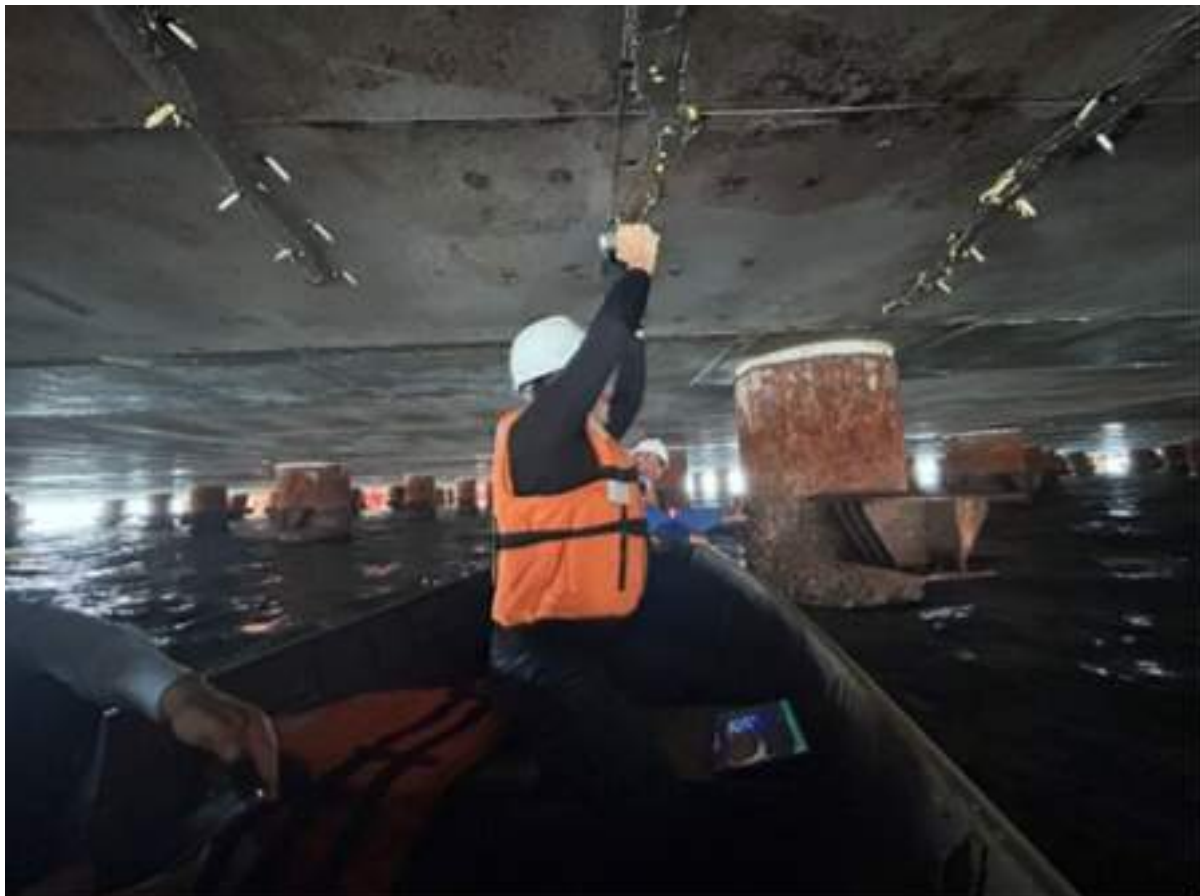
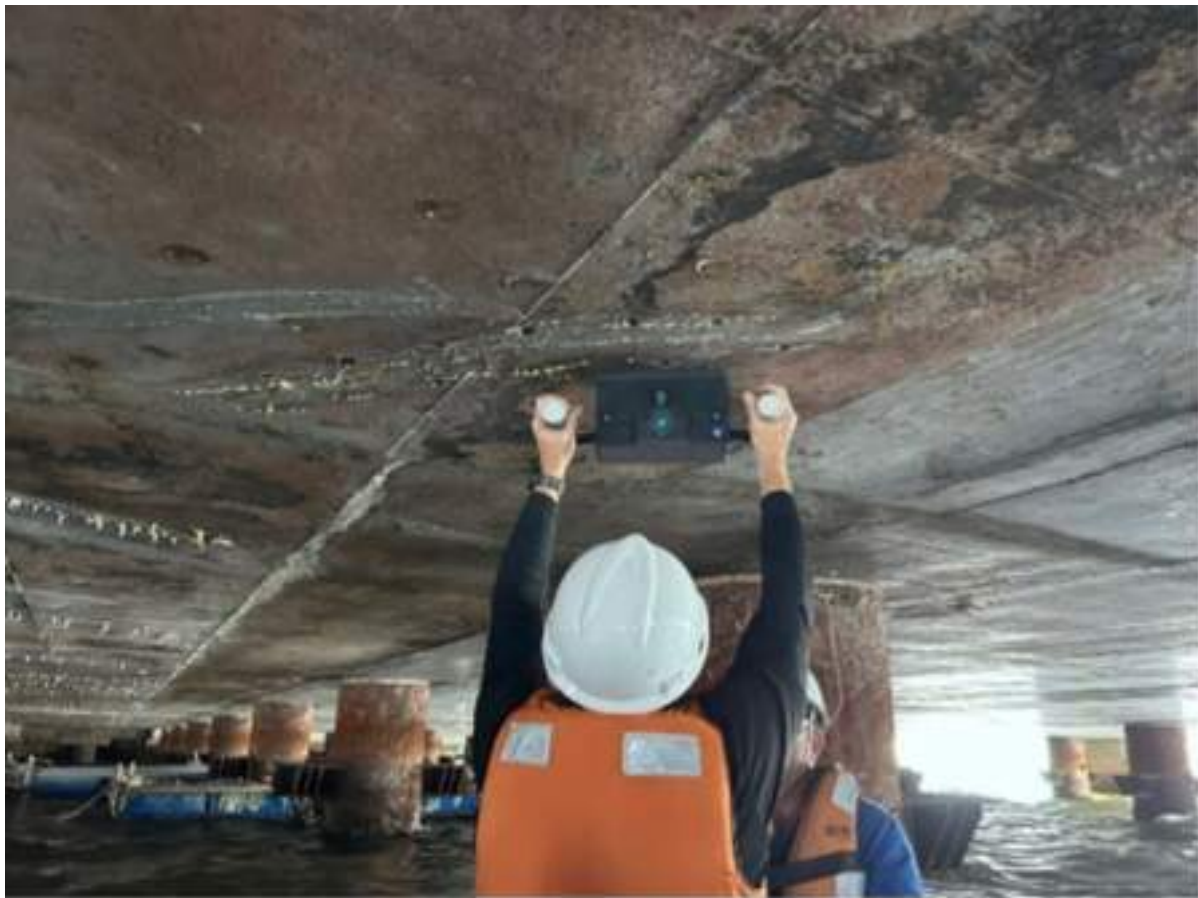
The use of the Pundit PD8050 phased-array pulse-echo further assisted in verifying areas not filled by the epoxy injection. Through the phased-array pulse-echo, which can reach up to two (2) meters scanning depth, tomographic imaging enabled the visualization of some cracked regions that were not completely filled by the epoxy resin injection.
