# Non-destructive Testing of a Shotcrete Wall

- [FPrimeC Solutions](#) was hired by a Shotcrete Contractor to verify the quality and integrity of shotcrete on or around a cold joint that was formed during the shotcrete construction.
- The [Pundit PD8050](#) and [Proceq GP8100 GPR](#) were used to assess the shotcrete wall.
- The team were able to provide the client with a precise percentage of the area affected by anomalies and quantify the degree of improvement after the injection program.

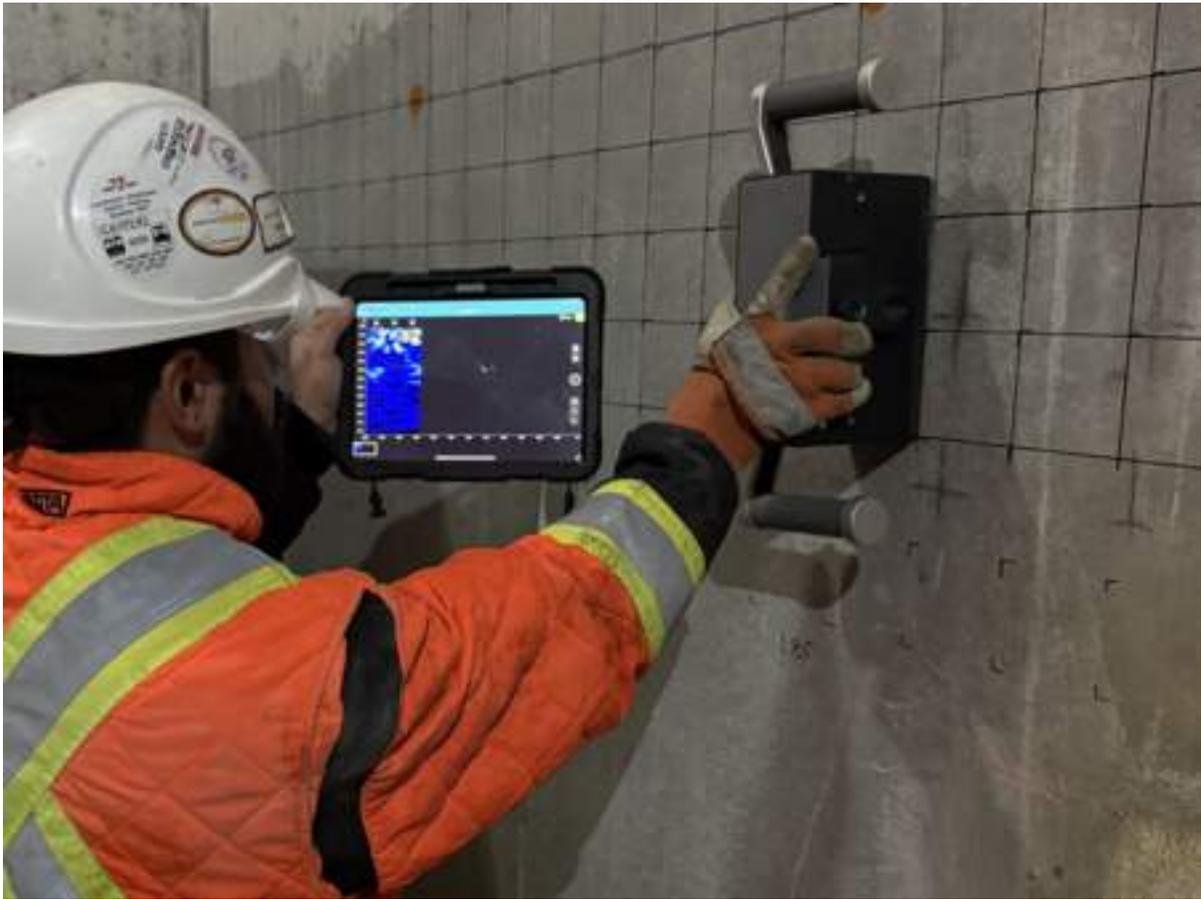
**Ultrasonic Pulse Echo (UPE) Tomography:** FPrimeC utilized Proceq's UPE technology as the primary assessment tool. The wall was mapped using a dense 100 mm x 100 mm grid. By performing line scans before and after the repair, the team could visualize internal reflections.

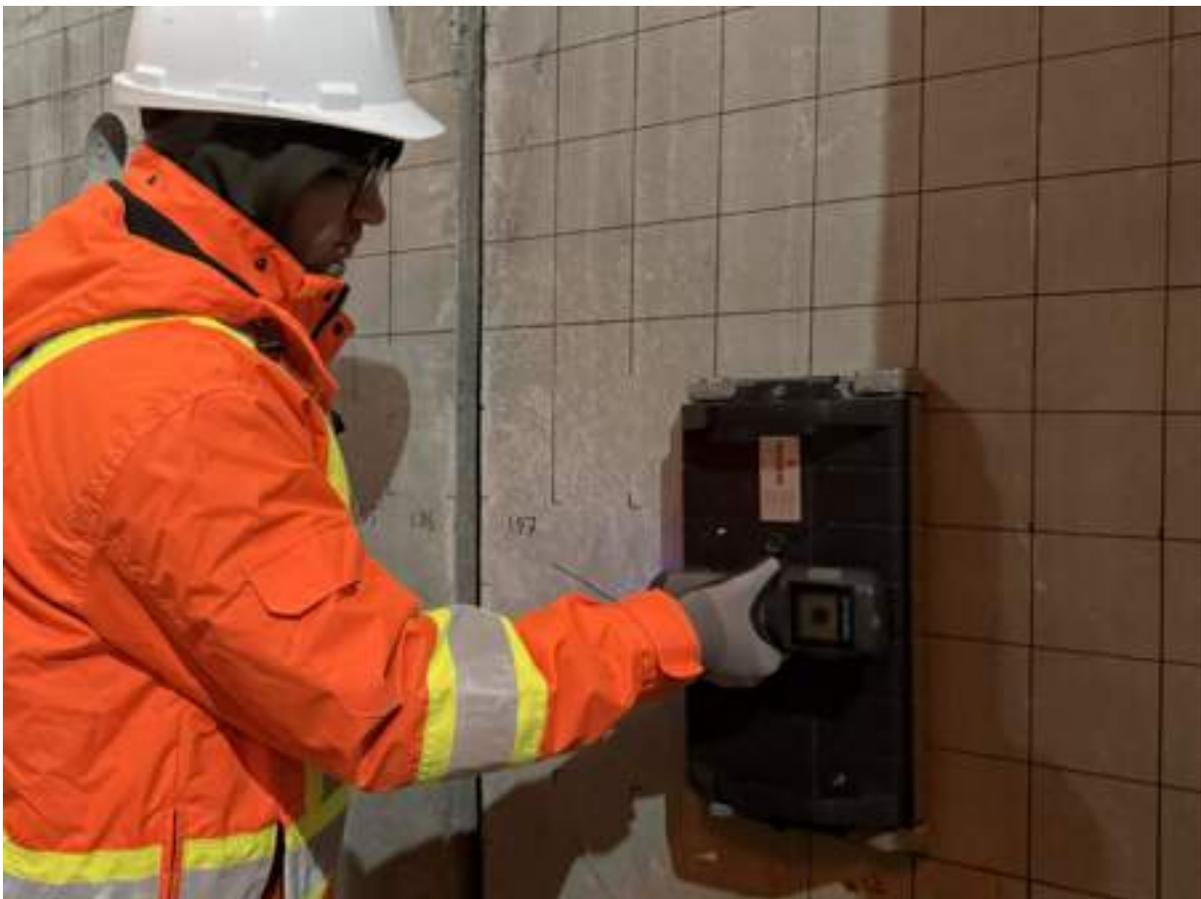
The goal was to monitor the change in acoustic response: voids and cracks show high-intensity reflections, while successfully grouted areas allow the signal to pass through, indicating a monolithic structure.

**Visual Proof of Repair:** Post-repair UPE B-scans showed a significant reduction in reflection intensity from the previously identified anomalies. This provided visual and mathematical evidence that the grout had effectively filled the voids and cracks.

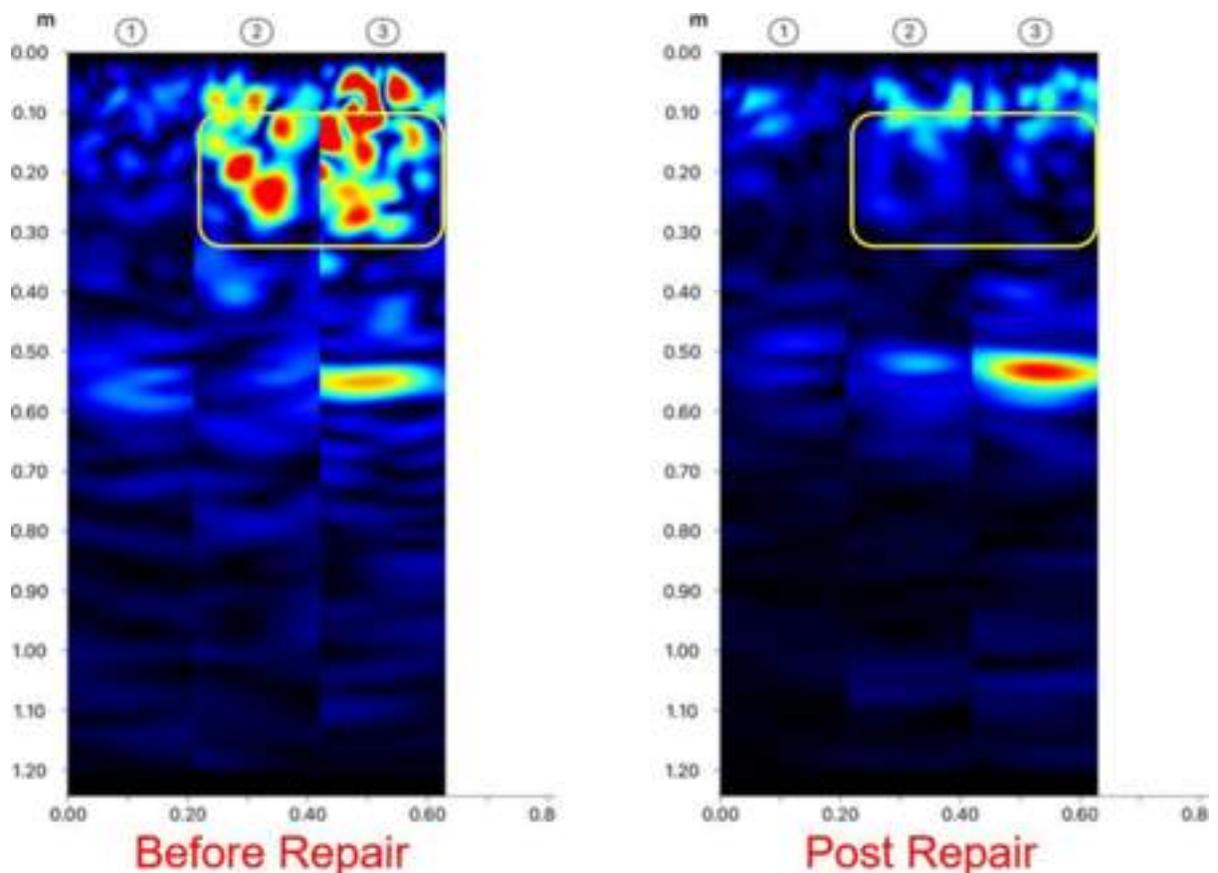
**Quantifiable Improvement:** FPrimeC was able to provide the client with a precise percentage of the area affected by anomalies and quantify the degree of improvement after the injection program.
