Durability Engineers: Condition Assessment of an Aging Pool Deck and Basement

Inspecting a 100-year-old swimming pool deck and basement with NDT

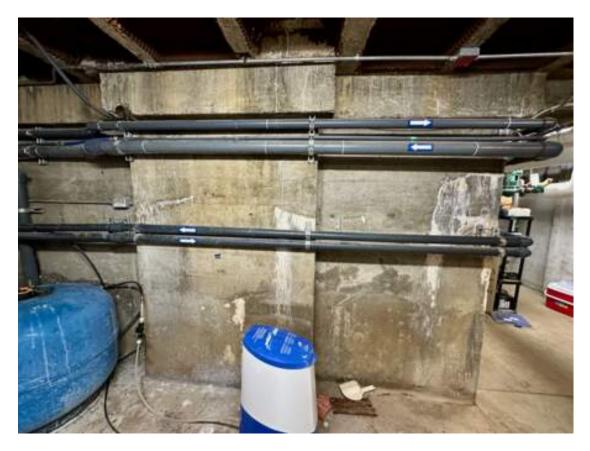
In a U.S. municipality building in Michigan, issues were encountered with the aging infrastructure of the pool deck and surrounding sub-grade basement. Originally constructed in 1926, the pool deck exhibited signs of extensive deterioration, primarily due to water intrusion over the years.

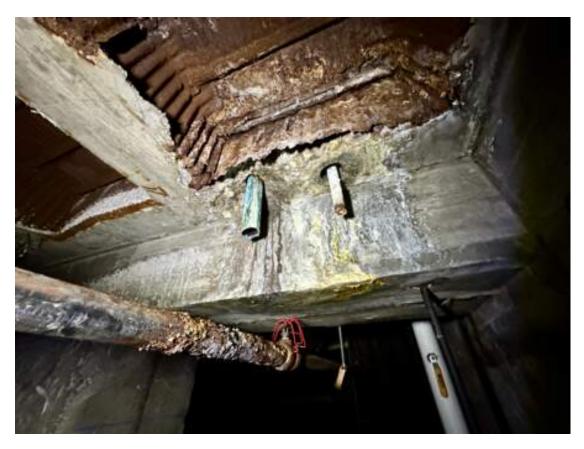
Significant areas of the concrete were compromised, and the steel reinforcement showed signs of corrosion. This deterioration posed risks to safety and operational efficiency, necessitating a thorough condition assessment to determine the appropriate remedial measures.

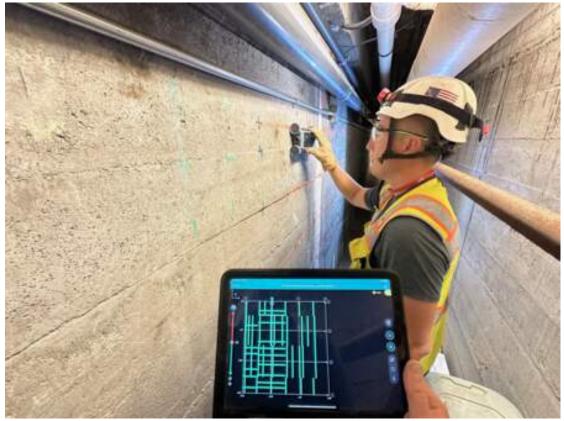
Reinforcement detailing with the Profometer PM8000 Pro cover meter, visualizing the results instantly on the iPad
