Detecting Cavities in a Tubular Bridge with Prestressing Channels

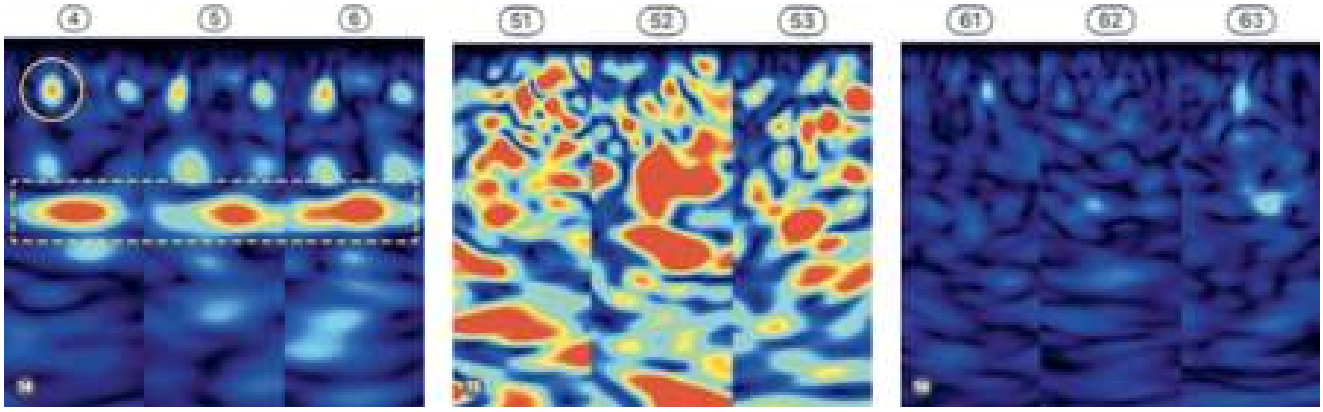
Measurement results from the PD8050

The ultrasonic measurements showed various indications of the presence of cavities in the prestressing channels. The investigation carried out was based on a limited sample, with less than 1% of all prestank channels being investigated.

Even based on this very limited sample, some cavities and structural risks have been identified. Is this a "fluke" or will additional research reveal a generic problem? The initial results are currently being incorporated into the structural assessment. It will then be decided which follow-up steps are necessary.
