Identifying Structural Damage on the Fukuoka Expressway Using MCGPR

Advanced Subsurface Assessment with the GS9000 Multichannel GPR

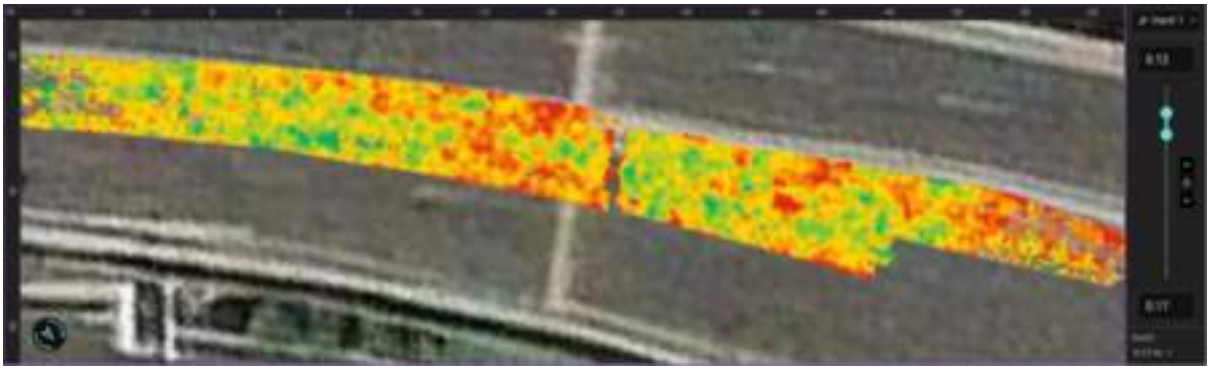
1. Likelihood of Deterioration Maps (Figure 4): These maps are computed following the ASTM D6087 standard, providing an assessment of the likelihood of concrete deterioration in bridge deck. This information helps in identifying areas that require closer inspection or potential maintenance interventions.
2. Condition Maps for Generic Reinforced Concrete Elements: These maps provide an overview of the condition of the generic reinforced concrete elements within the bridge deck. They offer valuable insights into the overall state of the infrastructure, enabling informed decision-making for maintenance and repair activities.

Figure 4. The most significant output of GPR mapping results is the Deterioration Map, based on the amplitude degradation of the top rebar.

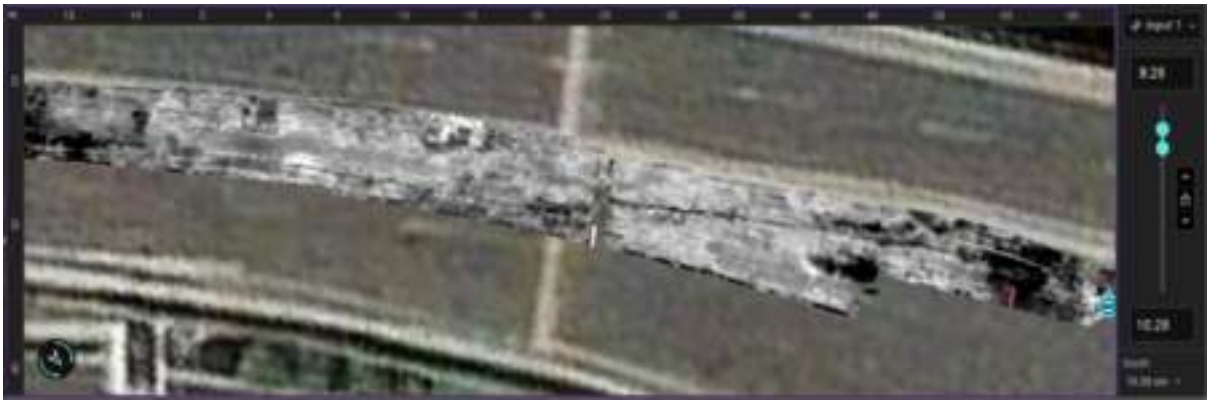
They could also detect defects between asphalt and concrete layers, such as delaminationn, and to identify the deterioration areas attributed to scaling and decomposition in concrete constituents (Figure 7); and to analyze the first rebar layer (Figure 8), to create a further insightful condition map (Figure 4), pinpointing areas requiring immediate attention or maintenance.

Figure 7. Interface defects between Asphalt-to-Concrete (A/C) layers (Delamination.)

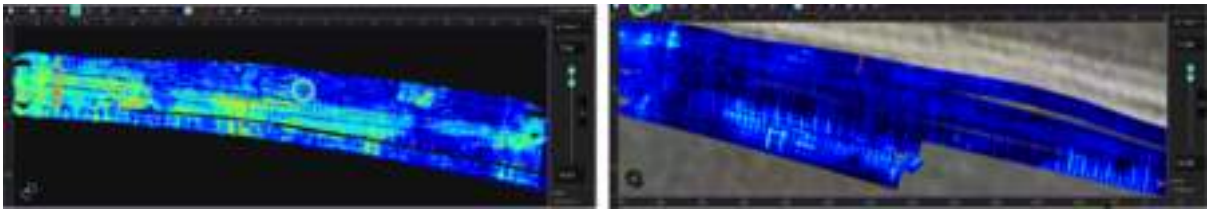
Figure 8. Live-Slice view of the first layer rebar mesh.
