How to use GPR and ultrasound to check the seepage points of new tunnels?

Non-destructive testing techniques for efficient seepage detection

Application Case

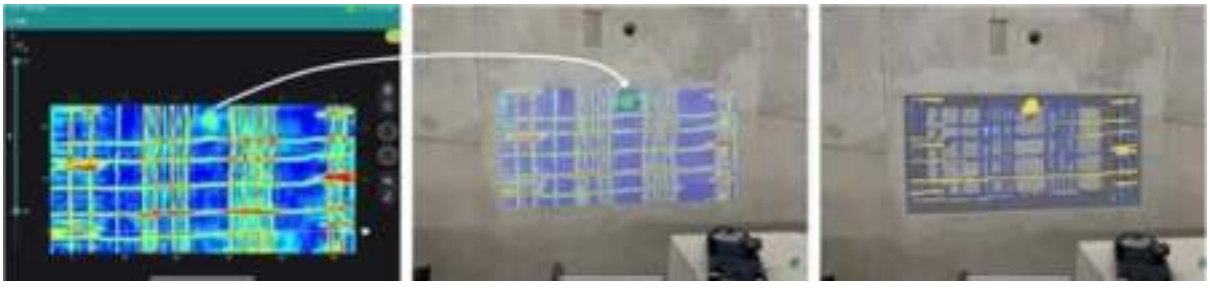
Area Scan Results of GP8100 GPR

On the left side of the above picture is the result of the regional scan, from which you can see that the transverse reinforcement is stirrup, arranged in approximately equal spacing in the vertical direction. Longitudinal reinforcement is the main reinforcement, in the horizontal direction, the middle area is a group of four arranged (close), in the two sides of the region is a single arrangement (sparse).

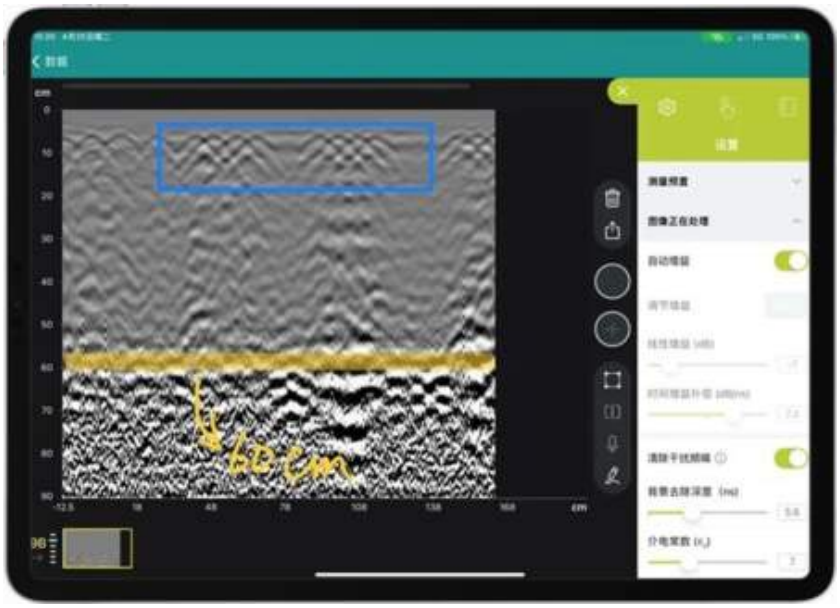
GP8100 radar cross section diagram

Judging from the radar cross section diagram, the inverted hyperbolic shape in the depth of 7 ~ 13 cm (blue frame) is mainly caused by the reflection of the double layer steel mesh signal. At the depth of about 60 cm (yellow mark line), the continuous plate reflection signal is mainly caused by the signal reflection of the initial branch of concrete (slab thickness). There is no obvious water-rich signal between the depth of steel bar and the base plate.

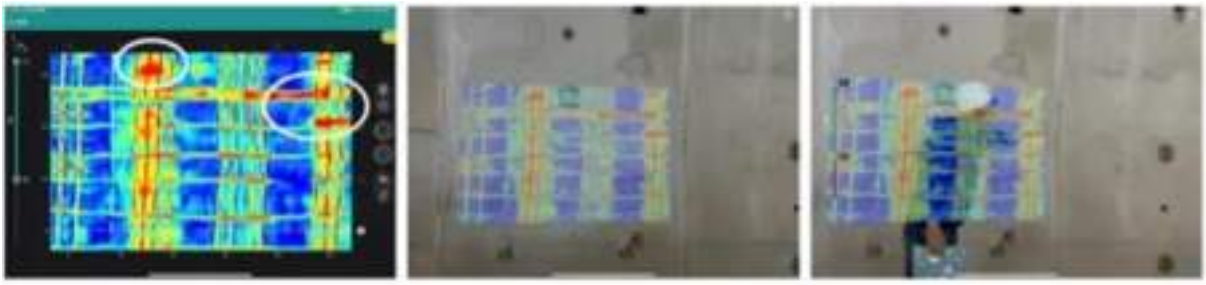
GP8100 Area Scan Results

First, the GP8100 is used for large area scanning. The left picture is the scan result of the area. The horizontal and vertical reinforcement distribution in the picture is similar to that in the A area, but in the area shown by the white circle, there is an obvious signal enhancement area after the reinforcement, which is suspected to be caused by water seepage. The middle and right images are AR structural projections of the scan results. By reducing the transparency of the structure image, the right engineer marks the suspected area for the later PD8050 test. To further verify why there is water seepage in the area, we select the 8th line in the radar area scan in the B area and the 9th line in the radar region scan in the A area for comparative analysis.

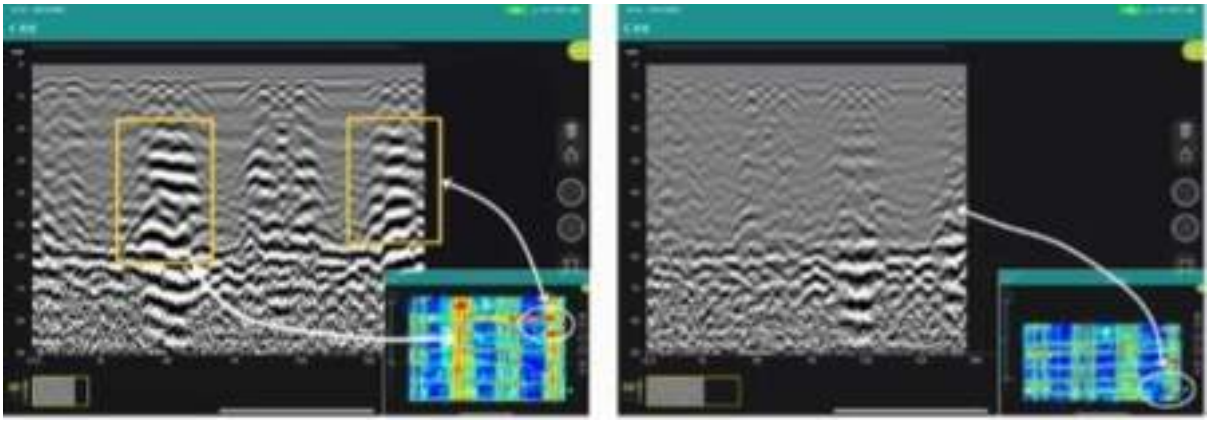
Comparison of Radar Line Scanning in Zone A and Zone B

Left is a section view of the 8th line in Area B and right is a section view of the 9th line in Area A. From the comparison of the two maps, there is no water enrichment or seepage in area A, and there is obvious water enrichment signal between steel bar and floor in area B.

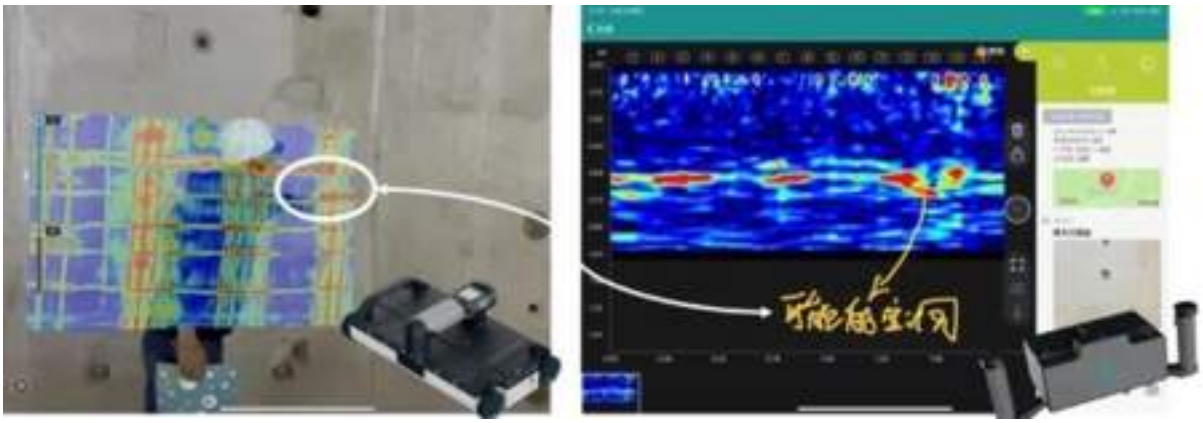
Linear Scan Results for PD8050

Above (right) is a linear scan view of the PD8050. At about 1.4m in the horizontal direction, there is a clear cavity reflection signal behind the initial support floor (about 65-73cm depth), and its actual position also corresponds to the previous radar scanning results (left), which further determines that there may be a cavity here, resulting in water seepage.

In response to the above results, we continued to perform a full 3D matrix scan of the area using the PD8050, and reconfirmed the results of the presence of voids at the depth of 68-74 cm.

The void position behind the base plate, with a depth of about 68-74 cm (shown by the blue circle in the figure)

According to our test feedback, the construction team saved and shared all the electronic data to the reporting objects, and formulated a correction plan for Area B on the spot.
