Non-Destructive Evaluation of Rotary Kiln Refractory Lining Thickness

Assess rotary kiln lining with high efficiency using ground penetrating radar (GPR)

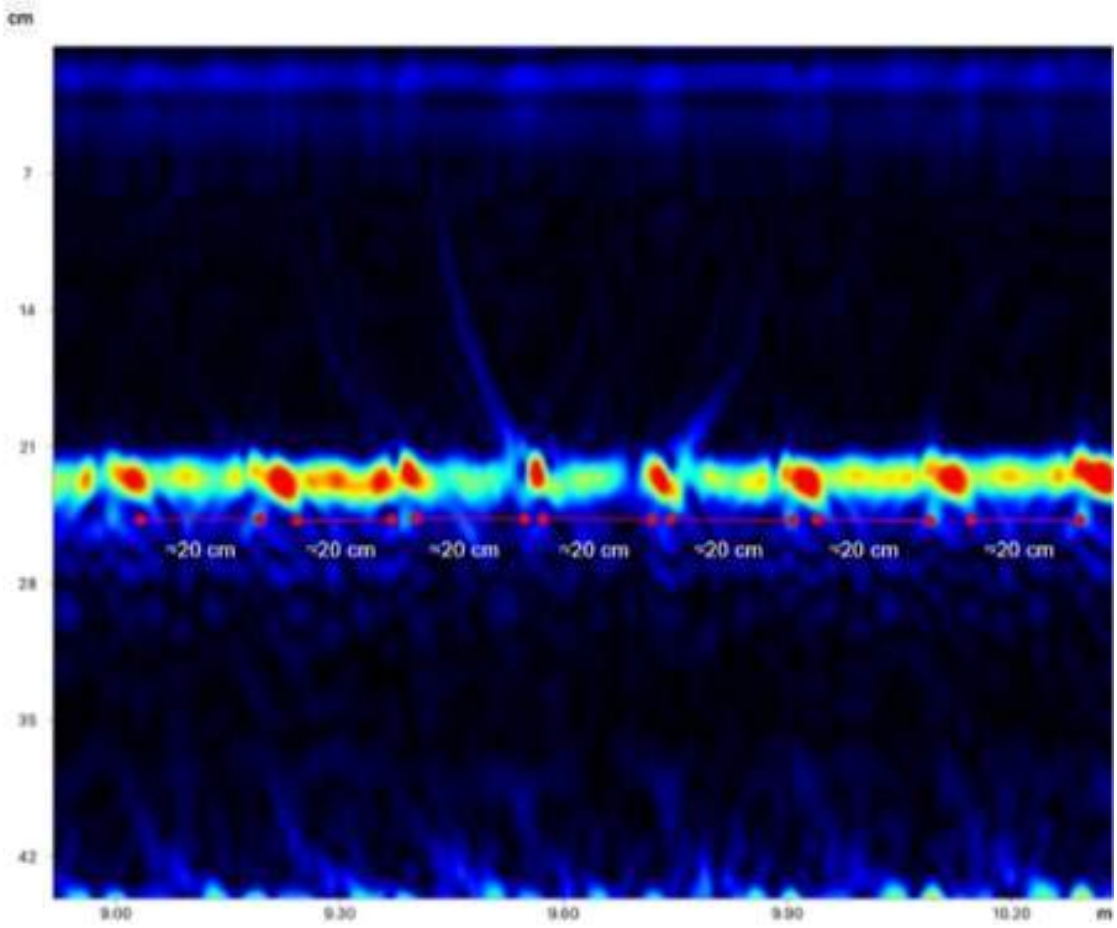
During the demonstration, the GP8800 system was used to collect data along three 60-meter profiles inside the kiln. The results—visualized as radargrams—clearly revealed the interface between the refractory lining and the underlying steel shell, allowing precise, continuous thickness measurements along the inspection paths.

- Accurate and Continuous Thickness Measurement: The GP8800 system delivered a high-resolution, continuous thickness profile of the refractory lining along the full length of the kiln, identifying significant variations.
- Detection of Critical Wear Zones: Localized areas with material loss of up to 5 cm were detected, enabling targeted and prioritized maintenance actions.
- Digital Logging for Historical Monitoring: All acquired data was digitally stored in a structured format, allowing the creation of historical datasets. This traceability supports comparative analysis in future inspections, enhances predictive maintenance planning, and improves long-term wear monitoring.
- Structural Integrity Assessment: The survey also provided insight into the internal layout of the lining, including the regular spacing between brick segments (~20 cm), indicating a modular construction pattern.
