How to use GPR and ultrasound to check the seepage points of new tunnels?

Non-destructive testing techniques for efficient seepage detection

Application Case

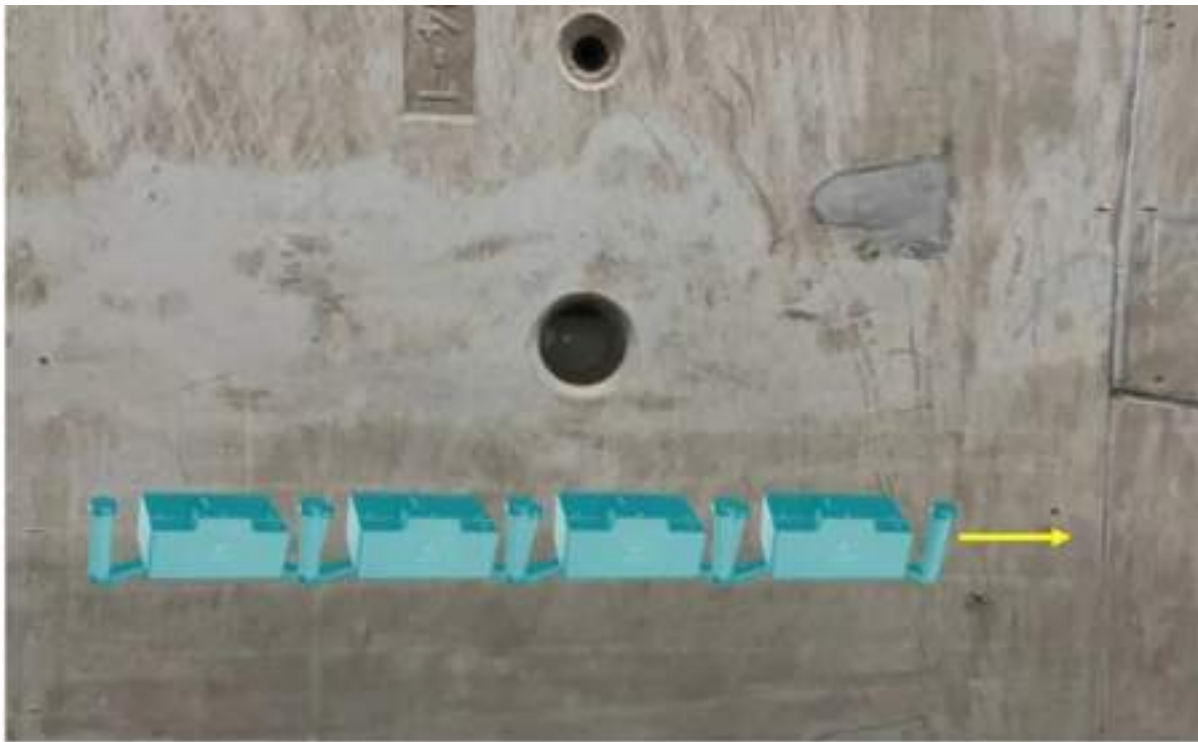
Scanning in the direction of the yellow arrow with ultrasonic imaging

Next, we used PD8050 array ultrasound imaging, scanning in the direction of the yellow arrow.
