# Non-Destructive Subsurface Mapping and Condition Assessment of a large Highway Bridge

## Comprehensive Bridge Deck and Waterproofing assessment with multichannel GPR

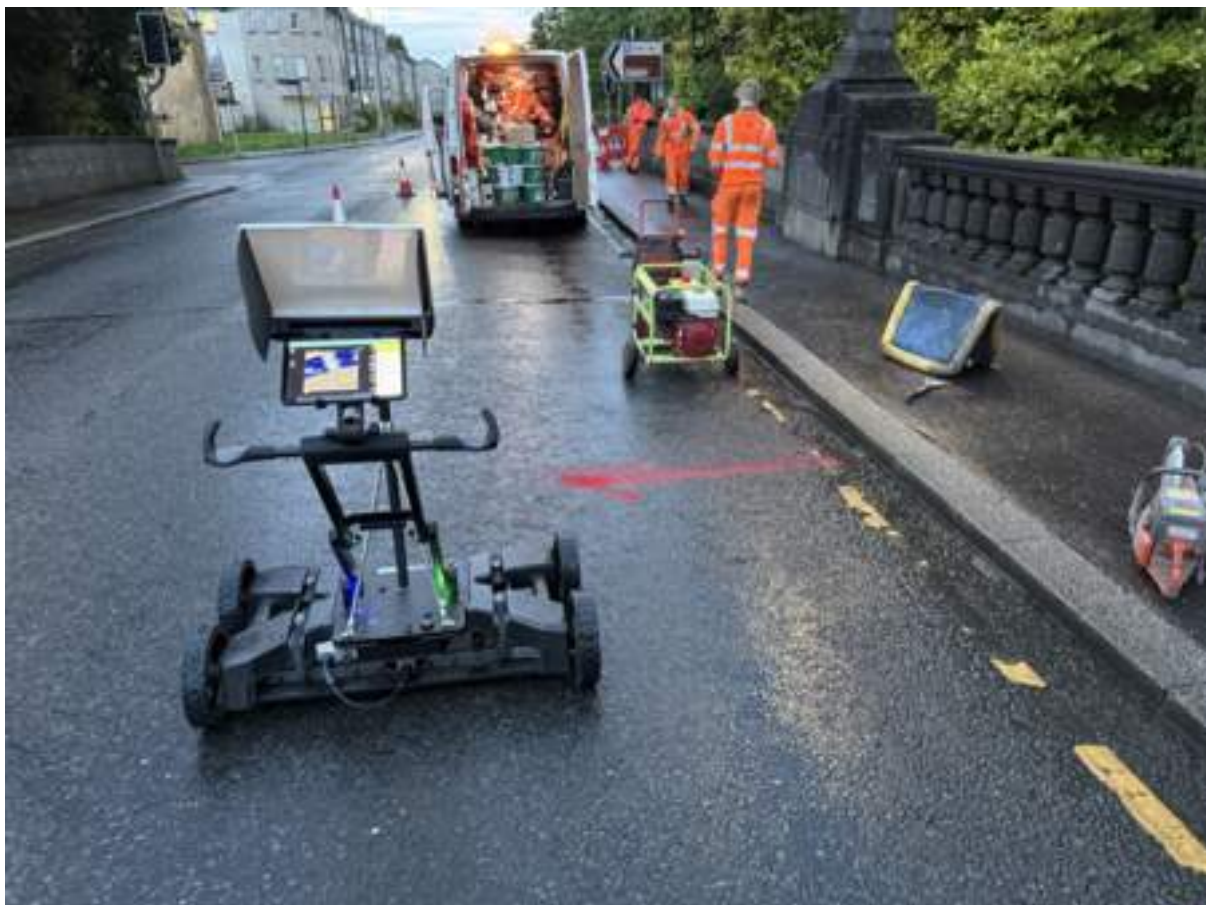
Rather than widespread destructive testing, only three localized trial pits were excavated to calibrate and confirm the GPR signal interpretations:

- Trial Pit 1 was placed in a high-amplitude zone to verify suspected waterproofing failure.
- Trial Pit 3 was placed in a low-amplitude (orange) zone to confirm healthy, intact waterproofing and dry concrete.
