# Time-critical investigation and testing of a precast concrete beam using Ultrasonic Pulse Velocity (UPV)

## Overview

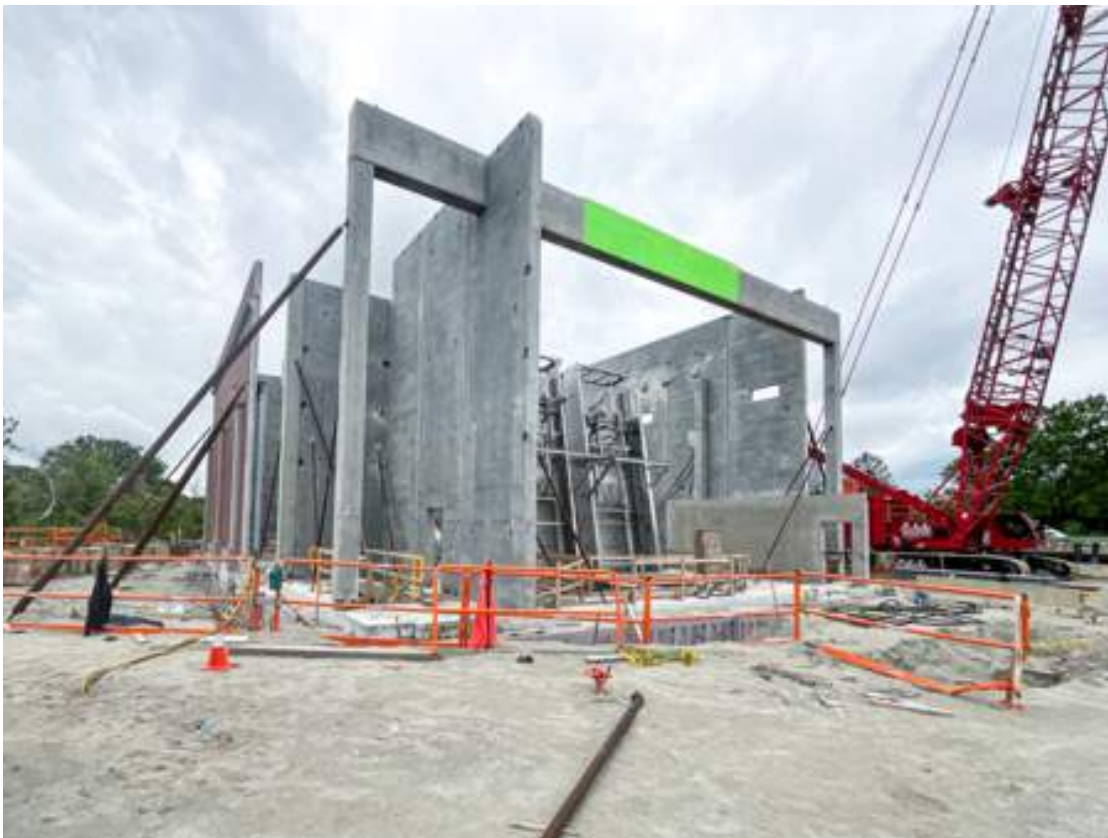
The results are shown superimposed on a photograph of the beam. Note that the blue dashed line shows the location of the presumed cold joint and the small white circles are the measurement positions.

The approach taken by Durability Engineers for this investigation paired with the real-time interpretation capabilities of Screening Eagle's equipment gave the client and IDOT the confidence to move forward with construction. The nondestructive approach mitigated the need for destructive laboratory testing, saving time and money to repair/replace the precast beam and resumption of construction safely, maintaining the original timeline and budget.
