Identify and Characterize Defects in Forged Components like Gas Turbine Rotors

This application note describes how to inspect gas turbine rotors with ultrasonics.

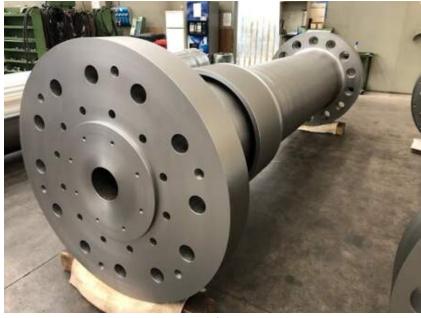
Item Condition:

- Roughness of the surfaces must not exceed 12.5 μm Ra
- · Surface cleaned and free from dirt, grease, paint, etc

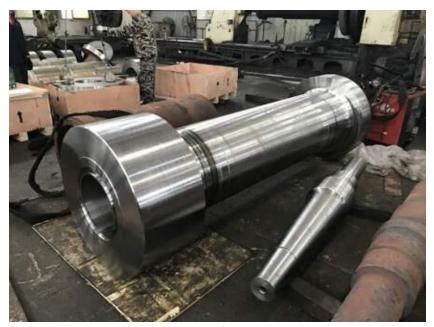
The micro-structure of the material as well the thickness can have impact on the ultrasound inspection, having a good signal- to- noise rate is important to identify grouped discontinuities as well isolated discontinuities.

DGS or DAC curve can be used to identify and characterize the defects in forged components like gas turbine rotors.

With the <u>Proceq UT8000</u> you have the possibility to record the A Scan pick of the defects and export the images/video directly on the report. Thanks to his 400 V square pulse you have the possibility to work with a lower noise level that allow the technician to identify and classify, more easily, the extended or grouped discontinuities defect. With his great signal- to- noise rate, UT8000 is making it easier to identify the defect.
