Bolt inspection: Internal Defect Assessment & Data Management

The purpose of this project was to investigate the capabilities of ultrasonic testing for detecting early failure of bolts and to log the data together with the bolt location. The customer was particularly interested in bolts along linear assets such as railway tracks.

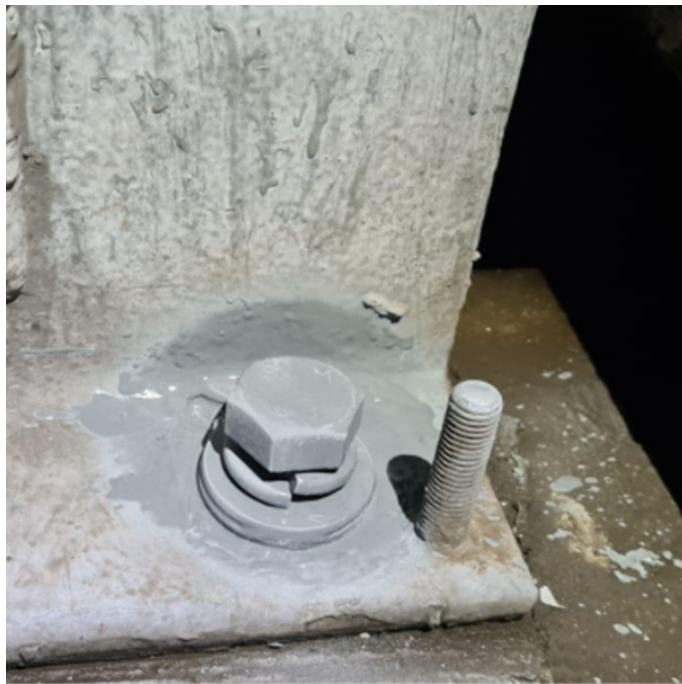
Bolt in-situ.

Causes of bolt failure in heavy industry include corrosion and overtightening. Failure starts from the weakest point, typically just beneath the bolt head. The result is that the bolt head is eventually sheared off, rendering the bolt useless. An inspection method is required to detect any defects as early as possible, before ultimate failure.

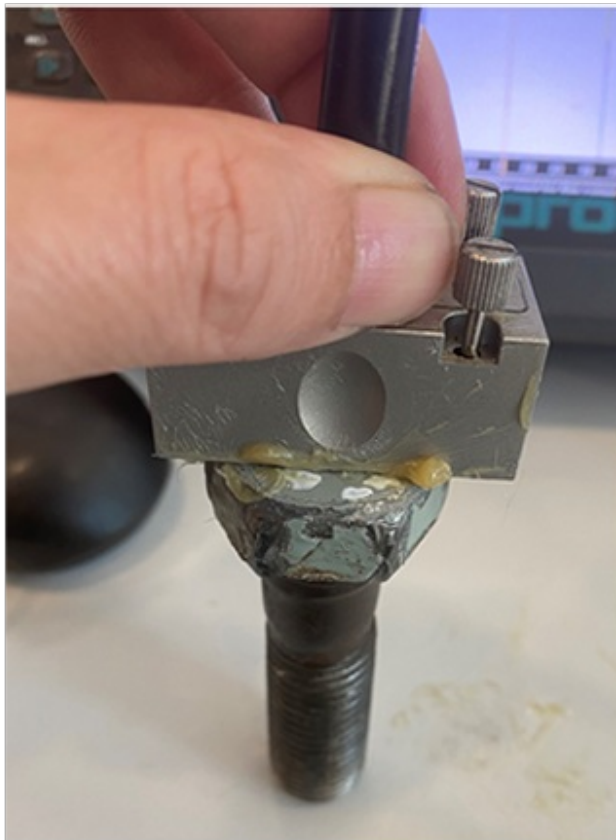
Phased array probe being held on a bolt. The bolt is ex-situ for the 'proof of concept' project but an identical testing method can be used with the bolt in-situ

The proposed solution is to use [ultrasonic pulse-echo technology](#) to non-destructively check the condition of the material, whilst not causing any damage or disturbance to the existing bolt. Two types of ultrasonic pulse-echo technology can be used. The first is conventional ultrasonic testing which provides the inspector an A-scan (amplitude-time plot) that must be interpreted by an expert. The second and more advanced option is phased array testing which provides the inspector with an image of the interior of the bolt. This is much easier to interpret, immediately on-site.

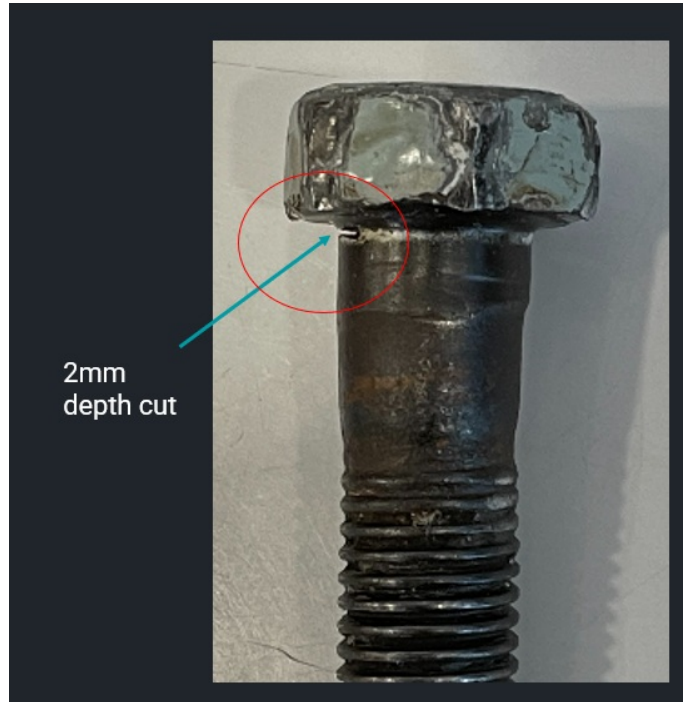
Bolt with a 2mm depth cut to simulate a defect.

To test out the proposed solution, a defect was simulated using a 2 mm cut, just beneath the bolt head. Phased array testing was used to get images from the two bolts - one with no cuts and one with the 2mm cut. In the images, the bolt threads and base of the

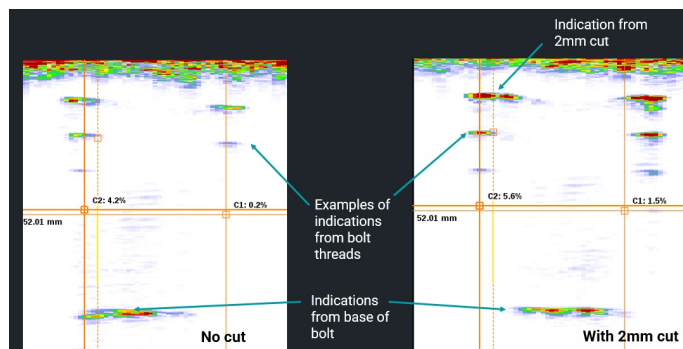
Phased array images from a bolt with no cut (left hand side) and a bolt with a 2mm cut (right hand side)

bolt can be identified. And in the bolt with the 2mm cut, an additional indication is visible from the 2mm cut. Further tests were conducted and it was concluded that ultrasonic array technology is a suitable approach for testing and sentencing bolts on-site.
