Figure 1. PT tendon locations inside the box beam

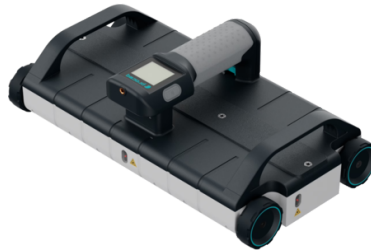
Figure 2. Proceq GP8100
GPR

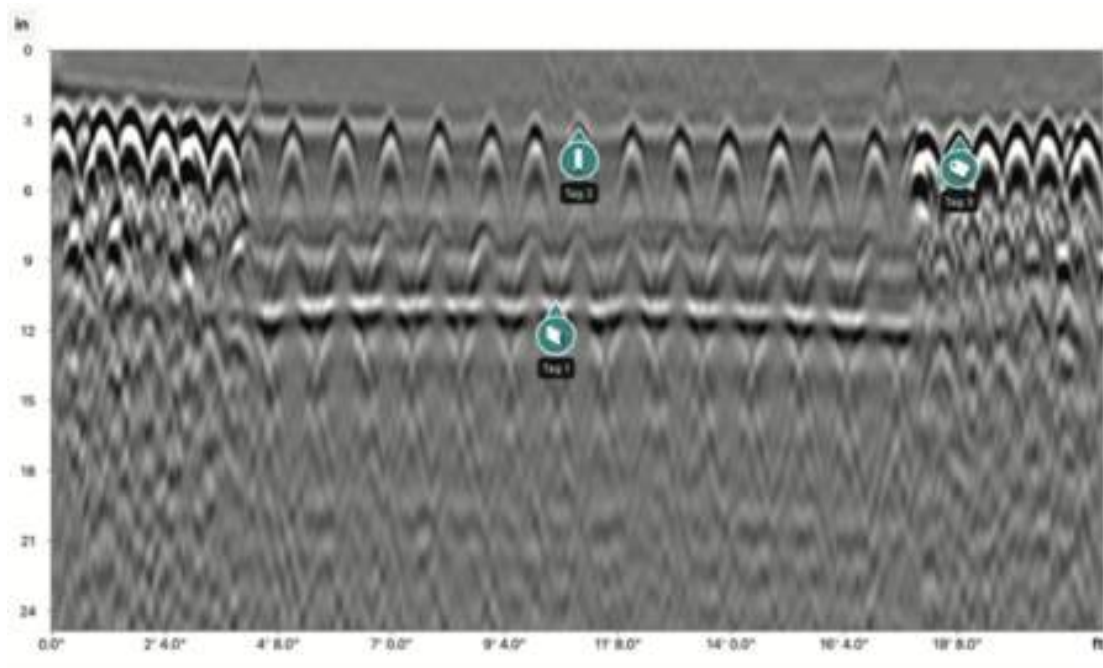
Figure 4: GPR scan across box girder width.

- ☐ Rebar
- ☐ Non Metallic
- ☐ Backwall
- ☐ Void
- ☒ Live Wire

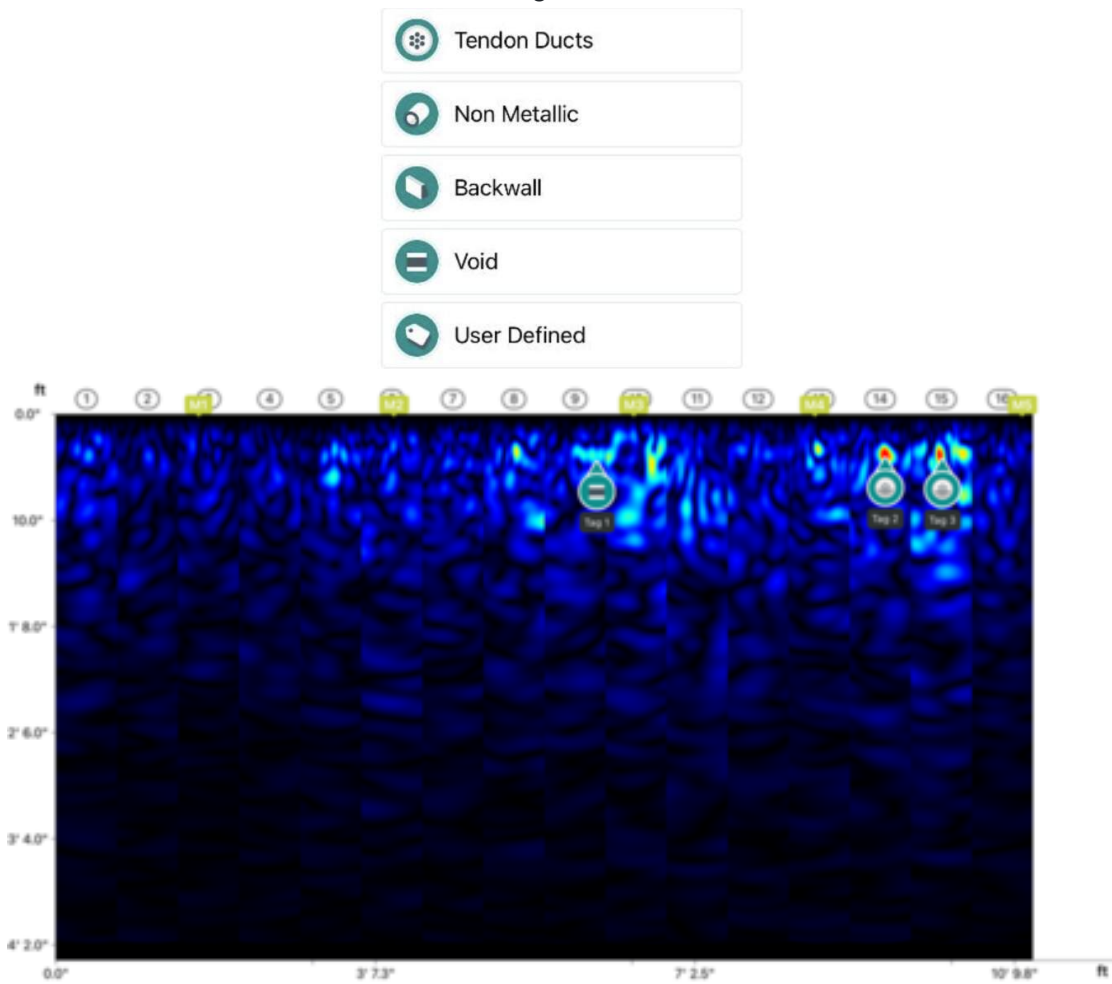
Figure 7: UPE scan

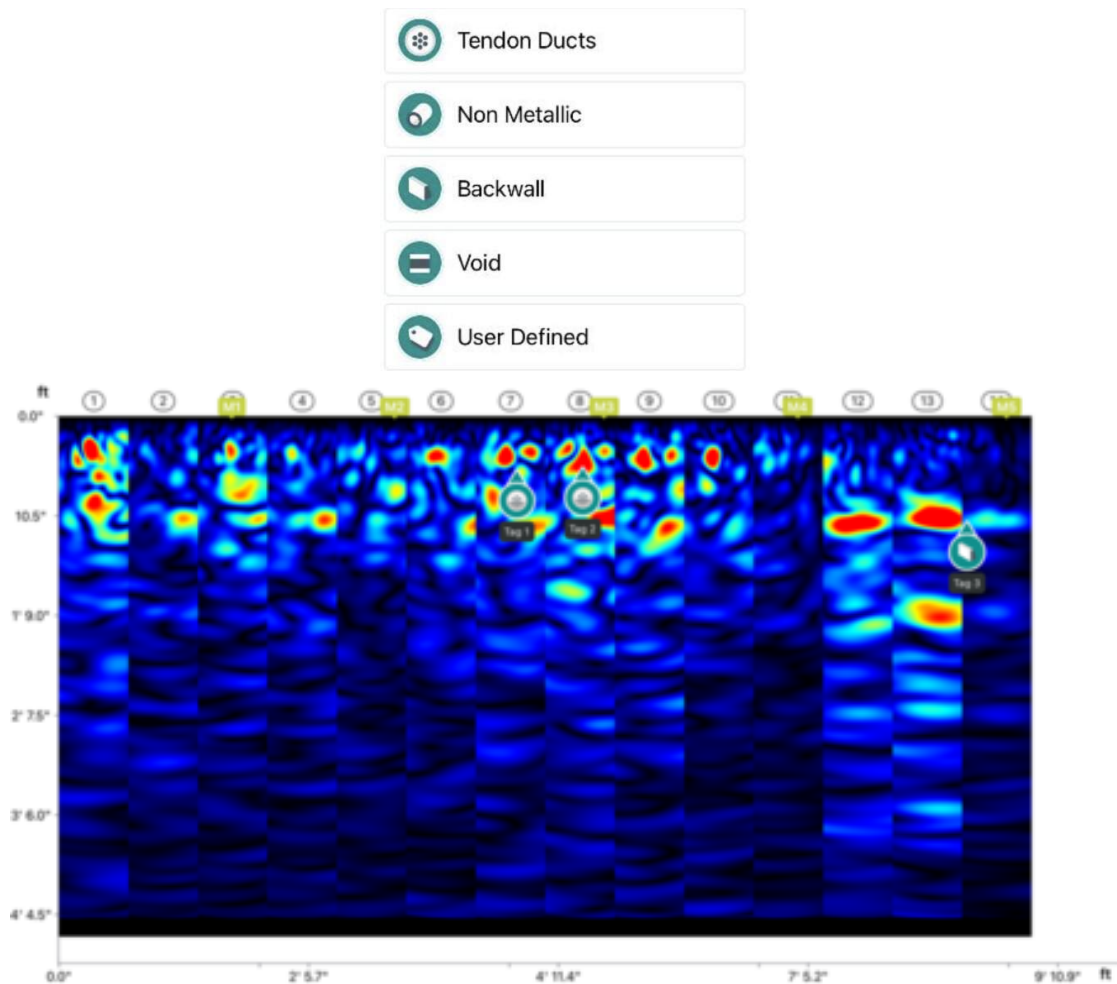
Figure 8: UPE scan
