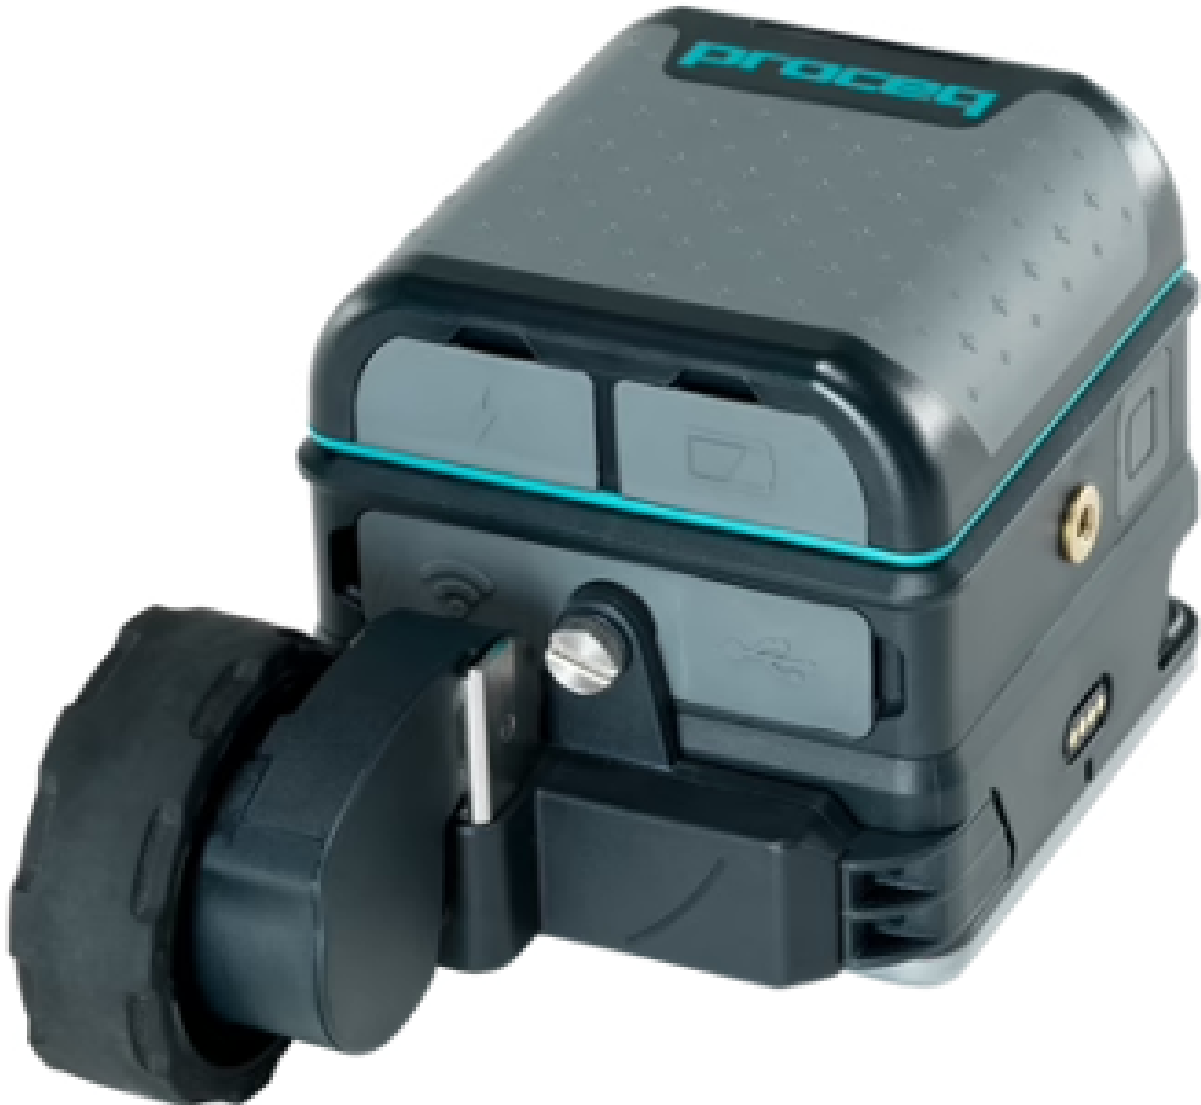
Figure 2: Proceq GP8800

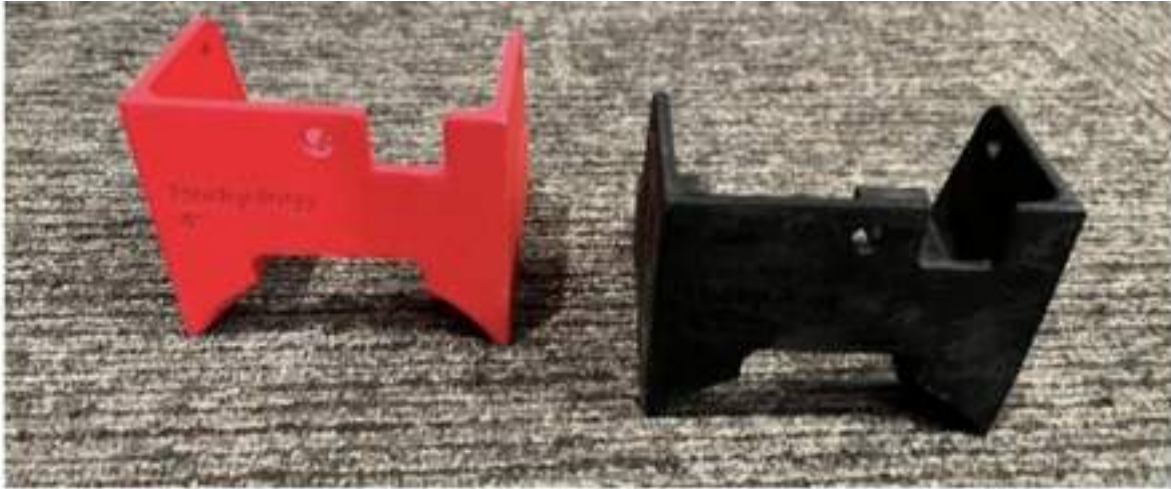
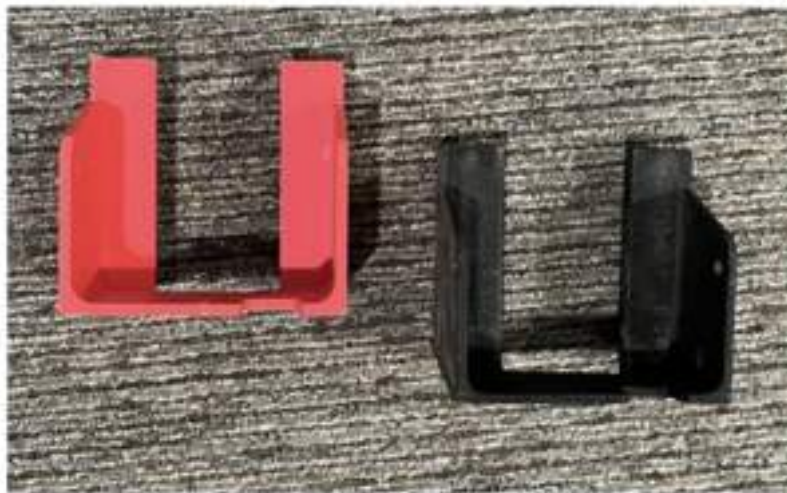
Figure 3: PT duct saddle

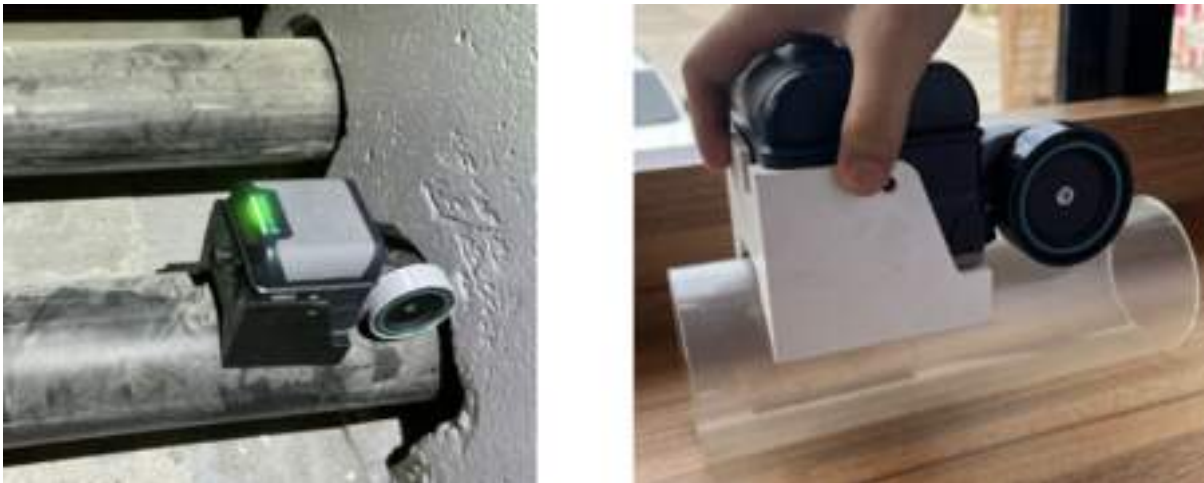
Figure 4: Saddle positioning in the field

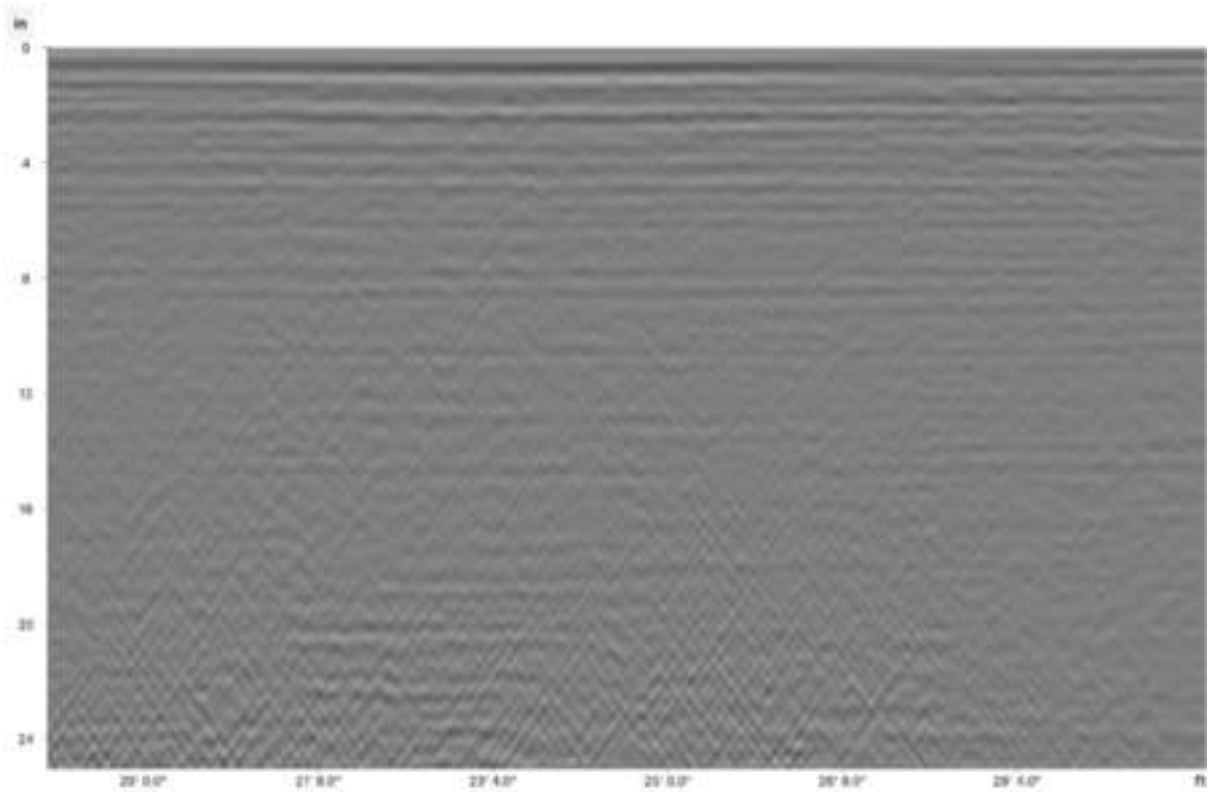
Figure 6: Data collected in the field

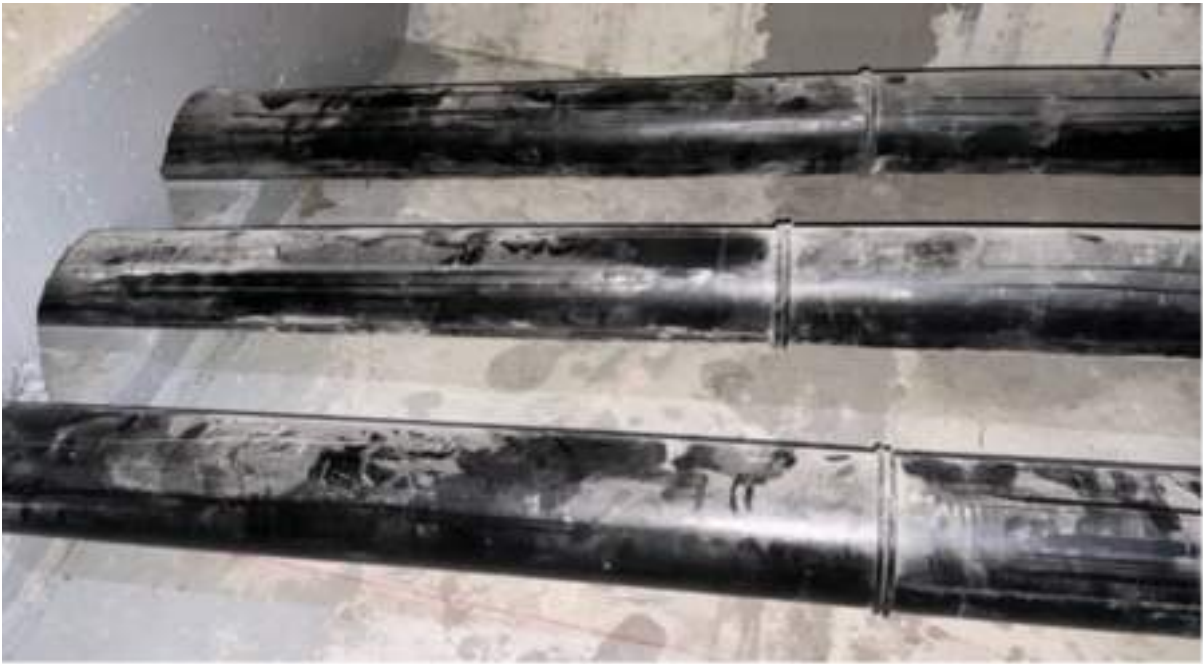
Figure 7: Anchorage and welding joints blockers

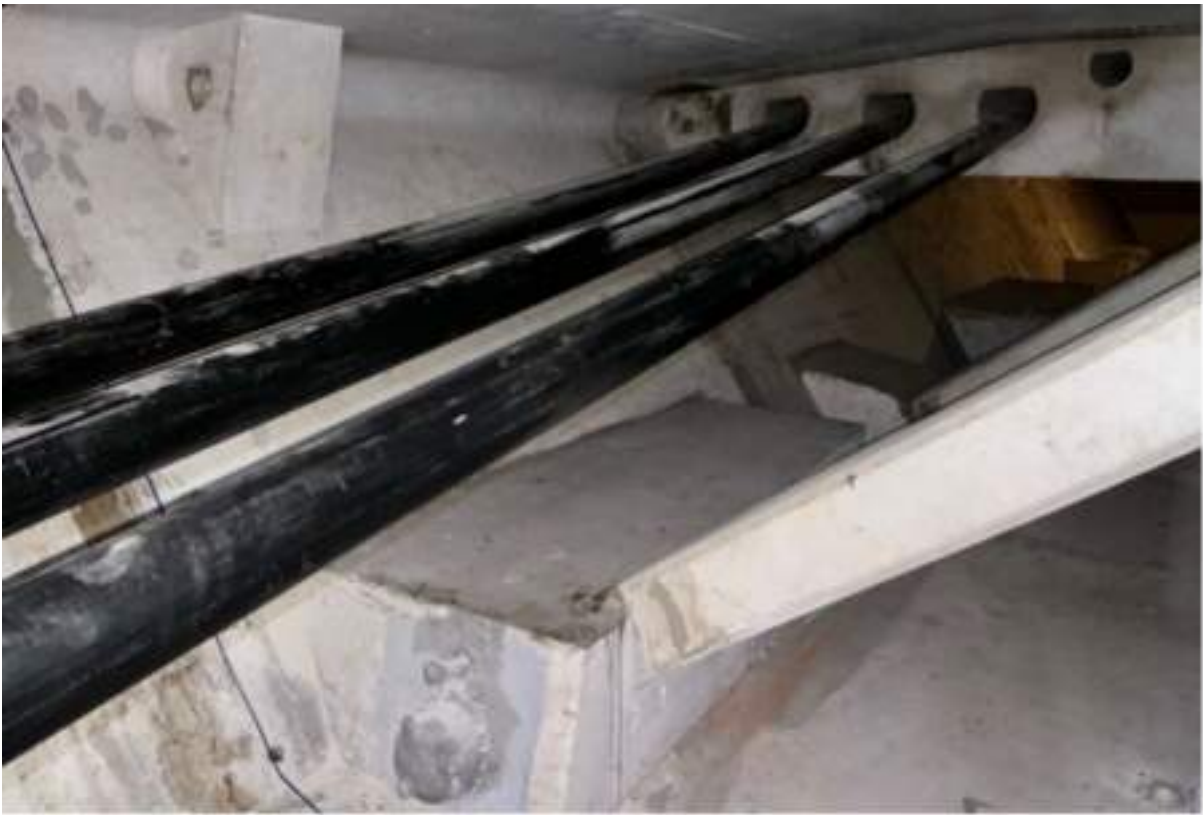
Figure 8: Obstacles around ducts

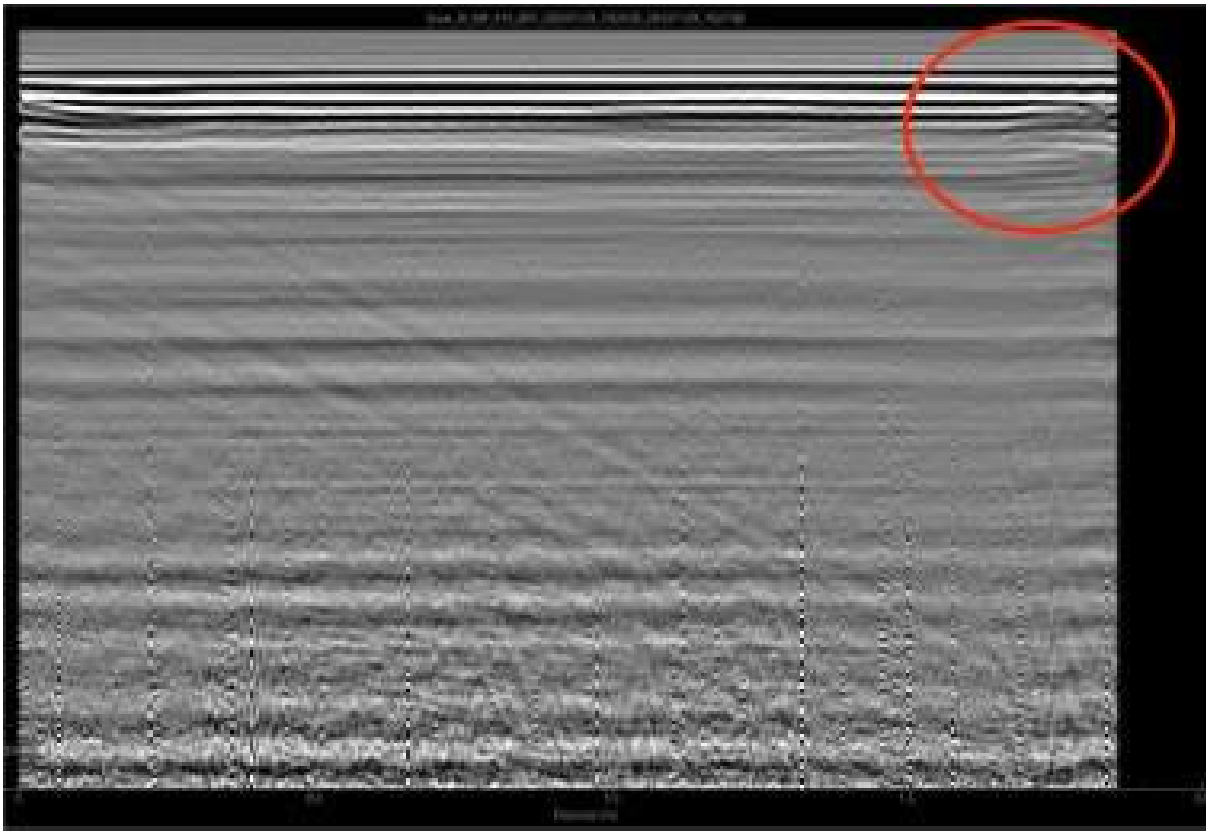
Figure 9: High likelihood of solid filler

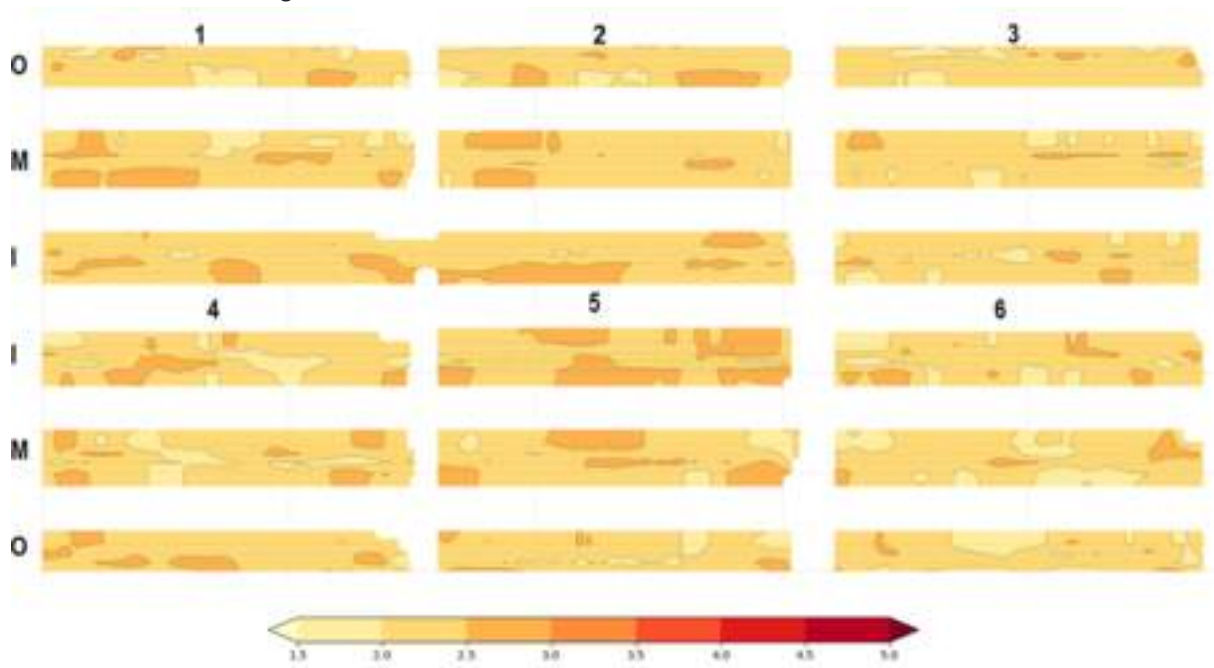
Figure 12: Homogeneity chart of section
