Precision Horse Racetrack Inspection Using High-Resolution Multichannel GPR

Identifying hidden soil anomalies to protect safety at horse racing tracks

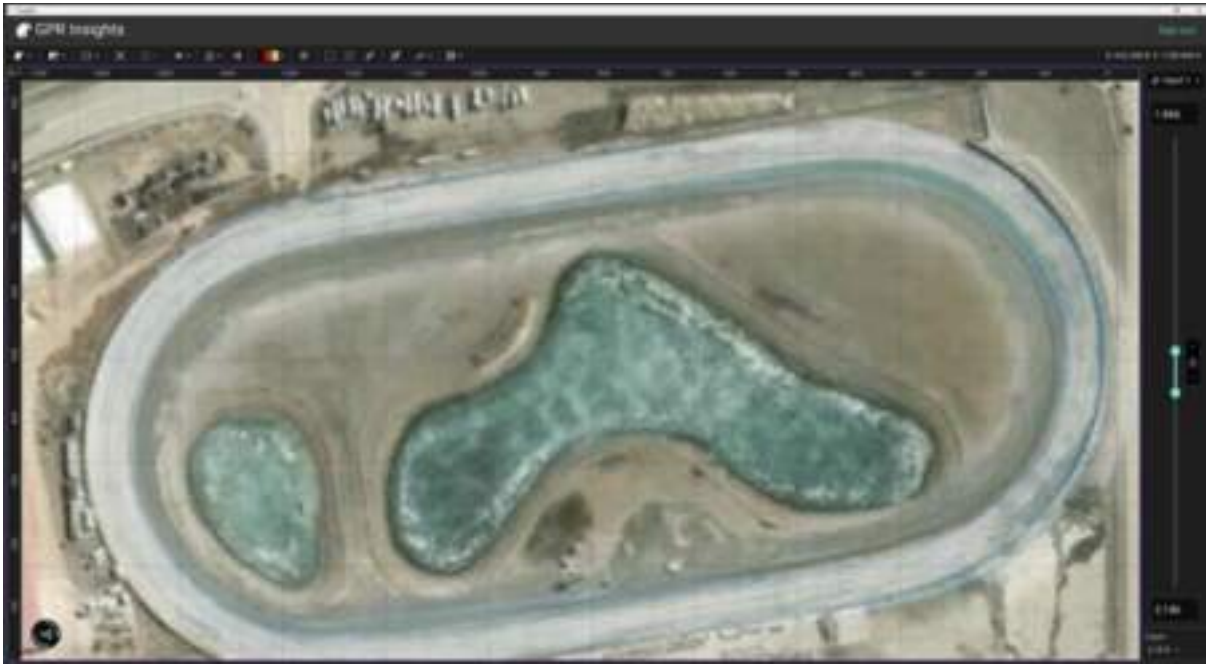
Figure 1: The GPR scan path displayed on a satellite image. Data collection began and ended in the northwest corner, utilizing Imperial units for local reporting standards.

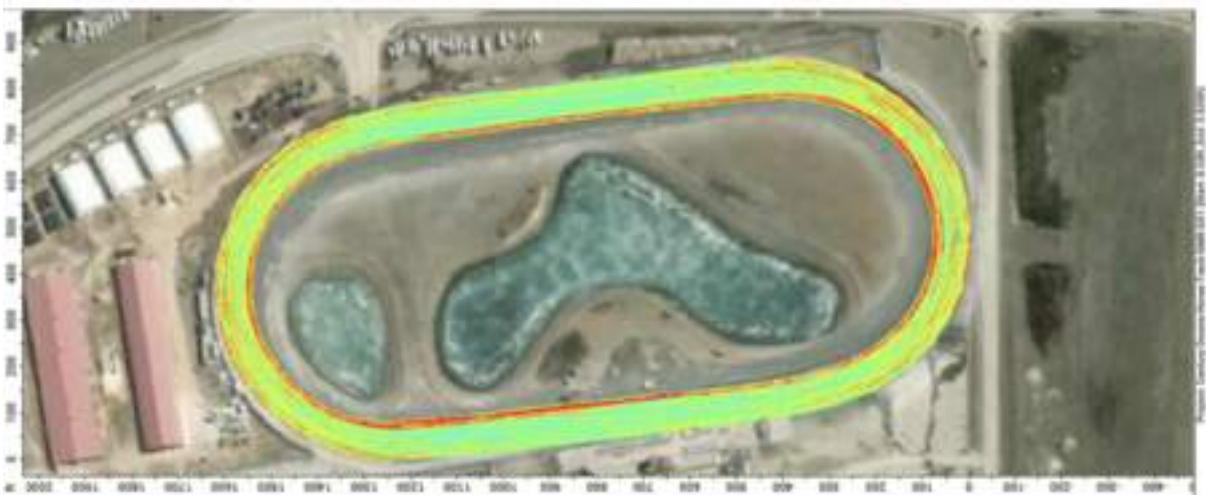
Figure 2. Illustrates the soil variability on the inside of the track

The scan results provided immediate clarity for the maintenance team. The data confirmed higher soil compaction on the inside of the track, where horses travel most frequently, and higher uniformity in less-traveled outer regions. Specifically, the Northeast turn of the track showed a 400ft non-uniform soil disturbance (Figure 4). There was a localized soil feature spanning 20ft (Red Box on Figure 4) with a 9° degree incline (Figure 5).

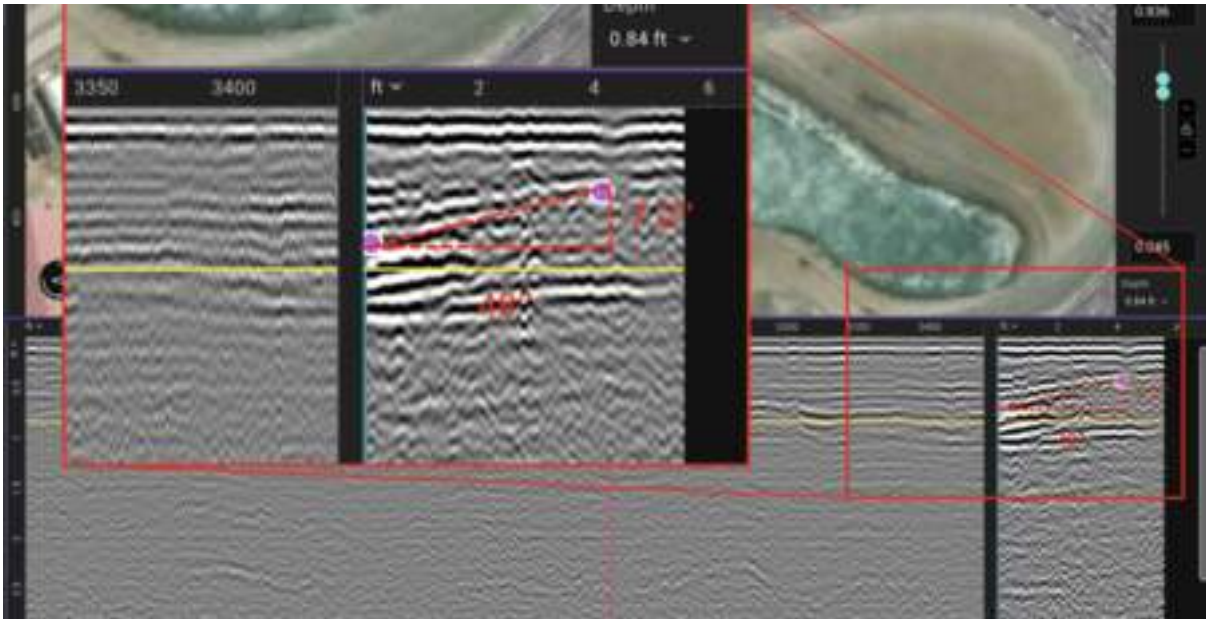
Figure 5. GPR data showing localized soil feature spanning 20ft with a 9° degree incline. By integrating the GM8000 and GX1 antenna into their track inspection routine, maintenance teams can:
