# Precision Horse Racetrack Inspection Using High-Resolution Multichannel GPR

## Identifying hidden soil anomalies to protect safety at horse racing tracks

This application note explores how the [GM8000 mobile mapping ground penetrating radar](#) (GPR) provides horse racing track maintenance teams with a non-destructive, high-speed method to assess track health, ensure compliance, and protect both equine and athlete safety.

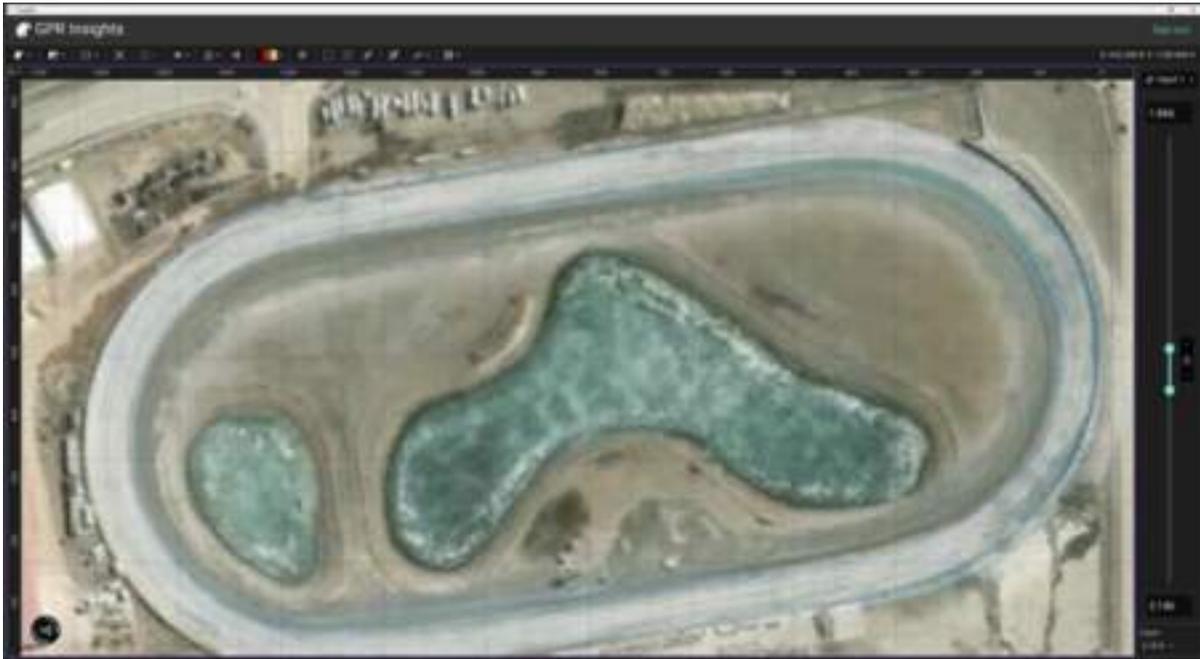
Figure 1: The GPR scan path displayed on a satellite image. Data collection began and ended in the northwest corner, utilizing Imperial units for local reporting standards.

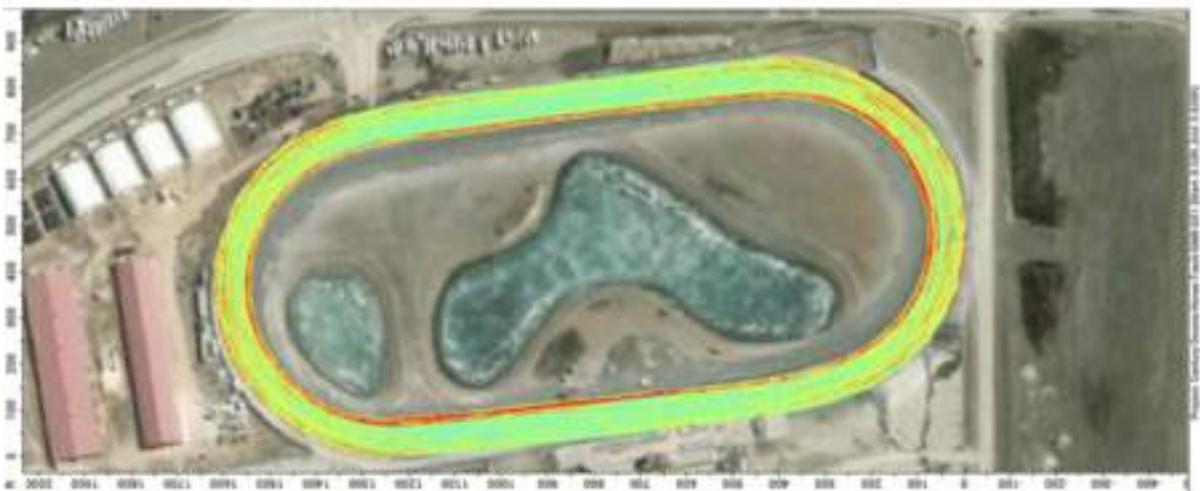
Figure 2. Illustrates the soil variability on the inside of the track

The scan results provided immediate clarity for the maintenance team. The data confirmed higher soil compaction on the inside of the track, where horses travel most frequently, and higher uniformity in less-traveled outer regions. Specifically, the Northeast turn of the track showed a 400ft non-uniform soil disturbance (Figure 4). There was a localized soil feature spanning 20ft (Red Box on Figure 4) with a 9° degree incline (Figure 5).

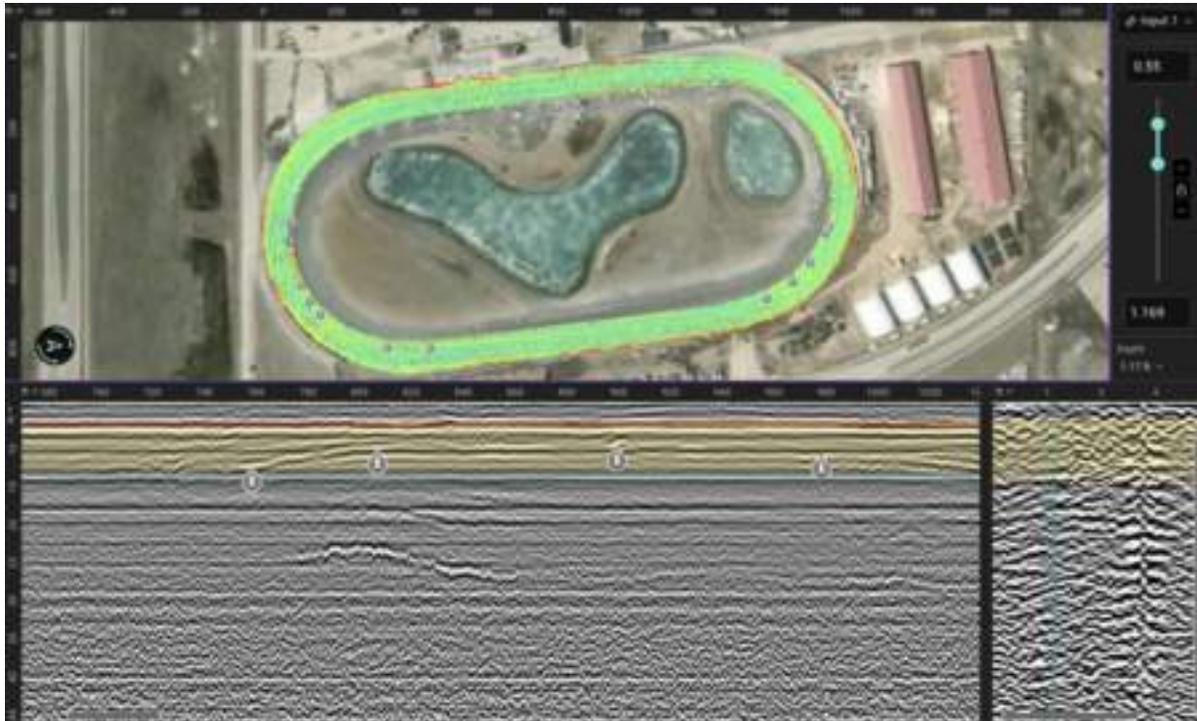
In this specific track, designed with two layers of engineered soil, the GM8000 identified several points of interest. These can range from buried horseshoes to critical structural concerns like breaks in soil layers or potential underground voids.

Figure 3. GPR data showing georeferenced tags of detected anomalies

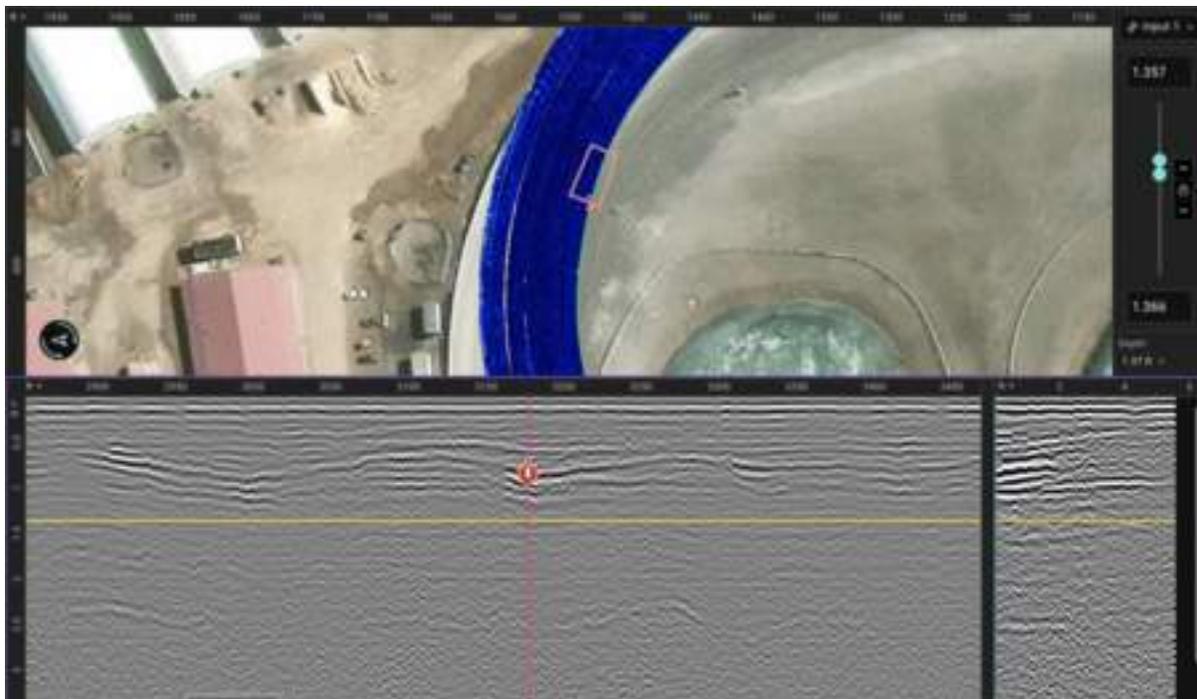
Figure 4. GPR data showing non-uniform soil disturbance.

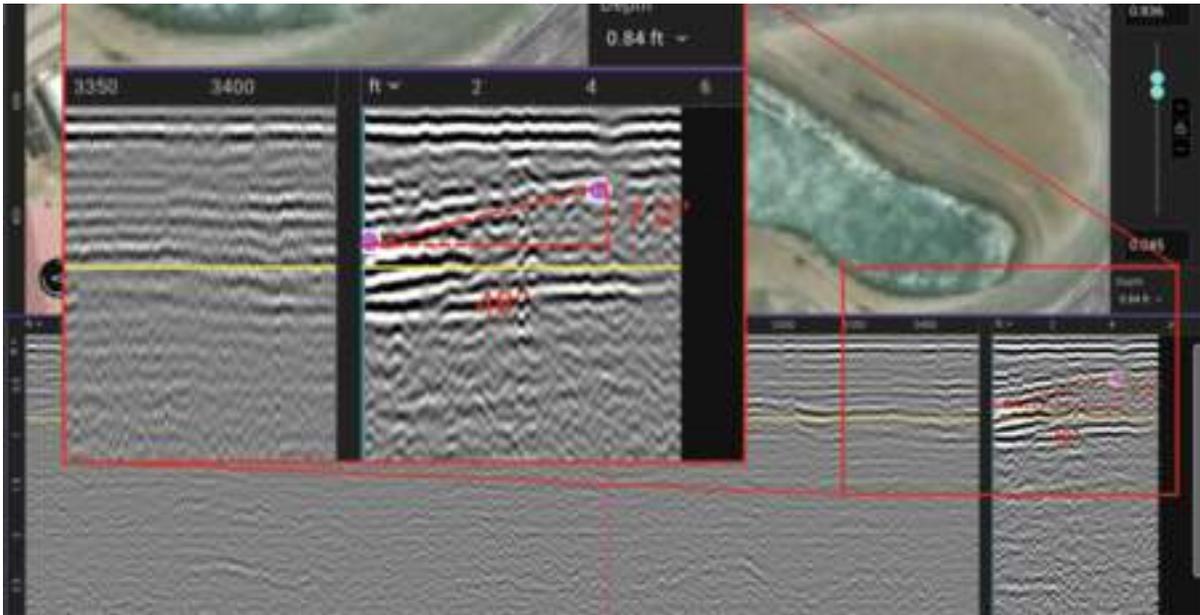
Figure 5. GPR data showing localized soil feature spanning 20ft with a 9° degree incline. By integrating the GM8000 and GX1 antenna into their track inspection routine, maintenance teams can:
