Efficient Detection of Corrosion in the Concrete floors of a Parking Garage

Nebest investigates large parking garage for corrosion using advanced half-cell potential technology

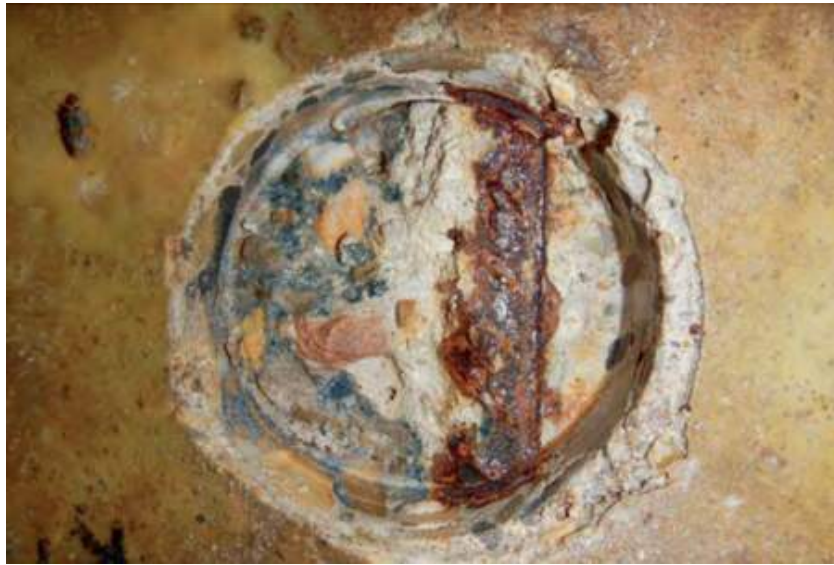
The floors of a parking garage under a former office building in the center of Rotterdam showed some local damage with compressed concrete. The building had been purchased by a property developer, who wanted to repurpose it as a high-end apartment complex.

Prior to the large-scale renovation of the complex, a good insight into the condition of the parking garage, investigation was needed in order to determine the nature and extent of the necessary maintenance measures.

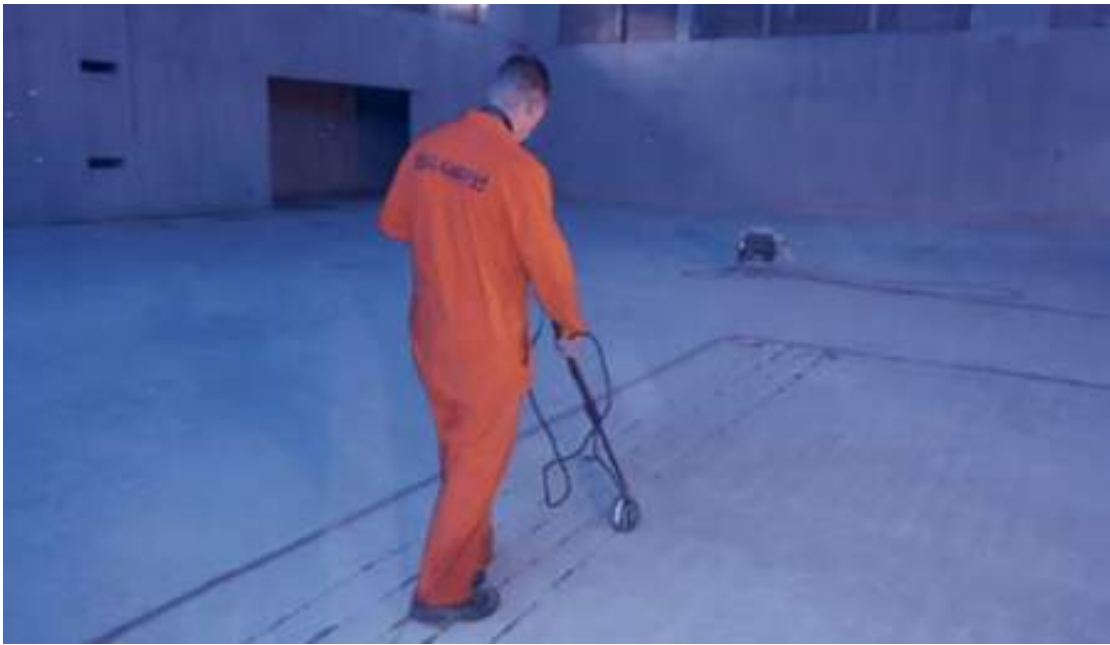
Performing half-cell potential measurements on the concrete floor with the Profometer PM8500 corrosion sensor
