Identify and Characterize Defects in Forged Components like Gas Turbine Rotors

This application note describes how to inspect gas turbine rotors with ultrasonics.

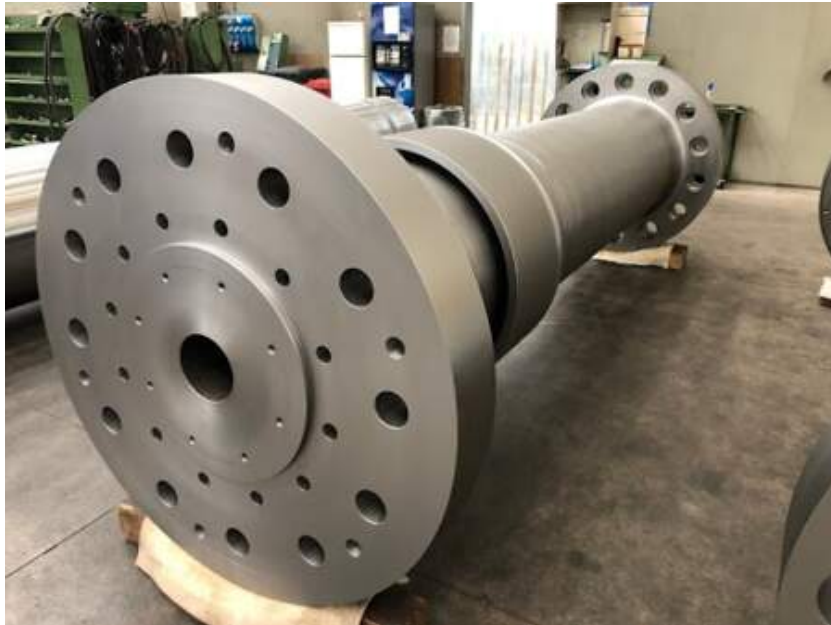
The forged disk shall be 100% ultrasonically tested according with the EN 10228-3.

- Roughness of the surfaces must not exceed 12.5 $\mu\text{m Ra}$
- Surface cleaned and free from dirt, grease, paint, etc

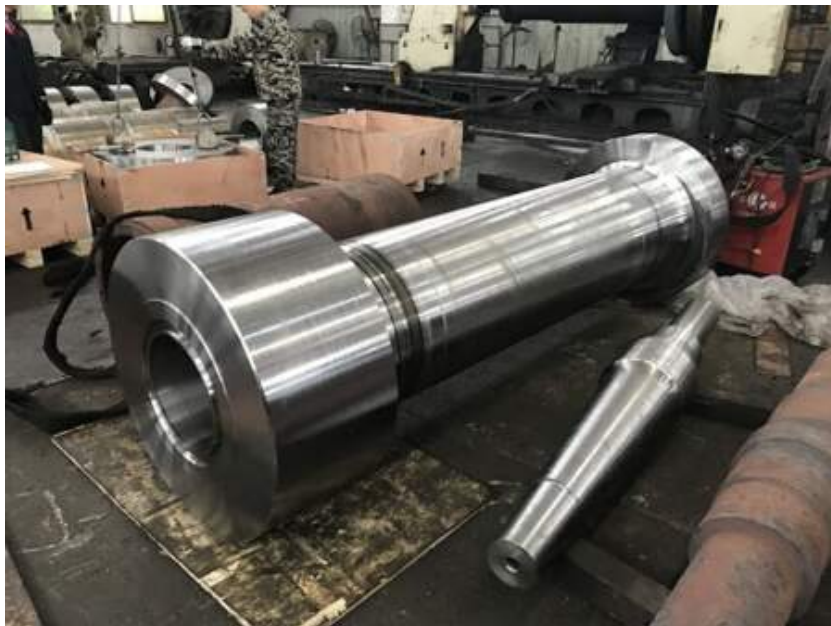
DGS or DAC shall be used for setting sensibility. Calibration shall be done on a test block on same material and heat treatment of the controlled item, as stated in paragraph 7.4 of EN 10228-3.

According to the table reported in the norm, the technician should be able to identify isolated discontinuities and grouped discontinuities.

The micro-structure of the material as well the thickness can have impact on the ultrasound inspection, having a good signal-to-noise rate is important to identify grouped discontinuities as well isolated discontinuities.

DGS or DAC curve can be used to identify and characterize the defects in forged components like gas turbine rotors.

With the [Proceq UT8000](#) you have the possibility to record the A Scan pick of the defects and export the images/video directly on the report. Thanks to his 400 V square pulse you have the possibility to work with a lower noise level that allow the technician to identify and classify, more easily, the extended or grouped discontinuities defect. With his great signal- to- noise rate, UT8000 is making it easier to identify the defect.
