# Identify and Characterize Defects in Forged Components like Gas Turbine Rotors

This application note describes how to inspect gas turbine rotors with ultrasonics.

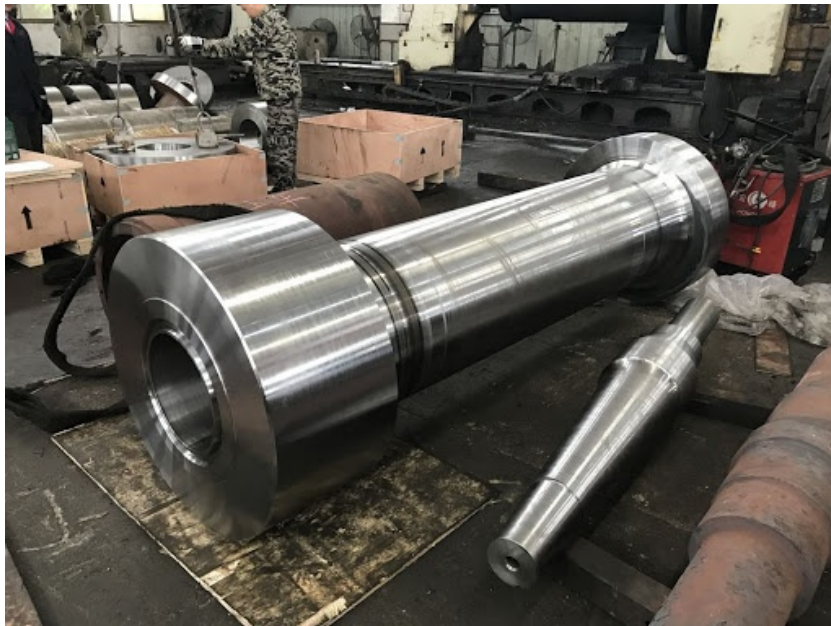
DGS or DAC curve can be used to identify and characterize the defects in forged components like gas turbine rotors.

With the [Proceq UT8000](#) you have the possibility to record the A Scan pick of the defects and export the images/video directly on the report. Thanks to his 400 V square pulse you have the possibility to work with a lower noise level that allow the technician to identify and classify, more easily, the extended or grouped discontinuities defect. With his great signal- to- noise rate, UT8000 is making it easier to identify the defect.
