## Identify and Characterize Defects in Forged Components like Gas Turbine Rotors

This application note describes how to inspect gas turbine rotors with ultrasonics.

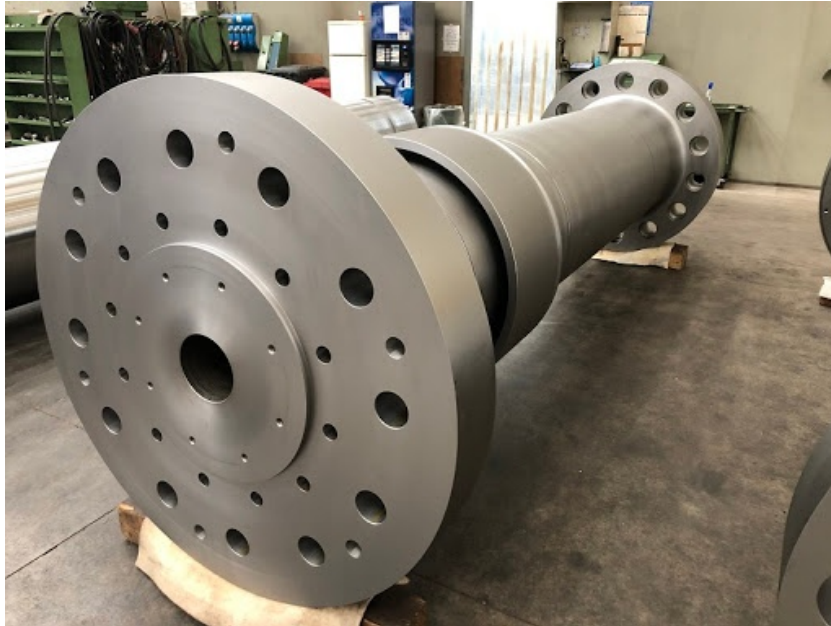
caption

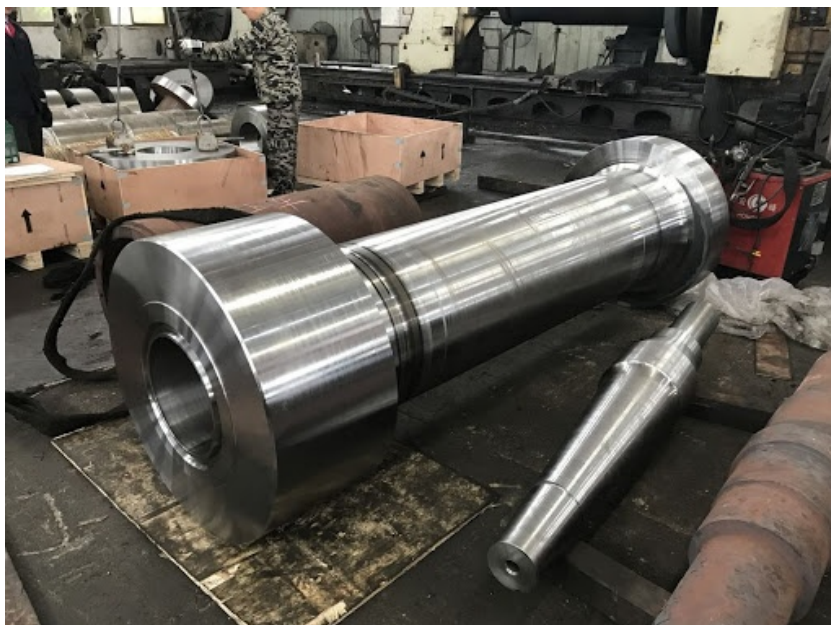
caption

DGS or DAC curve can be used to identify and characterize the defects in forged components like gas turbine rotors.
